Corrosion Behaviour of Materials in H₂S Abatement System for Geothermal Power Plants

60 ECTS thesis submitted in partial fulfillment of a
Magister Scientiarum degree in Mechanical Engineering

Faculty of Industrial Engineering,
Mechanical Engineering and Computer Science
School of Engineering and Natural Sciences
University of Iceland
Reykjavik, October 2015

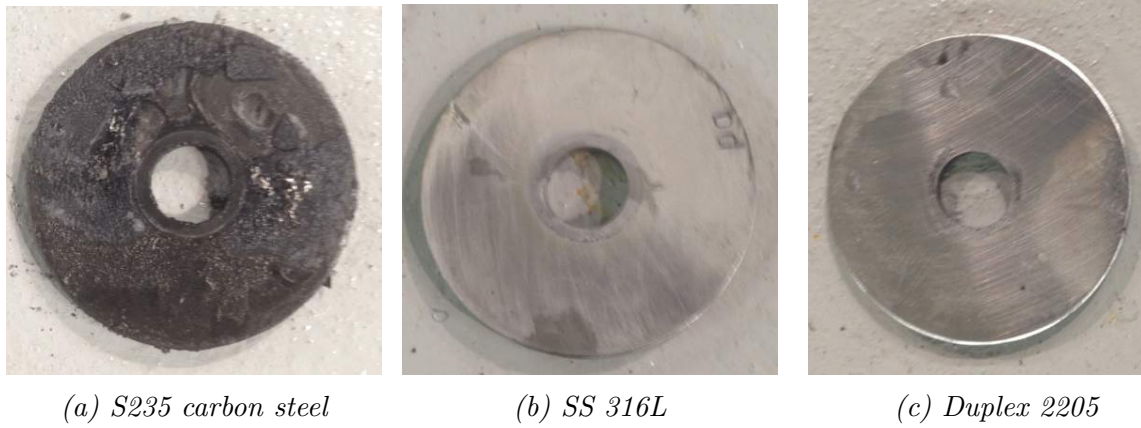
Figure 6.1: Coupons after they were collected from the absorption tower.

Visual inspection on carbon steel S235 showed a layer of dark corrosion products on the surface. The layer was hard, loose and fragile, specially after it had dried up, meaning that the corrosion products could easily fall off the sample. One carbon steel sample showed significant material loss. Figure 6.2 shows the difference on the carbon steel samples after chemical cleaning, it is clear that the lower sample was more corroded than the other.

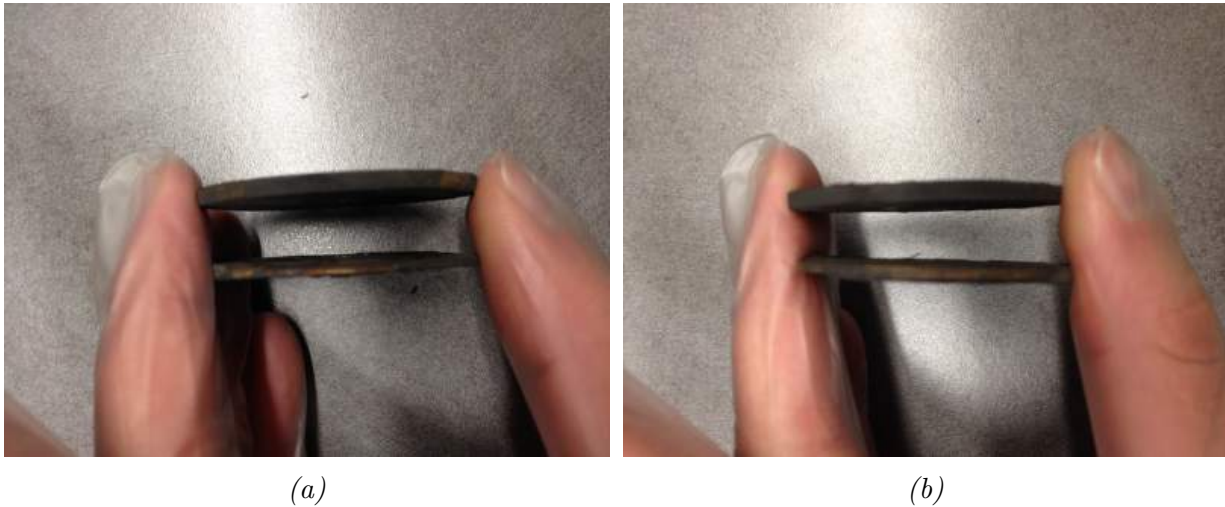
Figure 6.2: S235 Carbon steel. Thickness difference of the samples after a 4 week test.

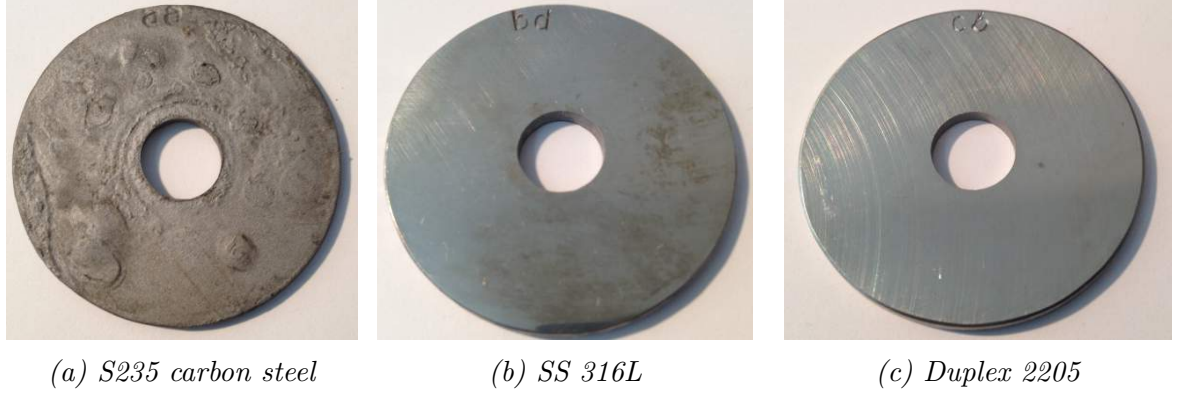
Hydrogen Induced Cracking (HIC) damages. The stainless steels, Figures 6.3b and 6.3c, were scale free and still showed no signs of corrosion. Further examination with the scanning electron microscope (SEM) and X-ray energy dispersive spectroscopy (XEDS) was used for analysing and to verify the absence of cracks and corrosion damages in the stainless steels as well as investigate the corrosion on the carbon steel. These results along with corrosion rate results are shown in the following sections.

Figure 6.3: Coupons after they were chemically cleaned.

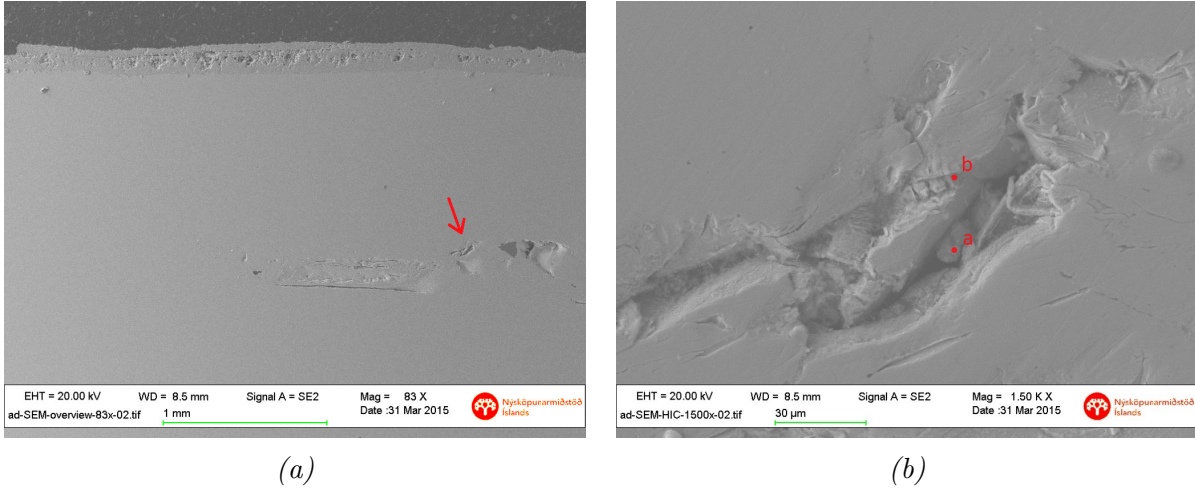
Figure 6.8: SEM image of carbon steel S235, showing an overview of the HIC on the sample. Red arrow points to the HIC damages where XEDS analysis were performed. The areas indicated with a red point on Figure 6.8b.

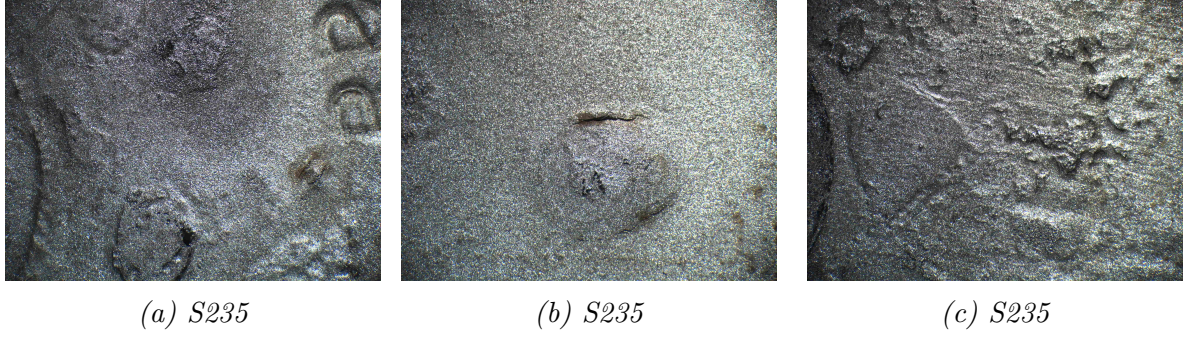
After chemical cleaning of the selected S235 carbon steels, blisters were obvious on the surface of the samples as previously discussed. Figure 6.9 shows the surface of a selected carbon steel S235 that showed the most damages in three different locations. Figure 6.9b shows the blisters on the surface and cracks that have initiated near the blisters ends. These blisters are considered to occur when the hydrogen (H) diffuses into the BCC structure of the carbon steel and combines with another hydrogen (H) and forms H_2 . The formation of H_2 creates internal pressure inside the carbon steel and because of ductility blisters are formed on the surface as well as the cracks in the middle of the metals cross-section.

Figure 6.9: Microscopic images of Carbon steel S235 surface after chemical cleaning.

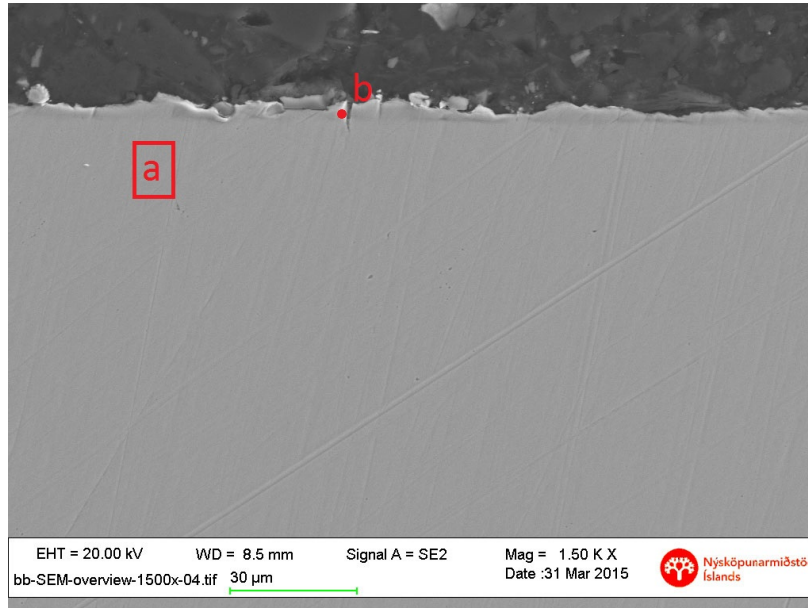
316L coupon was cross-sectioned and viewed in SEM. During the cutting process of 316L alot of heat generated, smoke rose from the sample and a sulfuric smell. Chemical analysis were conducted on the samples as seen in Figure 6.12. The analysis can be seen in Table 6.8. No scaling on the surface of 316L was detected in SEM. The surface was rough and uneven when examined in SEM. It is believed to be a loose material on the edges after the cutting procedure that have not been removed sufficiently, creating artefacts on the surface that could be interpreted as cracks or pits. However, no cracks or pits were detected on the sample.

Figure 6.12: Cross-sectioned SEM images of the austenitic stainless steel 316L where the chemical composition analysis were performed, the areas indicated with a red box and a point.

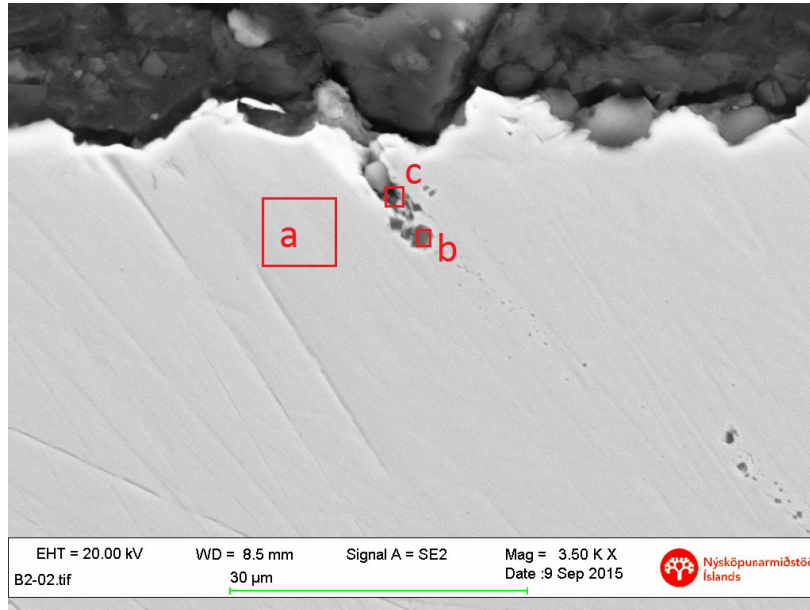
When 304L was examined in SEM, areas were found that could be interpreted as pits or pit initiations, initiations points for cracking, such as SCC. Figure 6.15 shows the locations where chemical composition analysis were made.

Figure 6.15: Cross-sectioned SEM image of U-bent 304L where the chemical composition analysis were performed, the areas indicated with red boxes.

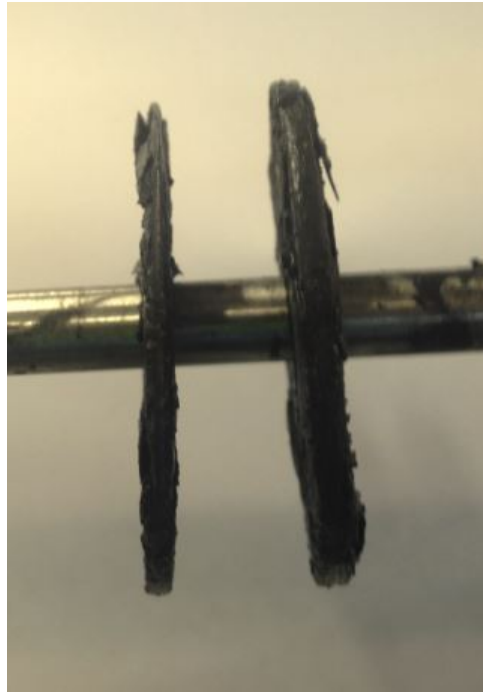
corrosion damages could be found on one of the S235 sample which was located in the same position as the highly corroded sample from previous test. This extremely corroded specimen can be seen in Figure 6.18 where it is compared to a normal sample which corrodes similar as the others. However, the chemical composition analysis from section 6.1.1 showed that no difference in corrosion products on the surface could be found.

Figure 6.18: Comparison of carbon steel coupons in second 4 week test.

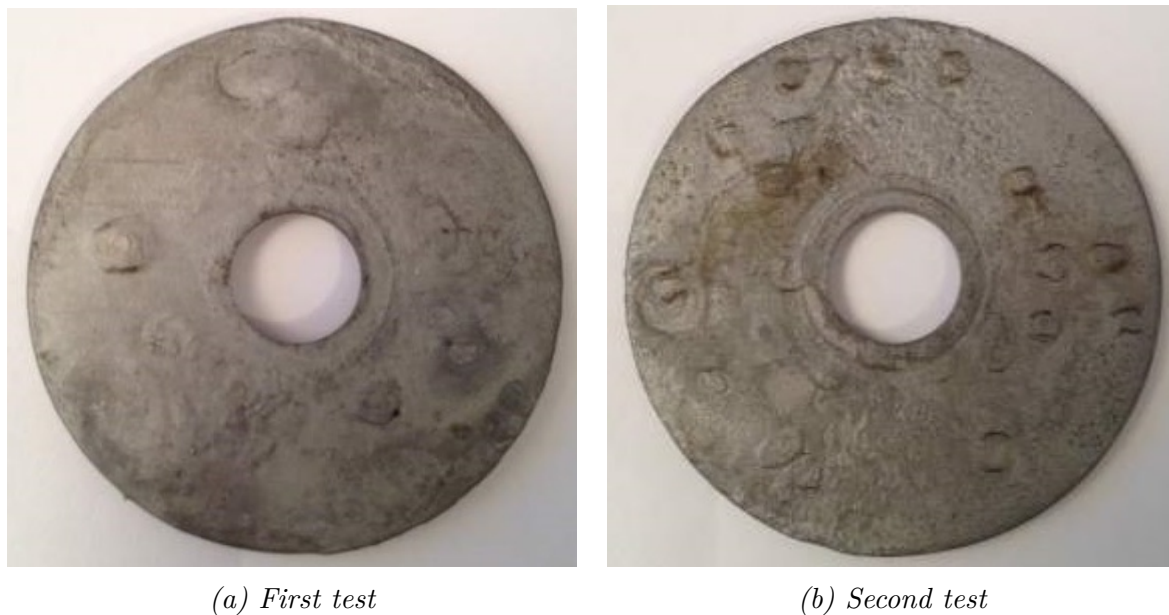
Figure 6.20 shows an example of difference in corrosion damages where the sample on the right represents this test. Figure 6.20 shows how the sample on the right has more blisters compared to the sample on the left.

Figure 6.20: Comparison on carbon steel S235, 4 week tests.

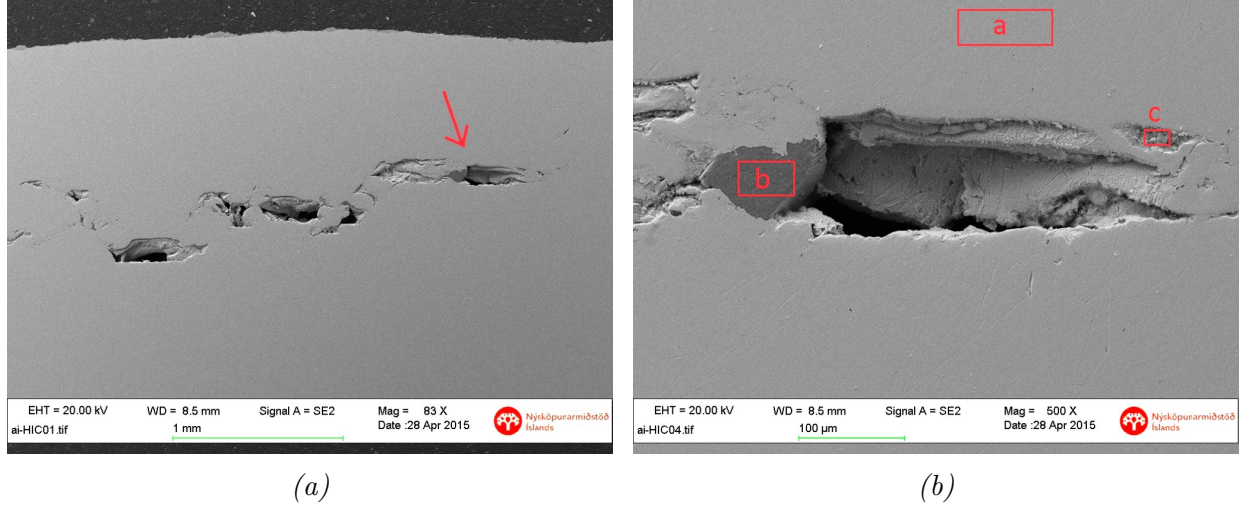
Figure 6.22: SEM images of the cross-sectioned carbon steel S235 where the chemical composition analysis were performed on the HIC damages, the area indicated with a red box.

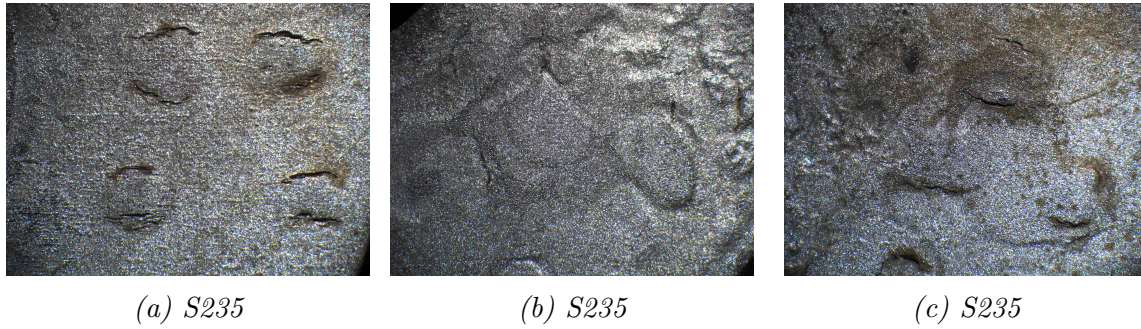
Figure 6.23: Microscopic images of Carbon steel S235 surface after cleaning.

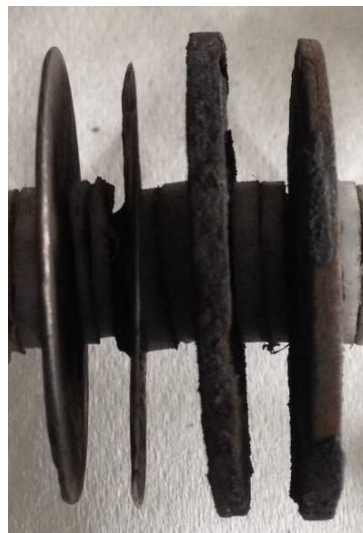
Figure 6.29: Comparison on carbon steel coupons for the 12 week testing, showing difference in thickness due to corrosion.

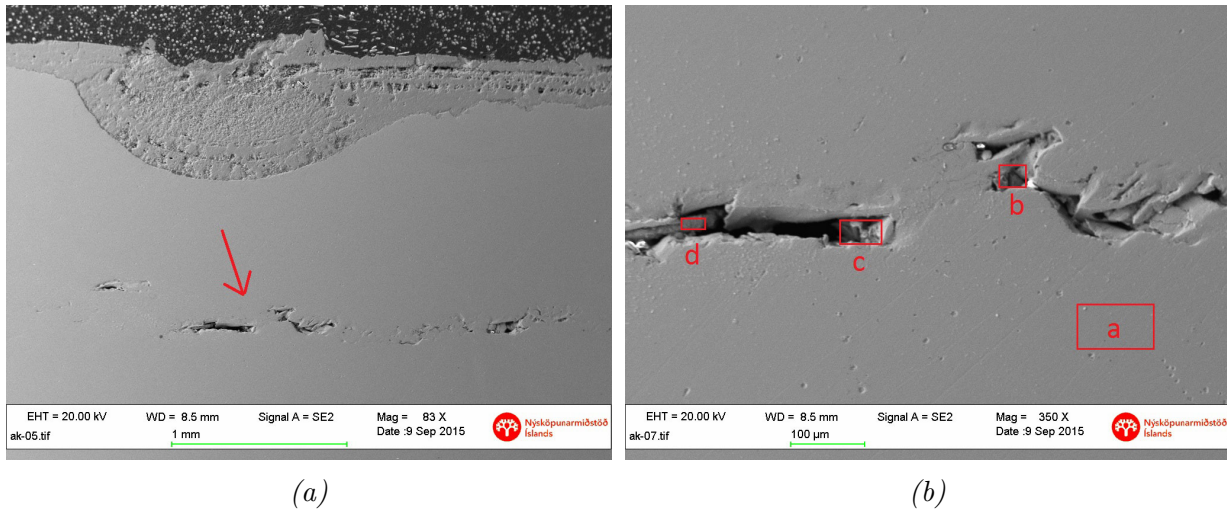
Figure 6.35: SEM images of the HIC damages after 12 weeks testing where the chemical composition analysis were performed, the areas indicated with a red box.

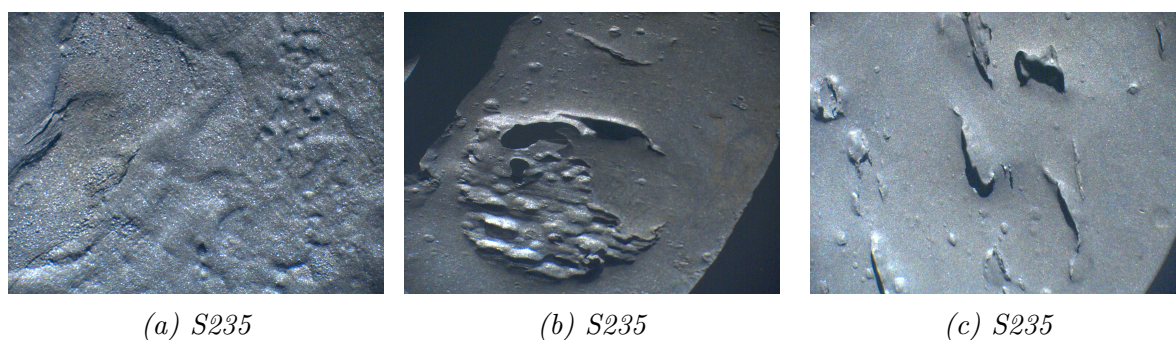
Figure 6.36: Microscopic images of carbon steel S235 surface after cleaning showing severe corrosion damages due to HIC.
