Corrosion in the Kalina cycle

An investigation into corrosion problems at the Kalina cycle geothermal power plant in Húsavík, Iceland

A 30 credit units Master's thesis

Akureyri, February 2009

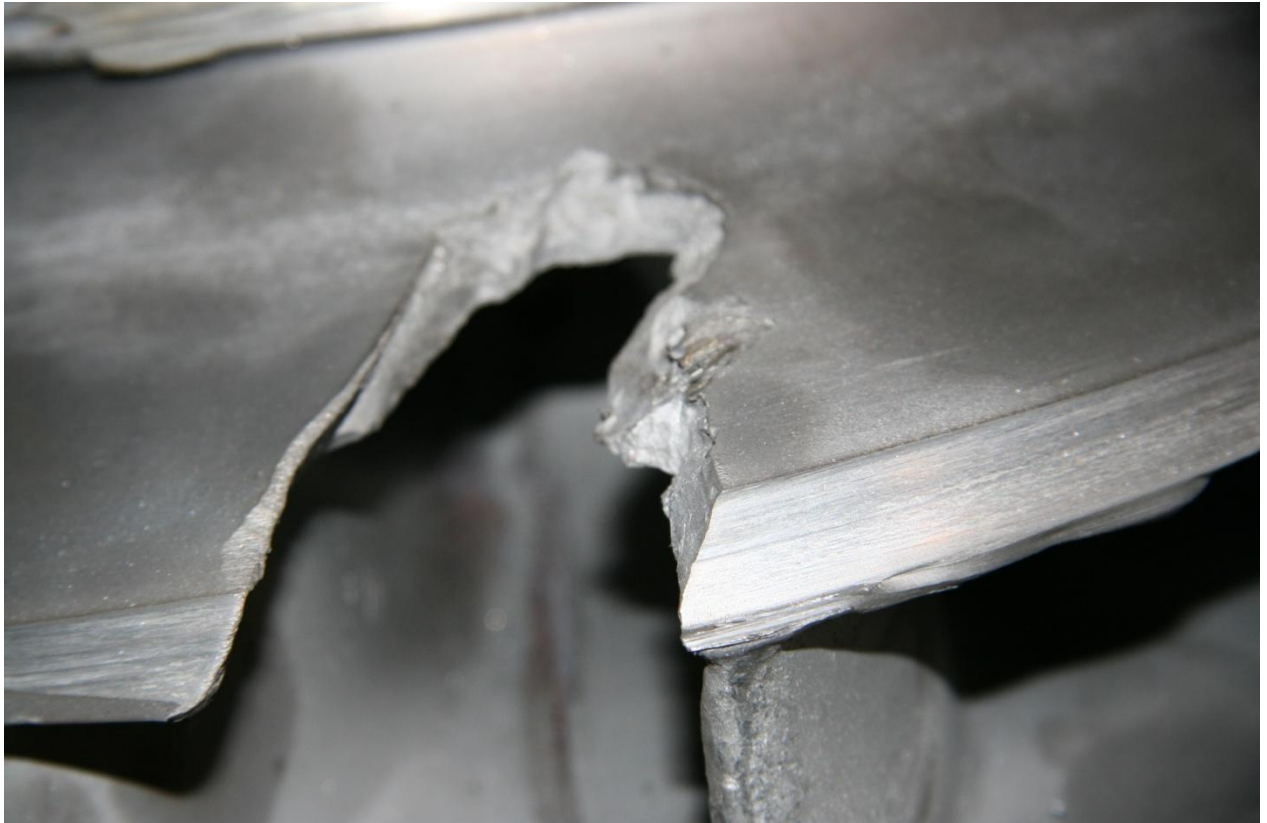
In January 2008 the GE-R turbine suffered a catastrophic failure. A part of the turbine wheel itself broke off and significantly damaged the turbine blades, shaft, nozzle vanes and housing. There were no signs of corrosion on the turbine and this failure is still unexplained. (Ásgeirsson, 2008)

In January of 2008 the titanium turbo-expander wheel from of the GE-Rotoflow turbine, installed in 2004, failed catastrophically. The damaged section of the wheel can be seen in Figure 11.

Figure 11. In January 2008 a piece of the titanium wheel broke loose, forcing the shutdown of the power plant. This material failure has not been explained.

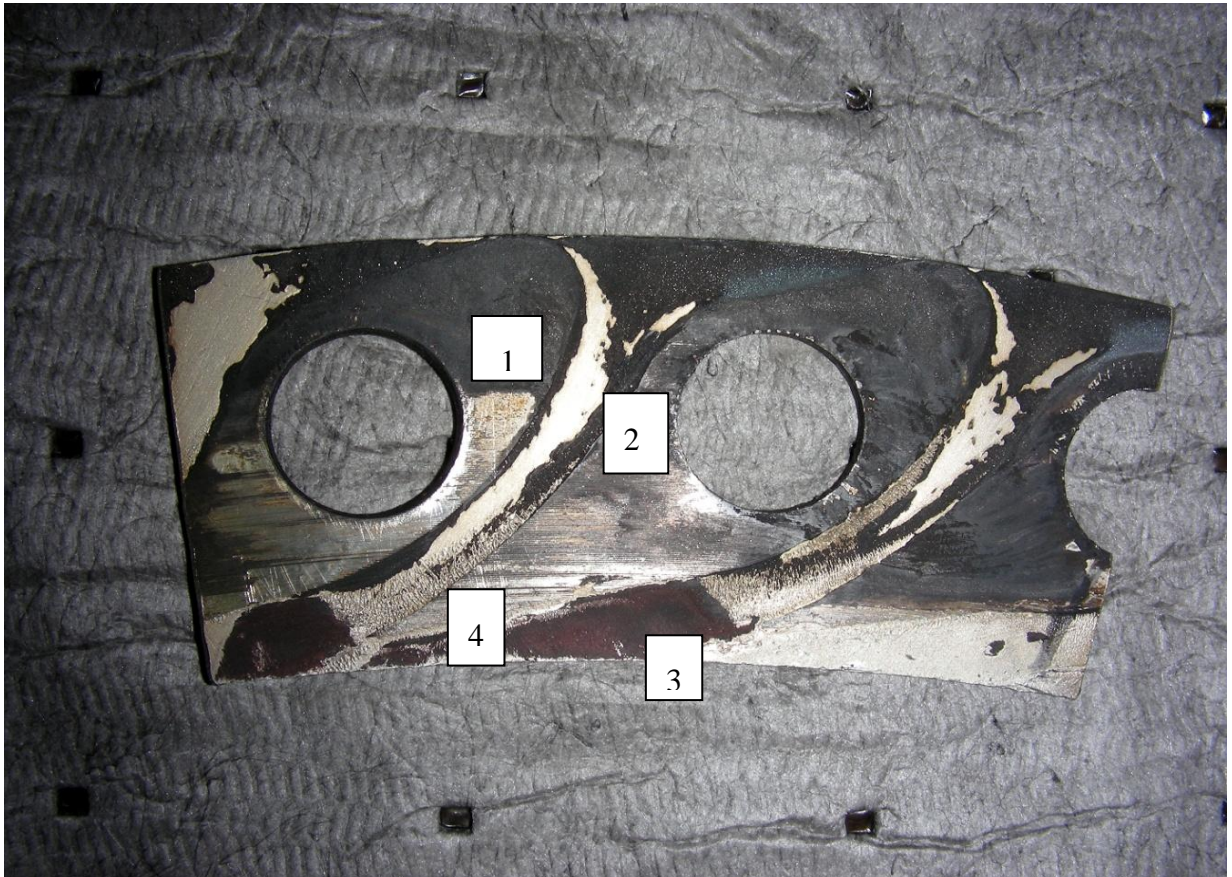
Four regions of sample #2 (Figure 13), a 316 stainless steel spacer ring, were inspected and analyzed. They are numbered as shown in the picture: area 1 the black corrosion products, area 2 the metal of the eroded channel, area 3 brown corrosion products and area 4 a rough area in the eroded channel.

Figure 13. Sample number 2, analyzed by SEM. Four regions were inspected. 1. The black corrosion products. 2. A smooth section of the eroded channel. 3. Brown/red corrosion products. 4. A roughly textured region in the channel.

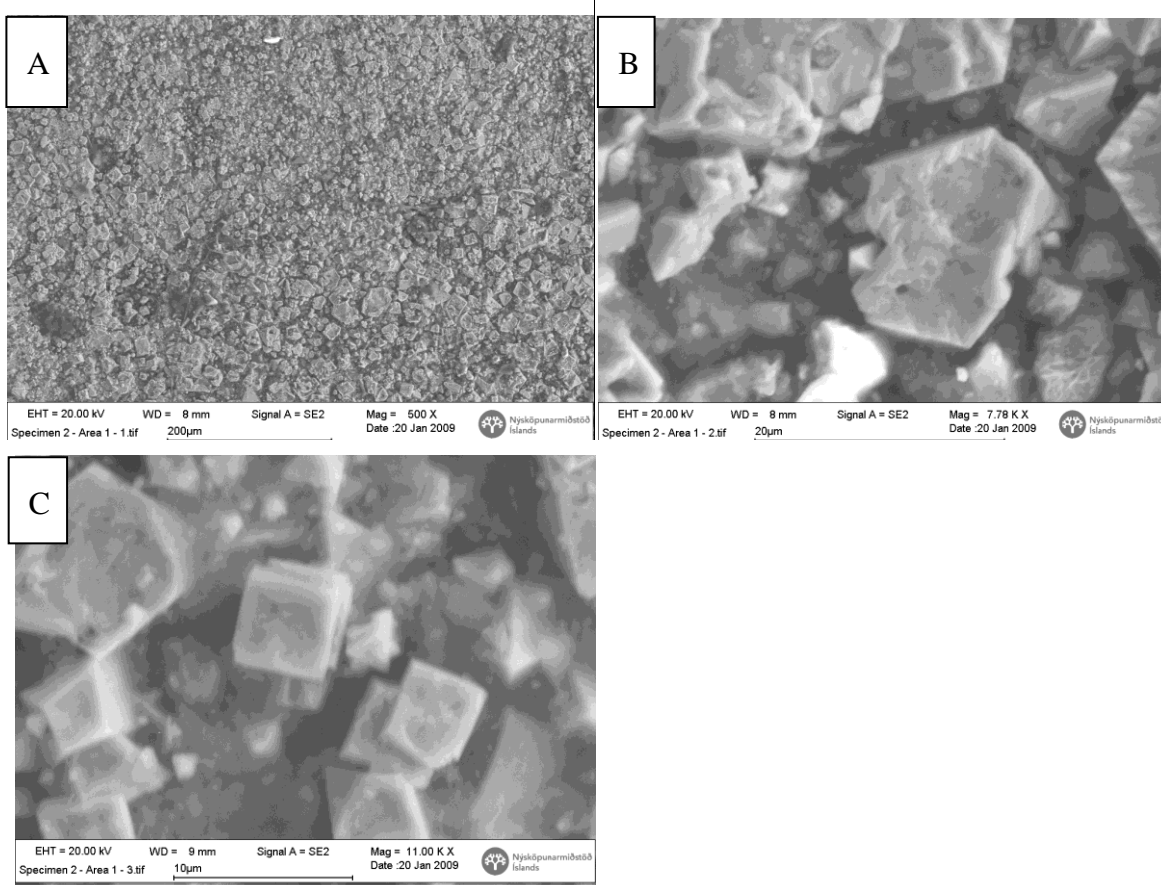
Area one consists of black corrosion products and was covered by one of the first stage nozzle vanes. Micrographs of area 1 are shown in Figure 147. In image A it can be seen that the surface is made up of roughly cubic crystals of varying sizes. Image B shows that not all of the crystals are cubic. The crystal shown has a rough, broken look to it and the angles of the crystal in the center of the picture and the one to its right are greater than 90° , though that may just be the effect of the crystals forming at an odd angle relative to the plane of the micrograph. Image C shows cubic crystals growing from a darker back ground.

Figure 14. Micrographs of area 1 of sample 2. Micrograph A is an overview of surface at 500X magnification. Micrograph B is a close up of one of an irregularly shaped crystal at 7780X magnification. Micrograph C is a close up of cubic crystals at 11000X magnification.

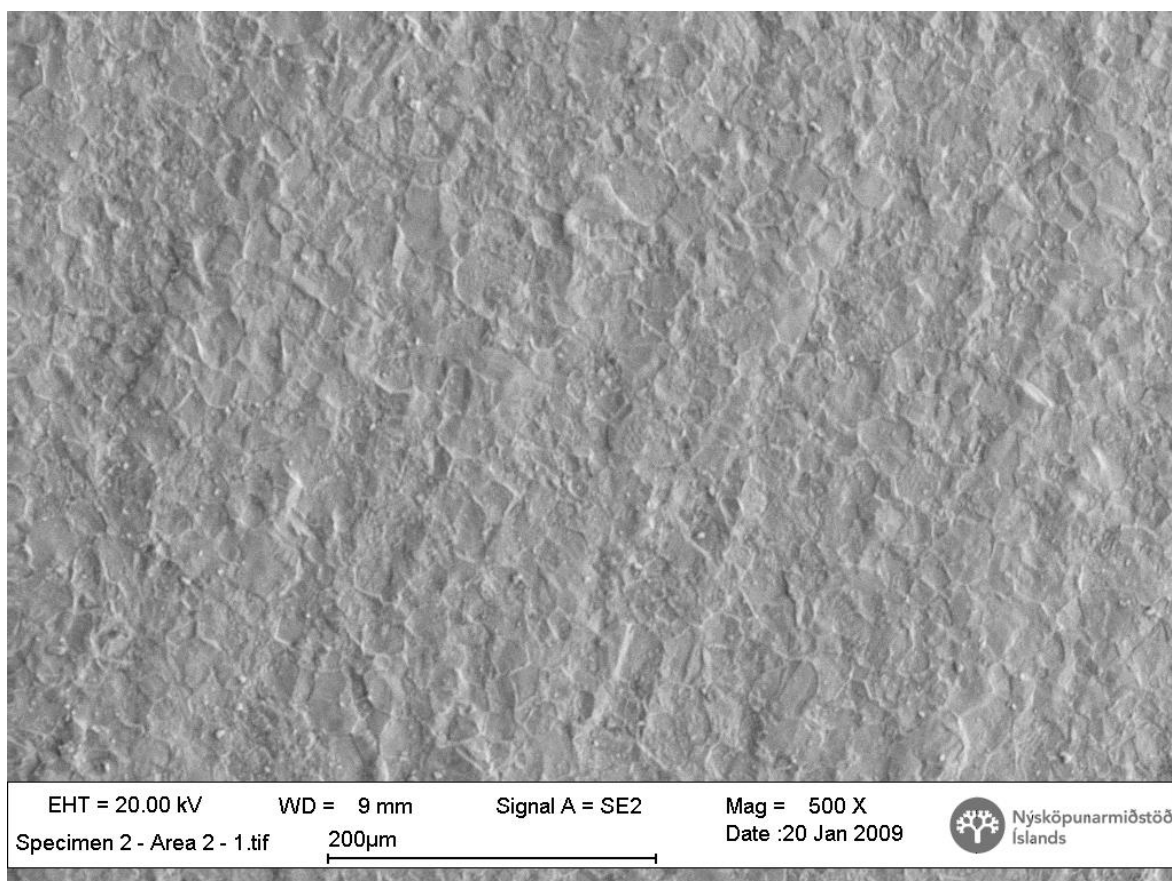
Area 2, of sample 2, is a channel in the surface of the 316 stainless steel ring. The areas outside the channel were covered by the first stage nozzle vanes, while the area of the channel was directly exposed to the fluid coming from the separator as it entered the turbine. To the naked eye it appears to be bare metal. A micrograph of area 2 is shown in Figure 15.

Figure 15. Sample 2, area 2 at 500X magnification. No corrosion products are visible.

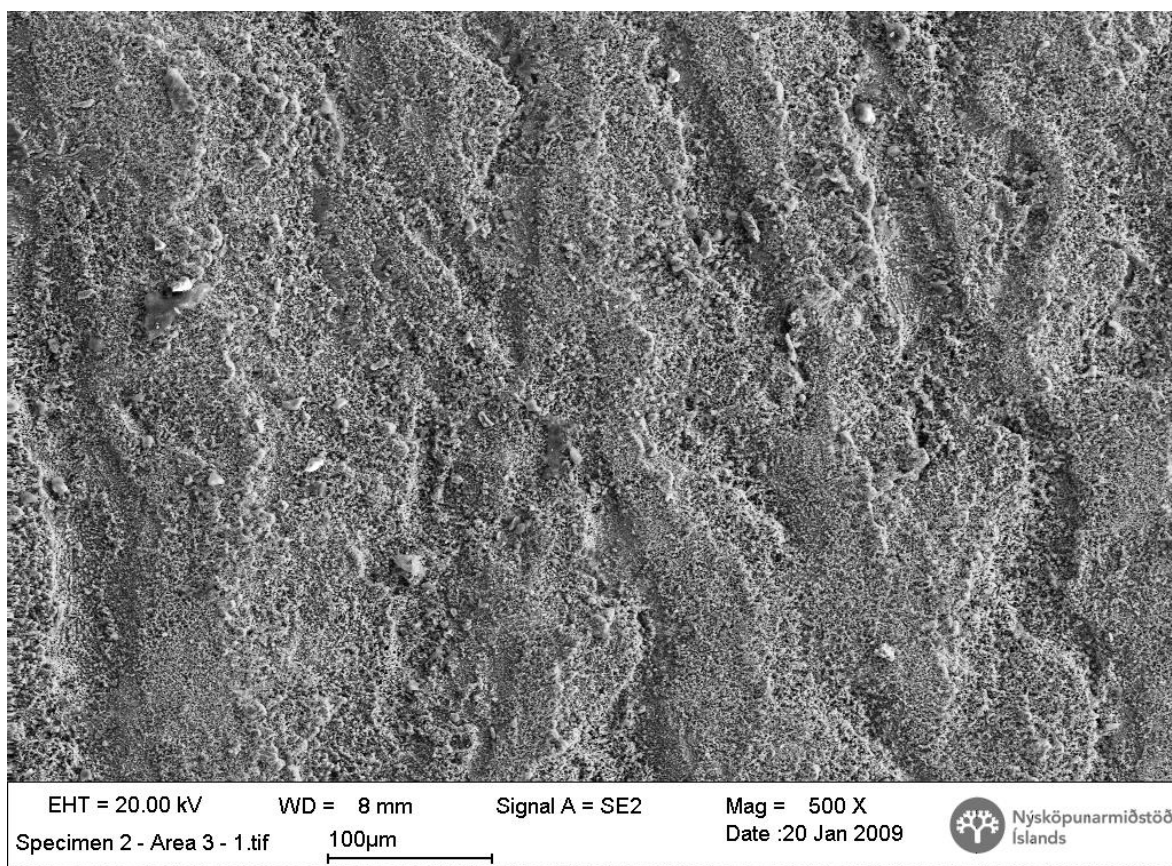
Area 3 is a formation of black and brown corrosion products near the inner edge of the ring at the terminus of one of the channels between the nozzle vanes. A micrograph is shown in Figure 16. At 500X magnification the surface looks very porous, like a sponge. It does not look like the crystalline structures from sample 2, area 1 (Figure 14).

Figure 16. Sample 2, area 3, brown and black corrosion products at the inner edge of the ring.

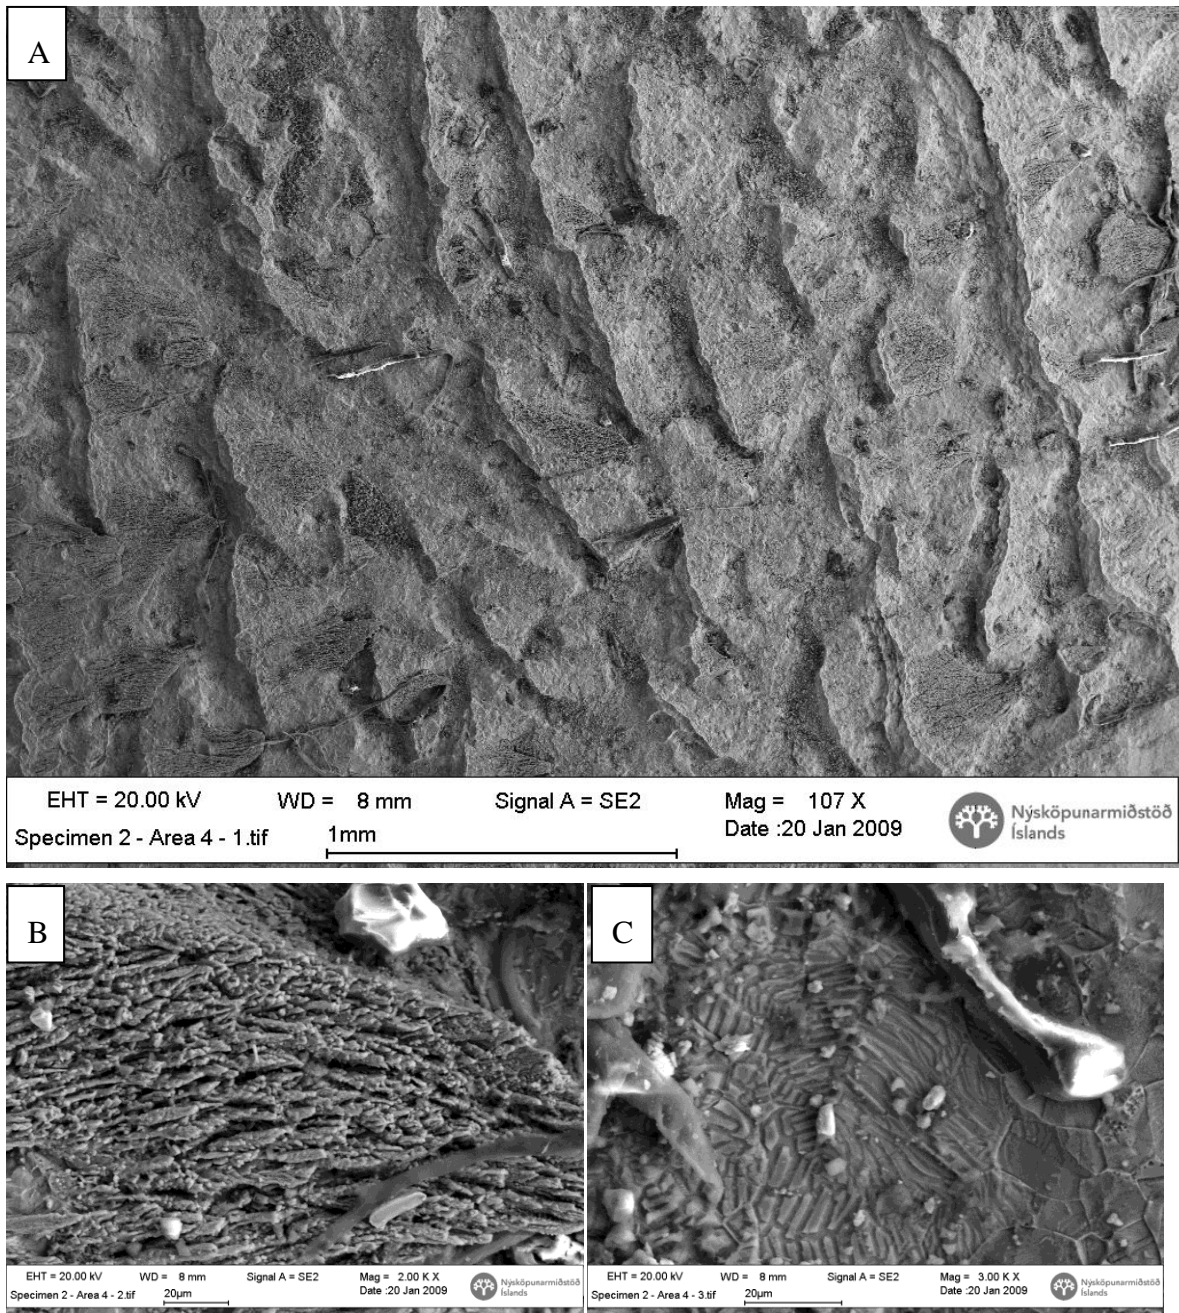
Four micrographs were taken of area 4. Three are shown in Figure 17 and one on the page after (Figure 18). In figure A the overall structure of the area is given. At 107X magnification ridges and channels can be seen and a forest of fine structures cover parts of the ridges. Figure B is a close-up on the “forest” of one of the ridges at 2000X magnification. Figure C shows scale formations in between the ridges at 3000X magnification.

Figure 17. Sample 2, area 4. A. The overall surface structure of the area. B. Close-up of a "forest structure" at the edge of one of the ridges. C. Oxide scale on the surface of 316 stainless steel.

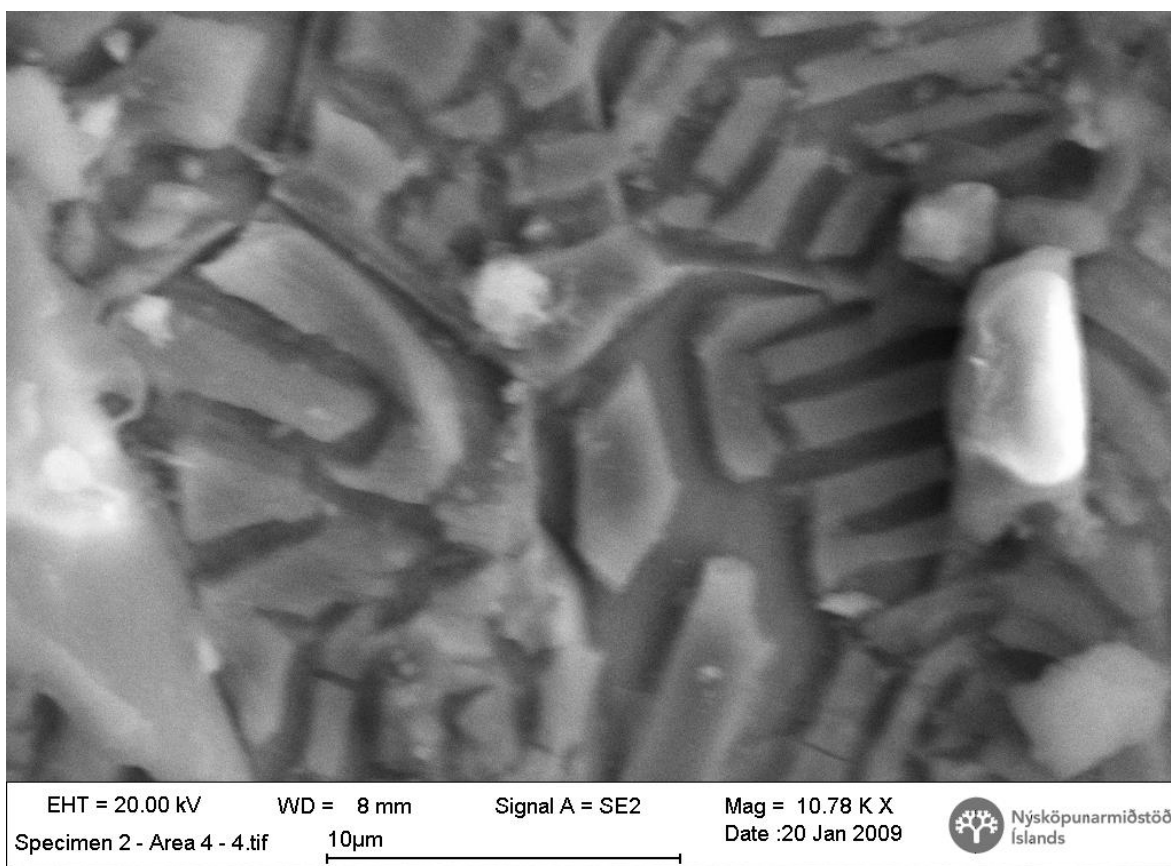
On the next page is a picture of the scaling at 10 780X magnification (Figure 18). It can be seen that the scale is on the order of 1 or 2 microns thick.

Figure 18. Scaling on sample 2, area 4. The grains or crystals are less than 10 microns across and only 1 or 2 microns thick.

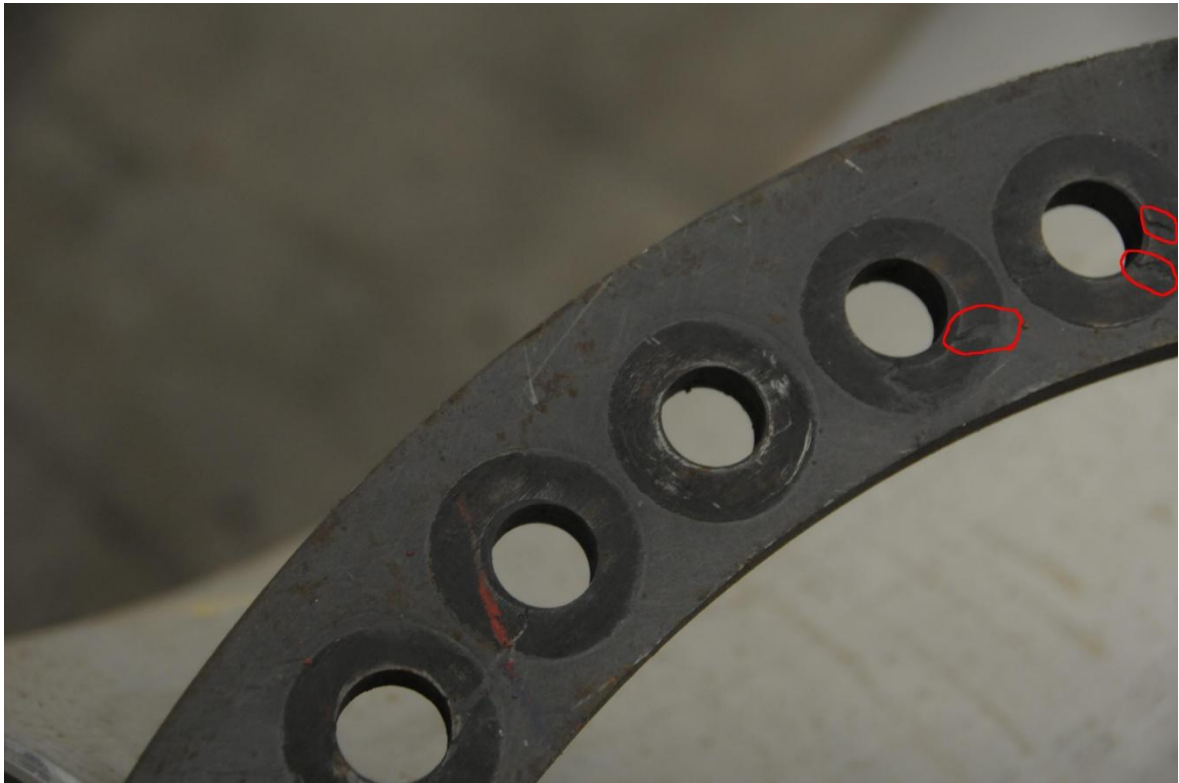
The exposed side of the retaining ring is pictured in Figure 19. The black circles are where washers shielded the ring from contact with flowing fluid. The black circles are noticeably raised from the grey surface, showing that material has been lost from the exposed areas. It can be seen that under some of the washers, significant crevice corrosion took place as channels are etched into the steel and are circled in red.

Figure 19. The exposed side of the retaining ring, from which sample 3 was cut. Evidence of crevice corrosion is circled in red.

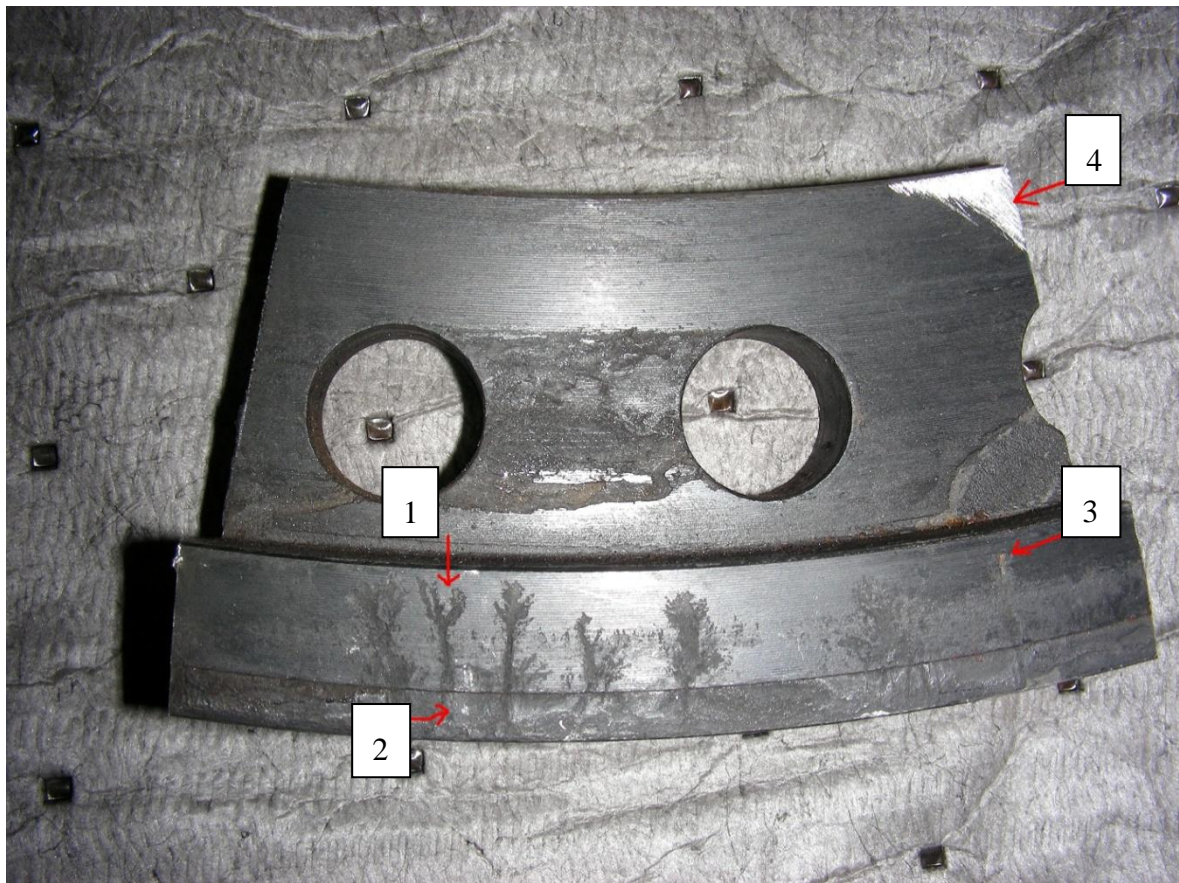
Sample 3 is pictured in Figure 20. There were 4 areas examined on sample 3, all of which are on the shielded side of the ring. Areas 1 and 3 are sites of filiform corrosion on opposite ends of the channel. Area 2 is on the lower side of a step that was etched into the ring. The upper side of the step (with the filiform corrosion) was held tight against the nozzle ring while the lower part of the step, while protected by the geometry of the turbine from the flow path, was uncovered. Area 4 is a corner of the sample that was filed down to bare metal to get an analysis of the composition of the ring, which is believed to be made of the same material as the turbine housing.

Figure 20. Sample 3. Area 1 is a filiform corrosion channel. Area 2 is a point in the region below the step. Area 3 is the tip of another filiform corrosion channel. Area 4 is bare metal, exposed by filing the sample before putting it into the SEM.

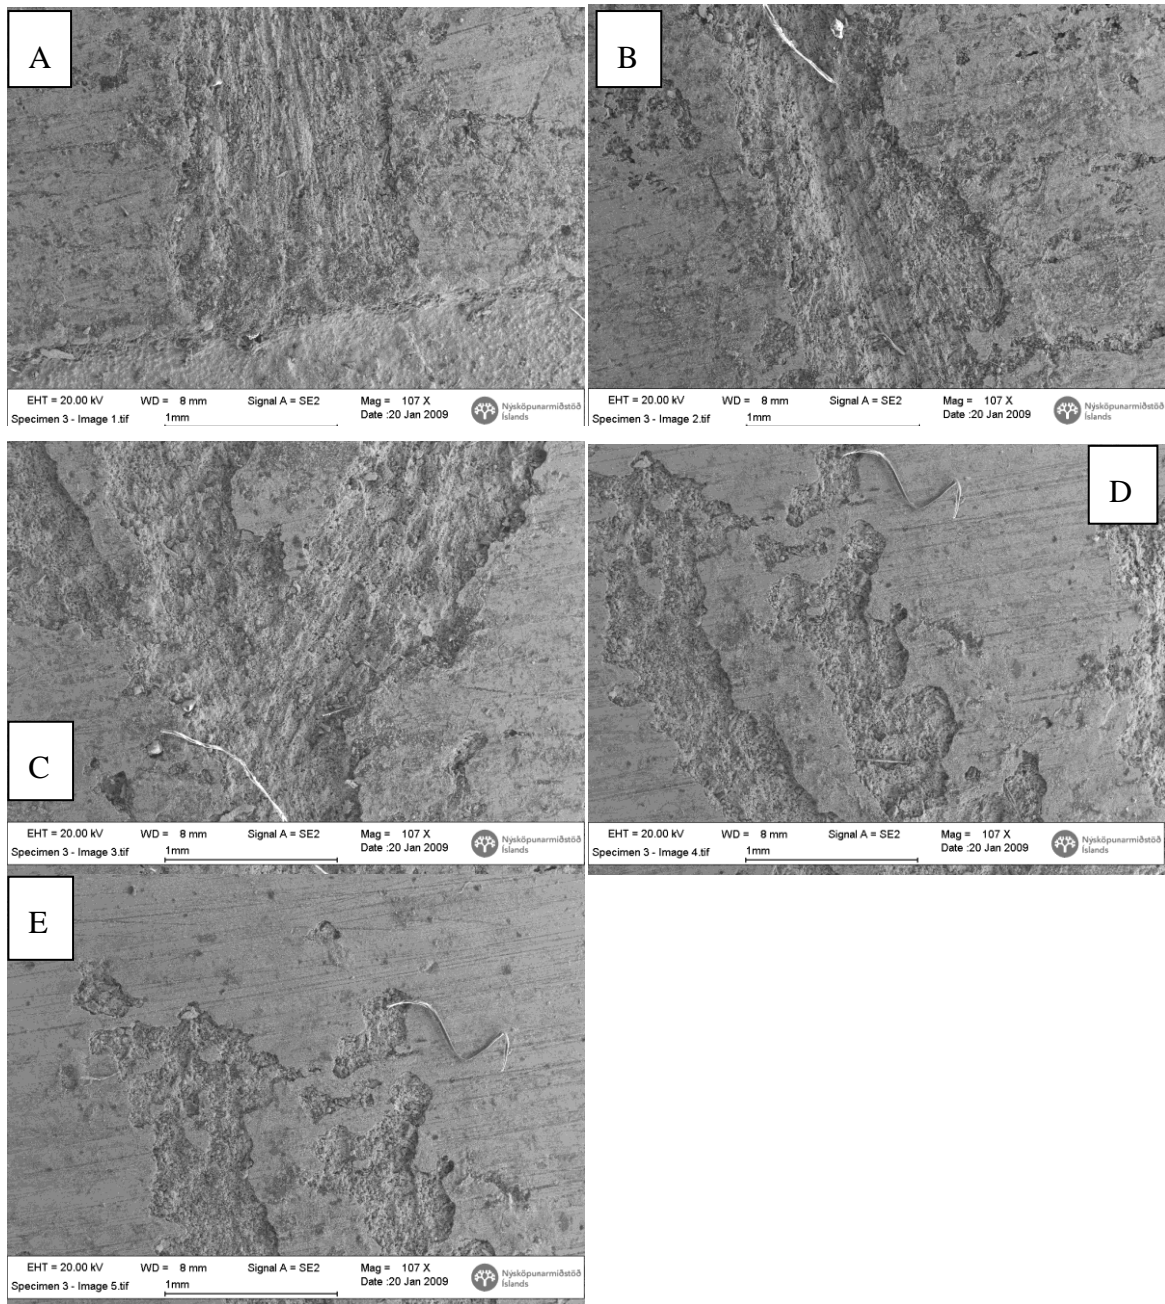
Five micrographs were taken of area 1, a filiform corrosion channel; they are shown in the following page and labeled A through E (Figure 2114). The step, etched into sample 3, can be seen at the bottom of image A. It can be seen from the image that the filiform channeling begins from this step and that below the step the corrosion was more uniform. Image B shows grooving in the bottom of the main channel of area 1. Image C shows channels branching off of the main channel. Branching like this is typical of filiform corrosion and distinguishes it from other types of crevice corrosion. Images D and E show the end of one of the channels, it can be seen that pitting of the metal takes place in advance of connection to the channel.

Figure 21. Micrographs of sample 3, area 1 at 107X magnification. A. The beginning of the filiform channel, the step can be seen at the bottom of the image. B. The main channel of area 1. C. Branching from the main channel, which typifies filiform corrosion. D. The end of one of the channels of area 1. E. The end of a channel in area 1, in which it can be seen that pits form in advance of the main channel.

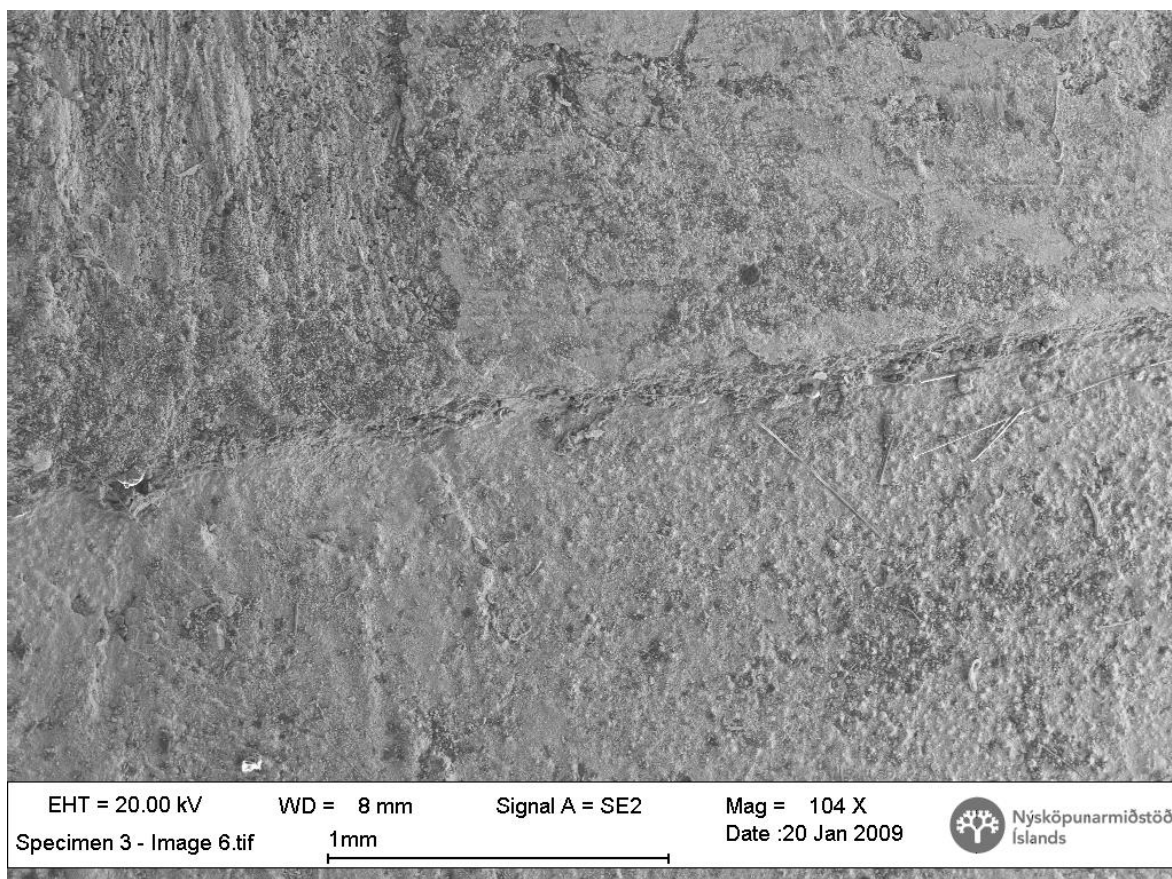
Area 2 is below the step structure on sample 3. The region above the step was pressed tight against the nozzle ring assembly and the region below the step was out of the path of flow but exposed. A micrograph of area 2, showing the step at the top of the image is shown below (Figure 225).

Figure 22. Area 2 of sample 3 can be seen in the bottom half of the image. Running horizontally through the middle of the image is the step structure and in the upper right corner is a filiform channel (area 1).

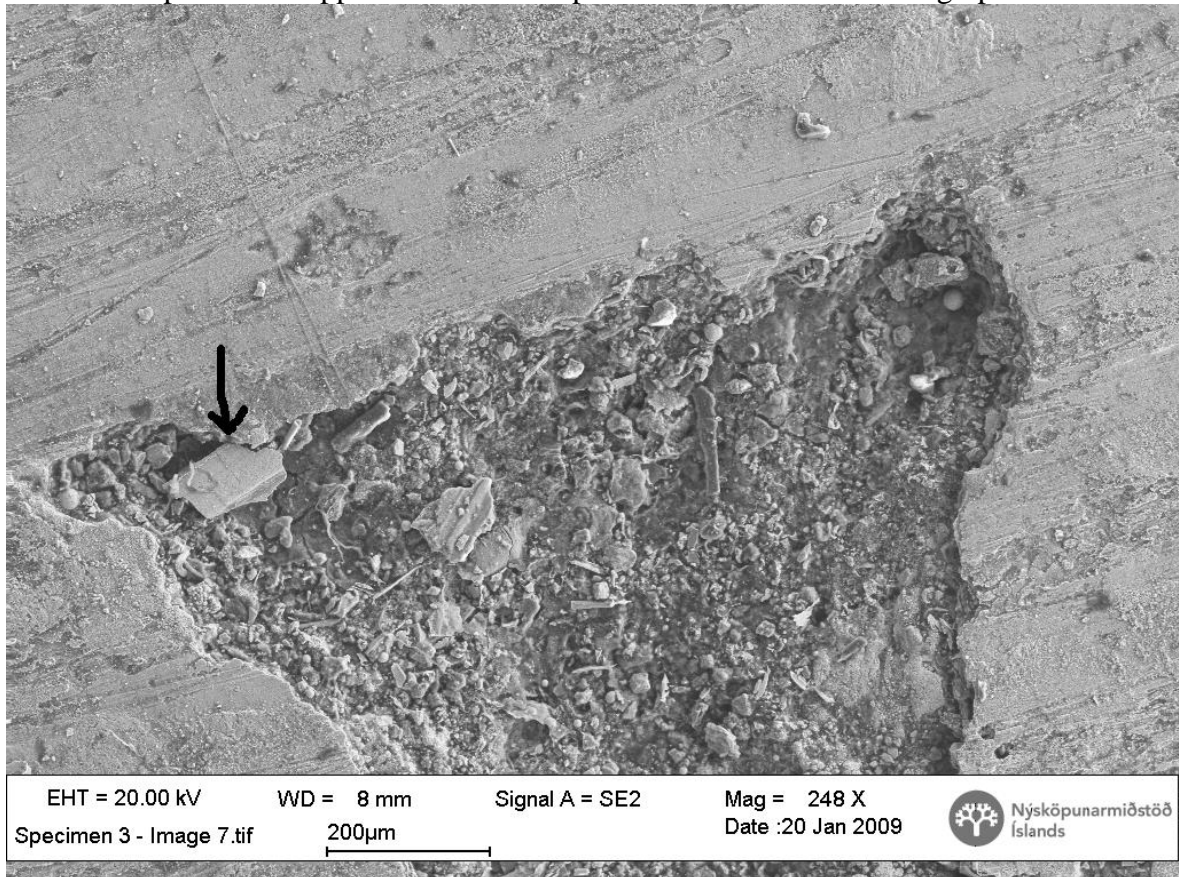
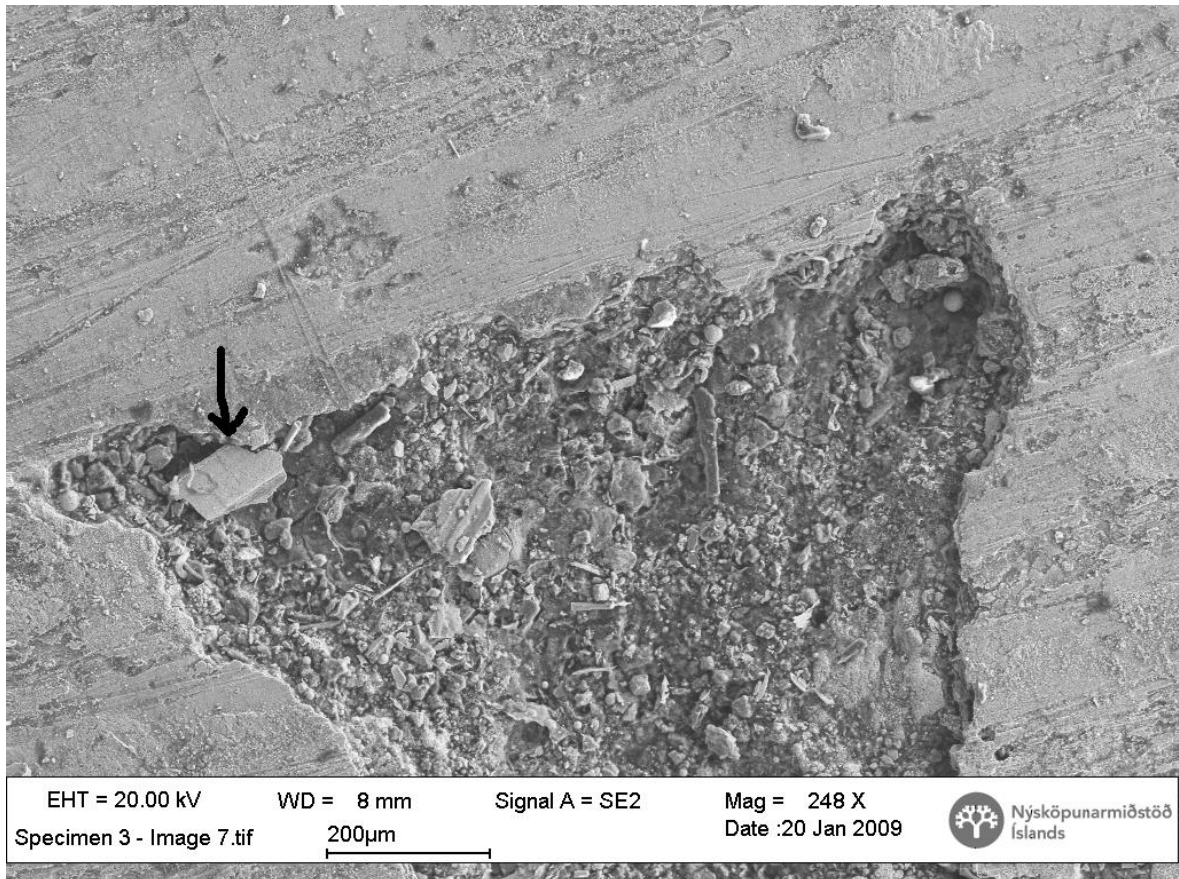
Area 3 is a pit on the opposite end of sample 3 from area 1. A micrograph is shown in

6. The area 3 pit is located at the end of a filiform channel.

Figure 23. Sample 3, area 3 a pit at the end of a filiform channel at 248X magnification. A particle, analyzed for composition, is marked by the arrow.

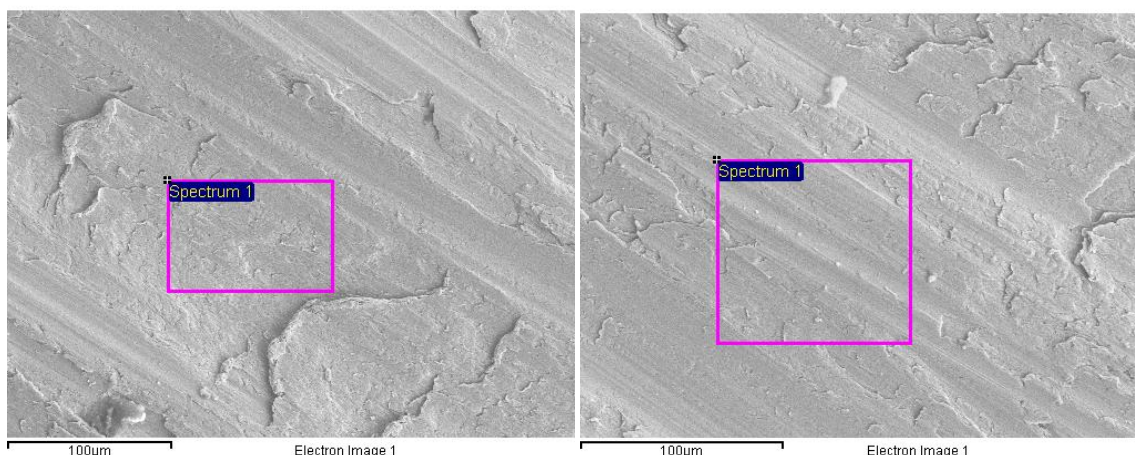
Area 4 is a corner of the sample that was filed down to bare metal just before being placed in the SEM. Analysis of this area and comparison with the corrosion products from the first 3 areas of sample 3 will help to establish the mobility, or lack thereof, of corrosion products in the turbine section of the power plant. Two micrographs of area 4 are shown in Figure 24. They show the regions analyzed for composition.

Figure 24. Sample 3, area 4, bare metal exposed by filing away the corrosion products prior to analysis. Images show the areas over which two analyses for composition were carried out.

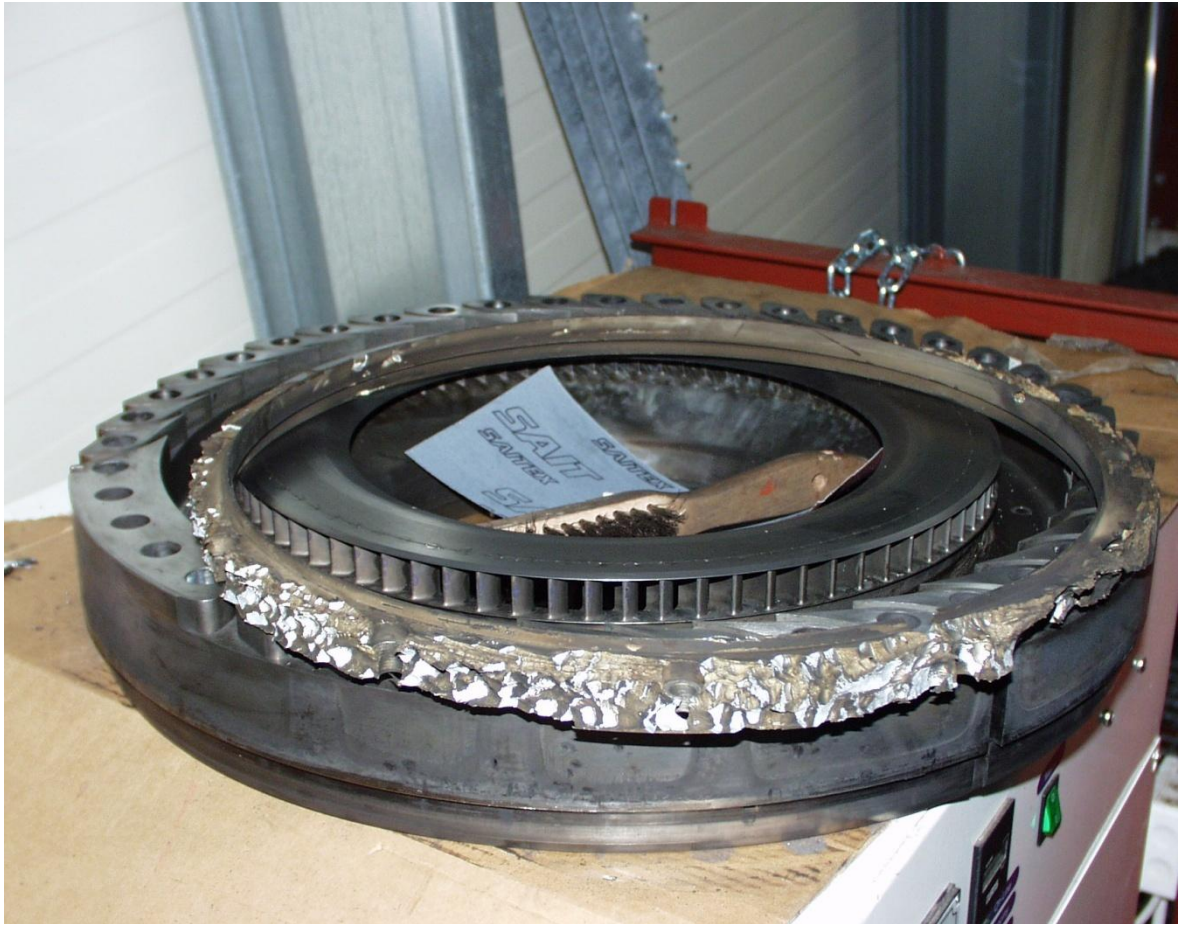
The transport of aluminum and copper from inside the nozzle ring assembly to crevices formed by the back of the assembly and the retaining ring and nickel from the plating on the nuts or the spacer ring to the shielded side of the retaining ring is suggestive of a violent and complex flow path. It might also be explained by the turbine repeatedly being taken apart and reassembled, with bits of worn material flaking off onto the gloves of the plant operators and then being deposited on other parts of the turbine – but this mechanism of transport seems more likely to lead to larger discrete particles that would have been seen on the micrographs.

Figure 25. The aluminum sealing ring, destroyed within a few months of plant operation. Seen here sitting on the nozzle ring assembly.

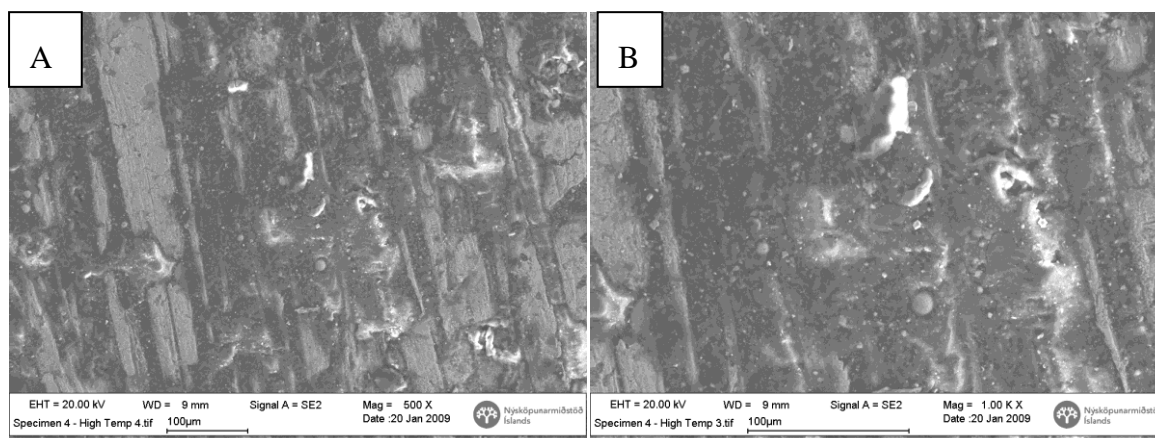
The micrographs in Figure 27 show the surface structure of cylinder 1. From the images it can be seen that the surface has bands of flat metal separated by narrow grooves filled with what are probably corrosion products.

Figure 27. Sample 4, cylinder 1. The two images show that the surface of the cylinder is made up of small bands of flat, exposed metal and narrow grooves filled with material thought to be corrosion products. Image A was taken at 500X magnification while B shows the surface at 1 000X magnification.

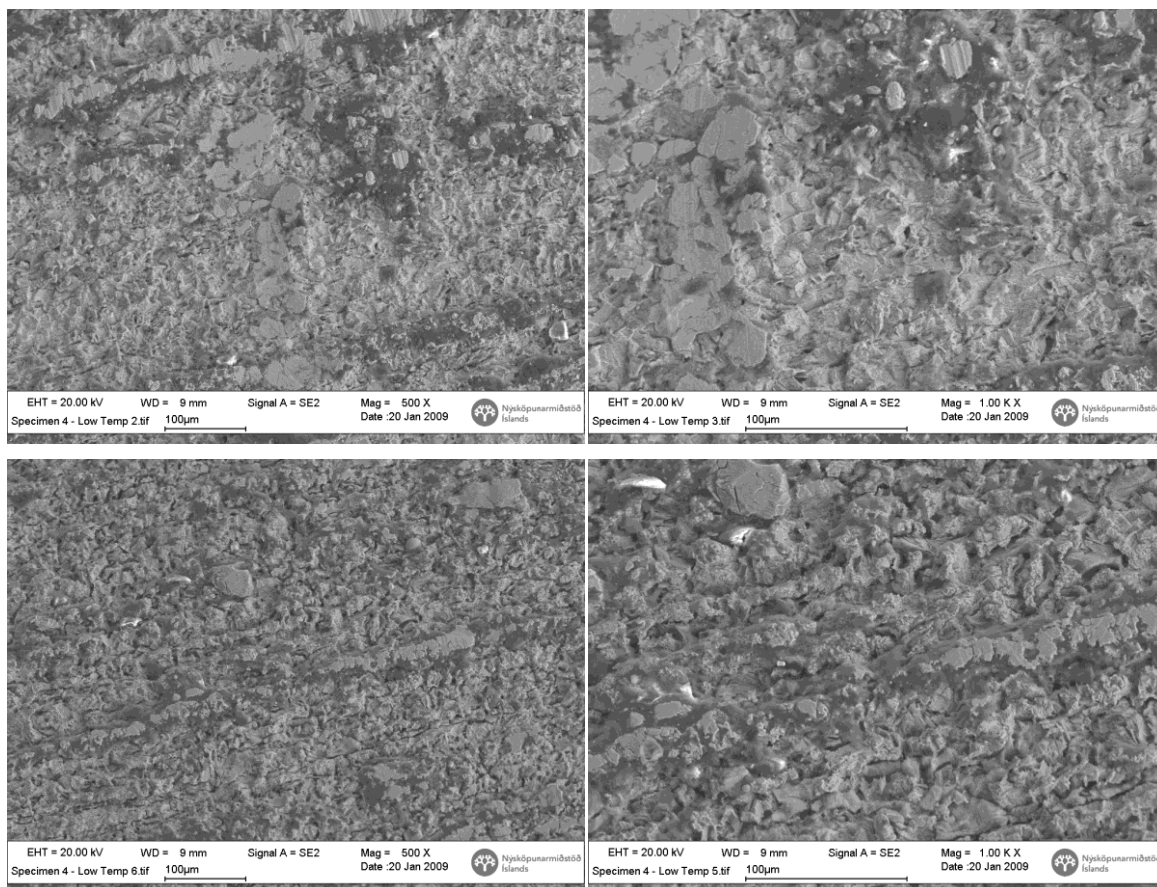
Cylinder 2 is made of the same metal as cylinder 1 but was installed on the low pressure side of the turbine and exposed to the exhaust. From talking with the plant manager, it is believed that the exhaust contained 6 to 7 percent liquid. Micrographs of cylinder 2 are shown in Figure 29.

Figure 29. Sample 4, cylinder 2. Micrographs A and C show different regions of the cylinder at 500X magnification. B and D show the same regions as A and C respectively but at 1000X magnification.

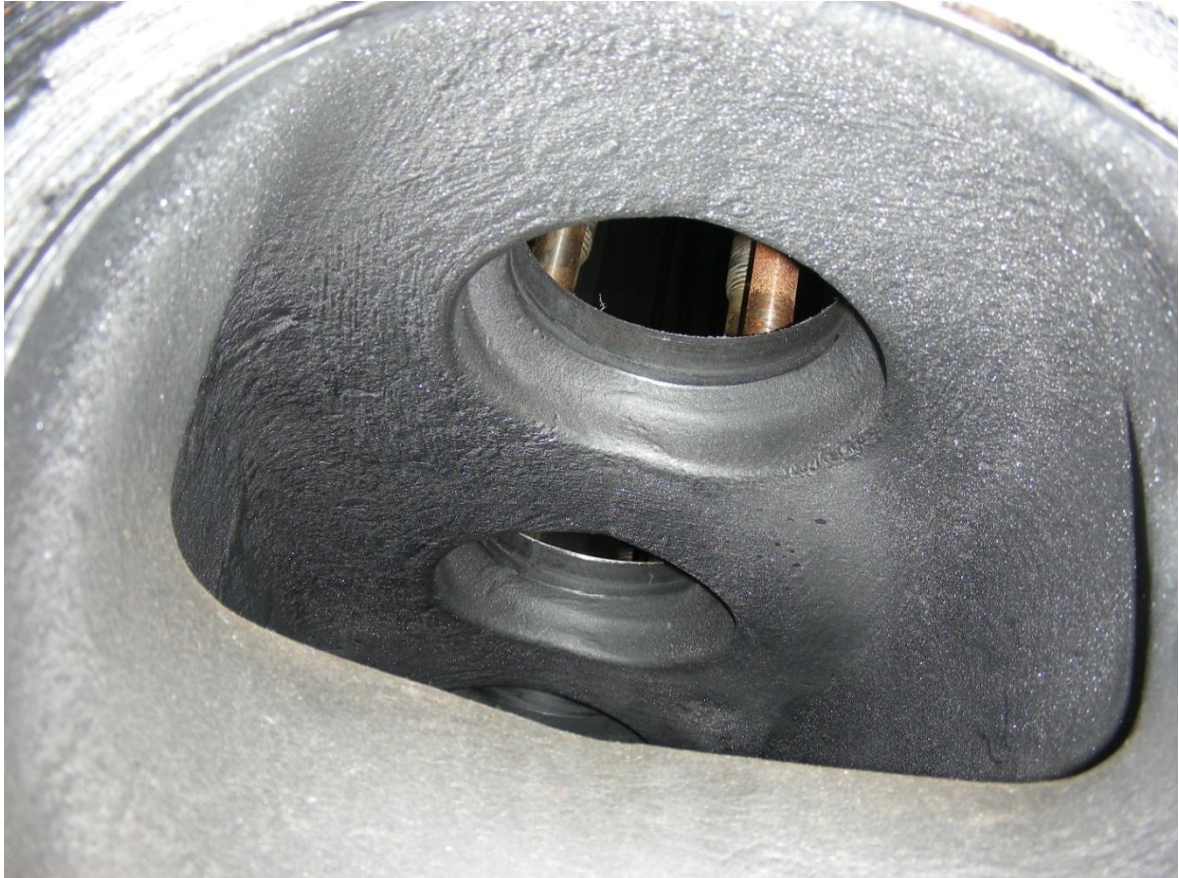
Figure 30. Inlet to the turbine housing coated with black corrosion products.

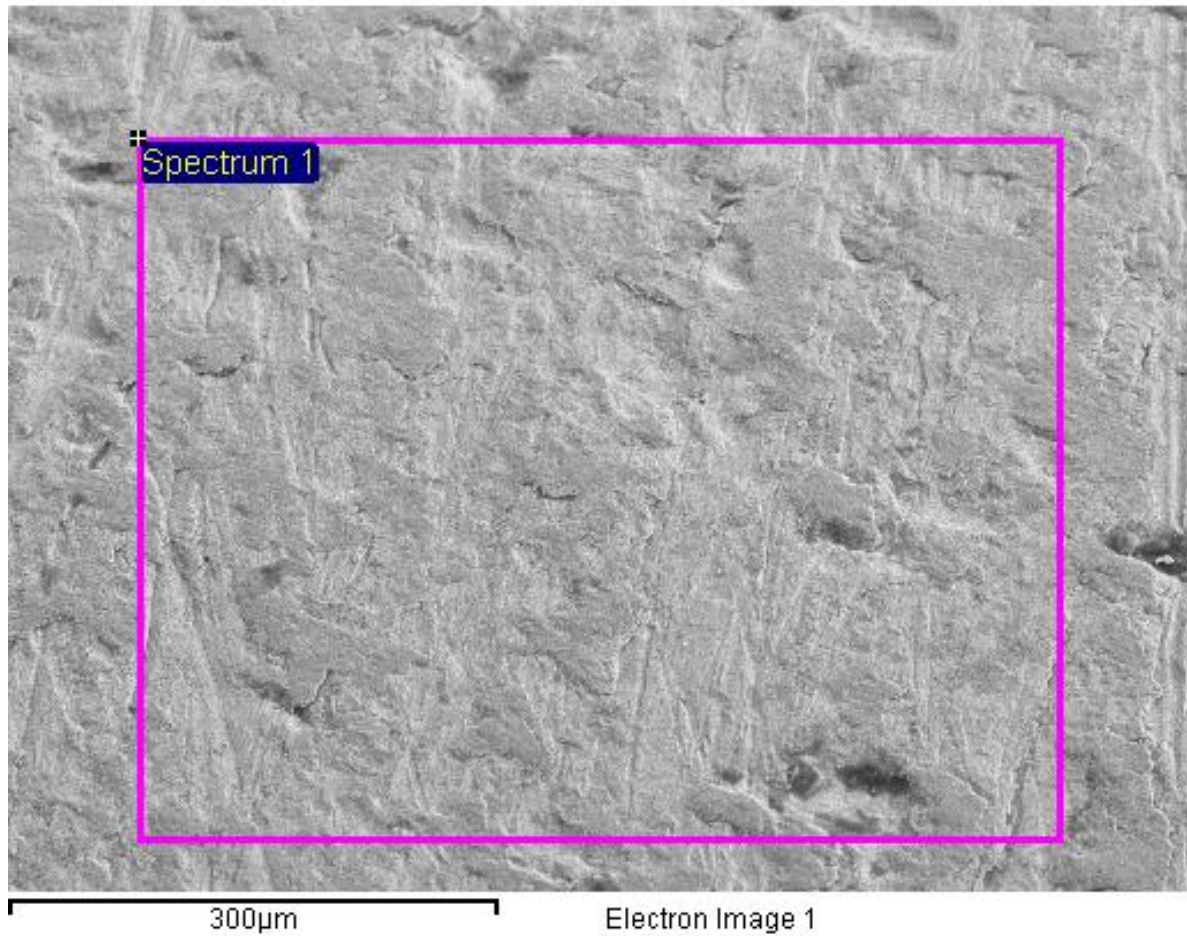
Figure 25. Figure 32. Surface of the duplex steel pin at 500X magnification. Defects in the surface can be seen but the black corrosion products are absent.
