Corrosion in the Kalina cycle

An investigation into corrosion problems at the Kalina cycle geothermal power plant in Húsavík, Iceland

A 30 credit units Master's thesis

Akureyri, February 2009

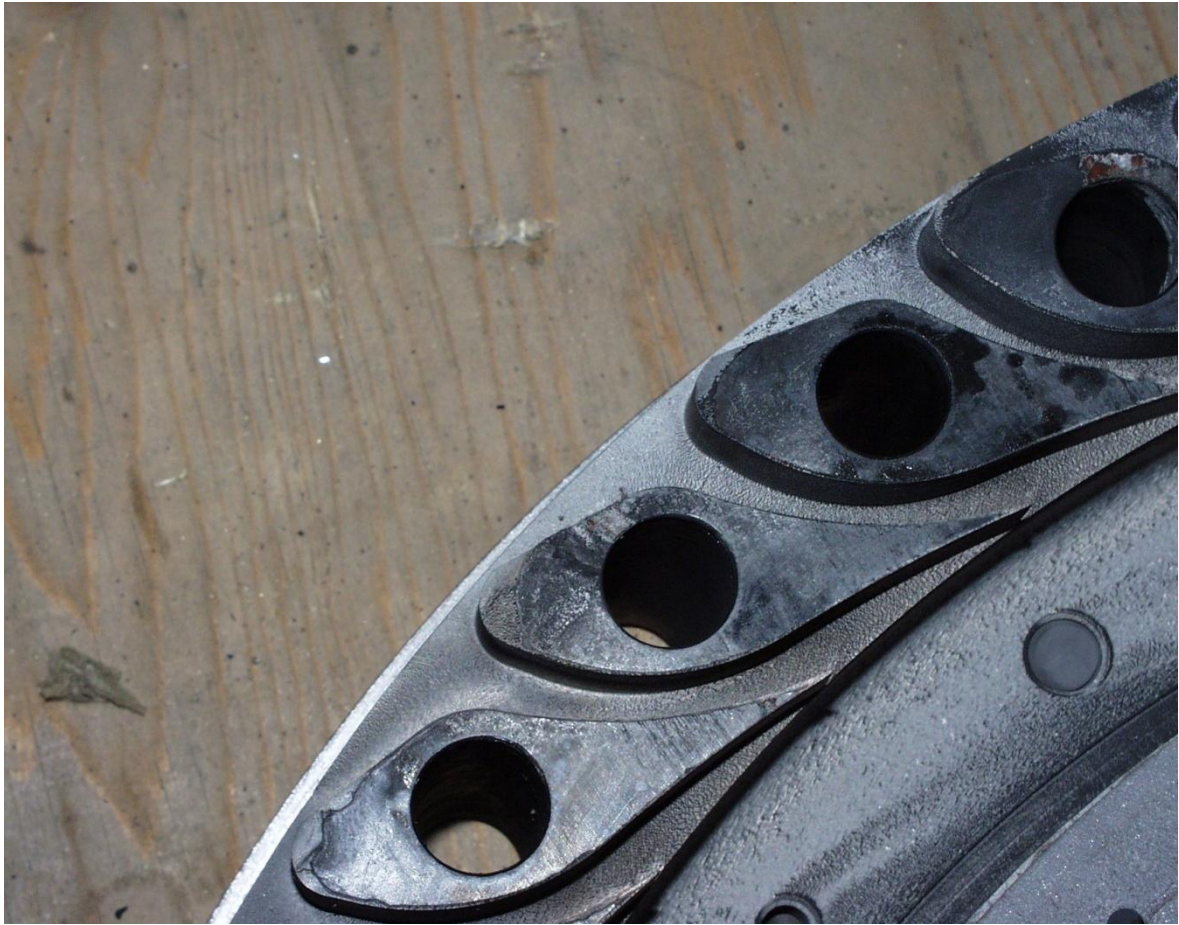
Figure 33. The first stage nozzle vanes, which were flush against the spacer ring that sample 2 comes from. Signs of corrosion can be seen on the face of the nozzles.
