Applying a Coastal Vulnerability Index (CVI) to the Westfjords, Iceland: a preliminary assessment

University of Akureyri
Faculty of Business and Science
University Centre of the Westfjords
Master of Resource Management: Coastal and Marine Management
Ísafjörður, June 2012

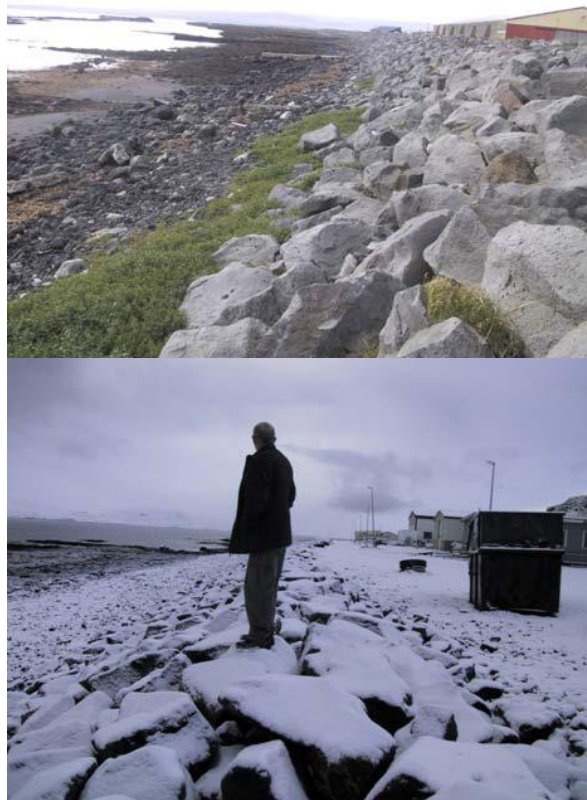
Figure 3.2 Photos of seawall defences constructed in Iceland. The left shows a larger quarried rock defence protecting a fish-processing factory in Eyrarbakki, the right a smaller quarried rock defence found in Drangsnæs (Isaksson and Helgasson, 2005, p5)

Much of Iceland's coastline is made of solid rock outcrop, reducing, to some extent, the impact of coastal erosion. However, low-pressure storms and wave height are both relatively frequent and high, contributing to stress and weathering of the coast (Jónsdóttir, 2011). It is estimated that severe coastal floods occur approximately every 11 years, the last flood occurring in Raufarhöfn in the North in 1995 (ibid). However, shoreline protection investment pales in comparison to expenditure spent on protection schemes for other 'natural disasters' such as avalanches and volcanic eruptions (Isaksson and Helgasson, 2005). Historically, lack of state-funding meant seawalls (the predominant form of coastal protection in Iceland) were 'weak constructions that neither lasted very long nor ensured much protection', although this gradually changed throughout the latter half of the 20th century (ibid, p2). The core material used for these seawalls is quarried rock, examples of which can be seen in Figure 3.2.

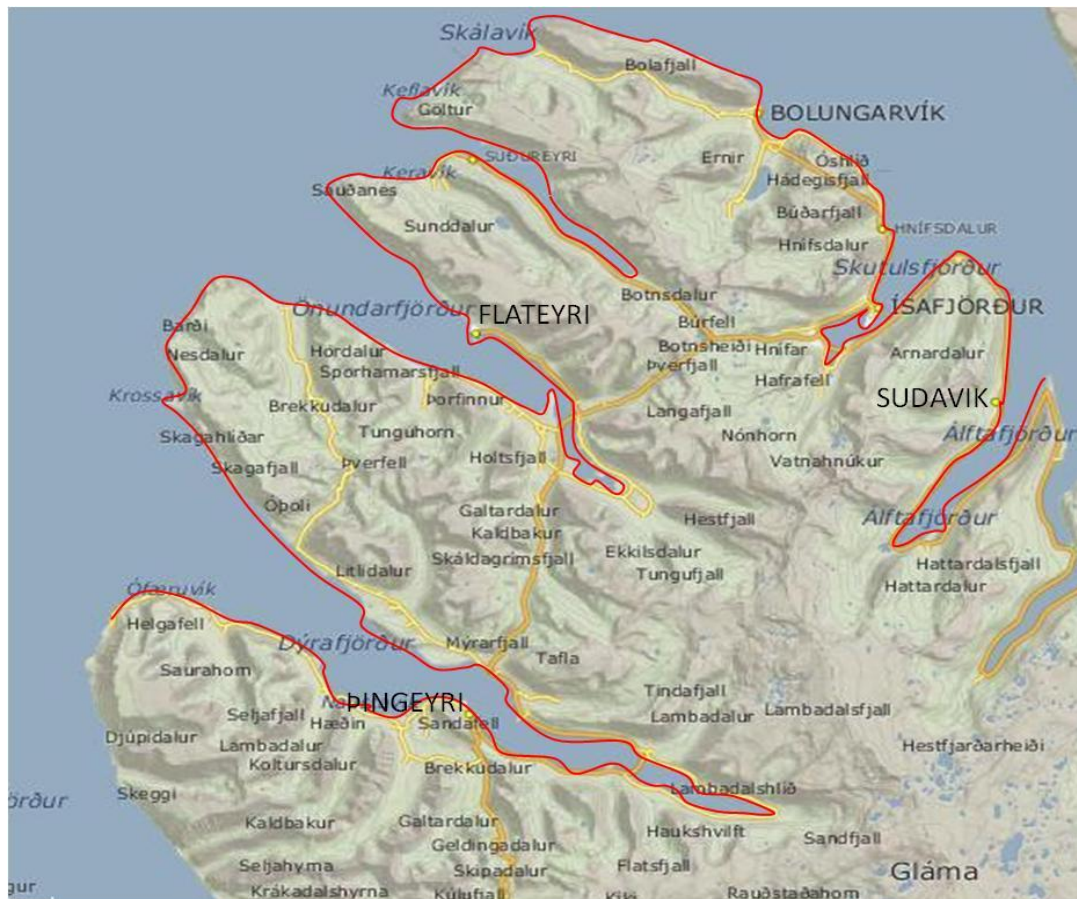
Figure 3.3 Study area: from Kambanes (the northern-most point of Álftafjörður) and Hafnarhryna (the western-most point of Dýrafjörður). The red line indicates the study area (Source: map.is)

The study area for this assessment is situated in the Westfjords: a large peninsula 22,271 km² in size possessing many fjords and located in north-west Iceland (Statistics Iceland, 2011). The study area does not assess the whole of the Westfjords coastline, focusing instead on a 240km located in the north of the region. This area incorporates a stretch of coastline ranging from Kambsnes (the northern-most point of Álftafjörður) and Hafnarhryna (the western-most point of Dýrafjörður). The study area is presented in Figure 3.3.

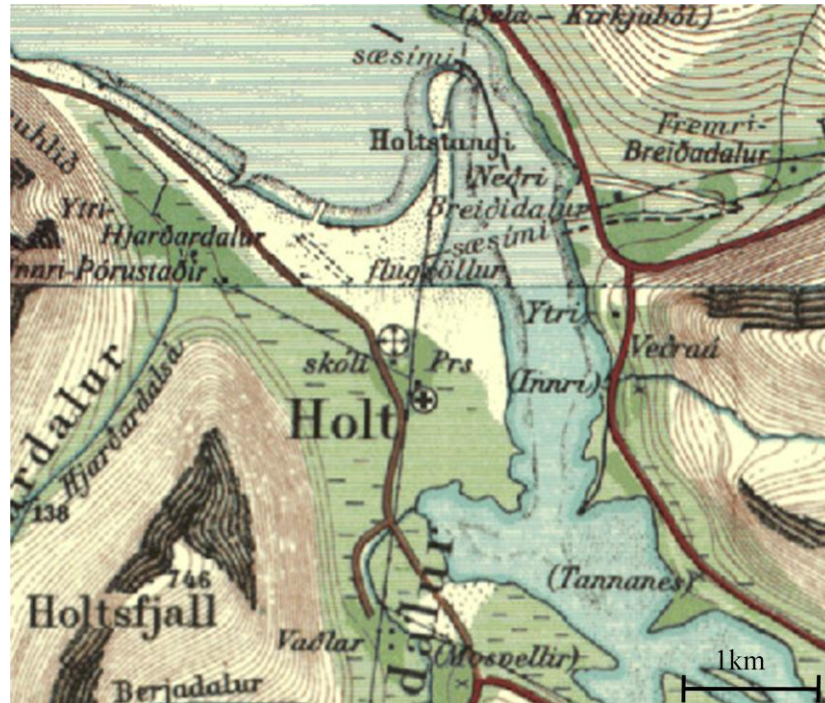
Figure 3.4 Map of Holtstangi. The white sandy beach located here notably differs from the rest of the study area's beach composition (Source: lmi.is)

Beach composition of the northern Westfjords predominantly consists of comprised of large, coarse clastic sediments (Decaulne and Saemundsson, 2006). One section of the coastline is notably different: Holtstangi beach in the upper reaches of Öndarfjörður.

The coastline here consists of white sandy beach, somewhat incongruous with the rest of the study area's coastline.

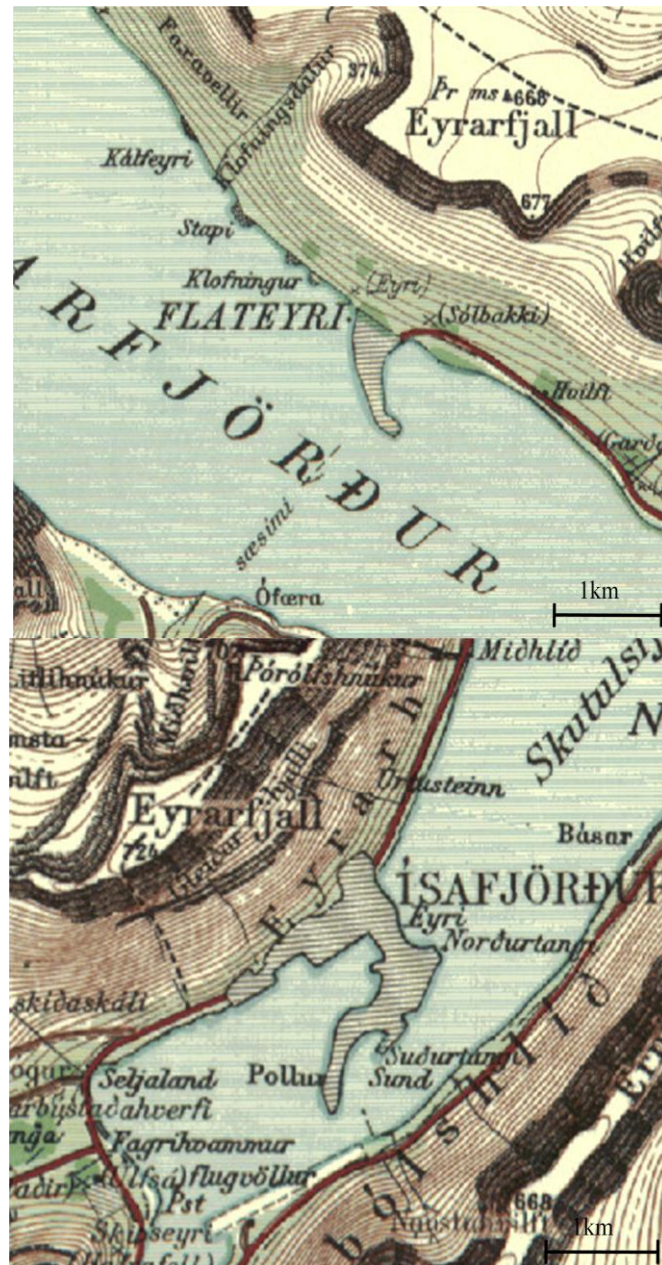
Figure 3.5 Map showing Flateyri (left) and Ísafjörður (right). Both are predominantly located on the flat land of a spit formation (Source: lmi.is)

The towns of Ísafjörður, Bolungarvík, Súðavík, Suðureyri, Flateyri and Þingeyri are located within the study area. These towns account for the vast majority of the Westfjords' ~7000 inhabitants (Statistics Iceland, 2011). For this reason, this area of the Westfjords was chosen as the focus of this study. Ísafjörður, the municipality capital, possesses ~4000 inhabitants and is home to nearly all of the Westfjords' administrative and other services. The economy is based heavily around the fishing industry with the region possessing one of the largest fisheries in Iceland. A controversial quota system has seen the fishing industry decline in recent years. Nonetheless, fish-factories in towns such as Flateyri and Suðureyri are by far the main employer, with the town's residents economically dependent on their presence (Matthiasson, 2000). Human settlement is predominantly situated on the relatively low coastal slope situated in-between the steep fjord walls and the ocean, or, in the case of Ísafjörður town centre and Flateyri, on the flatlands of spit formations (see Figure 3.5).

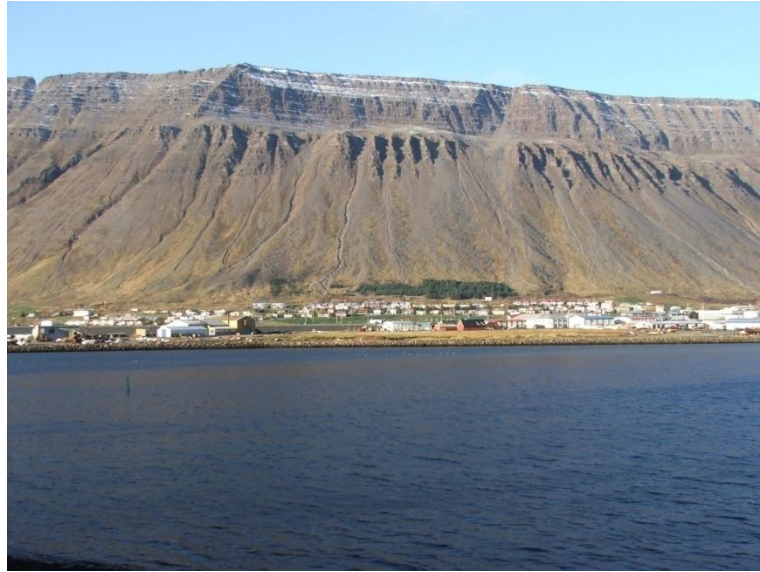
Figure 3.6 Image of outer Ísafjörður. Human settlement takes place on the low and relatively narrow space between the steep fjord walls and the ocean (Author).

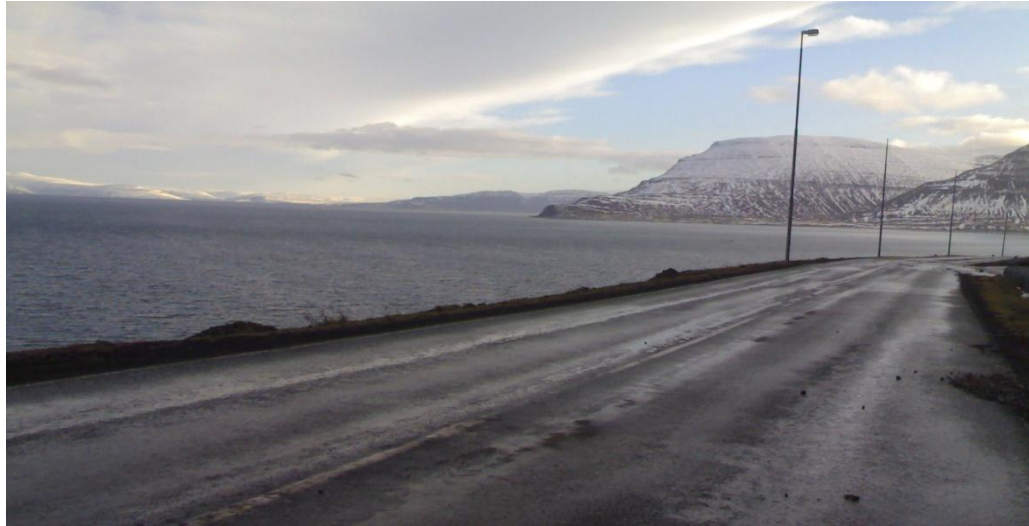
Figure 3.7 Road located near Hnífsdalur. This road has since been closed due to frequency of dangerous rock-fall (Author)

Between towns, there is little built environment. The only notable infrastructure present is the road that connects towns and predominantly hugs the coastline. All roads, to varying degrees, are susceptible to both avalanche risk and coastal flooding (Grímsdóttir, 2006). The major road in the region, Route 61, connects the towns of Súðavíkin to the east to Ísafjörður. Up until September 2010, Route 61 followed the coastline to Bolungarvík, the town found in the northwest of the study area. However, a tunnel was constructed to connect Bolungarvík, as this stretch of road between Hnifsdalur and Bolungarvík was deemed too dangerous from frequent and considerable rock-fall (Visir, 2009). Towards the south of the study area, the minor road infrastructure that connects Flateyri and Þingeyri to the towns in the north does not follow the coastline around the fjord, instead travelling via a tunnel in the south of Skutulsfjörður to Önundarfjörður and a mountain path from Önundarfjörður to Dýrafjörður. Whilst no major roads travel far up Önundarfjörður and Dýrafjörður, less-maintained minor roads travel to small farms located towards the mouth of the fjord.

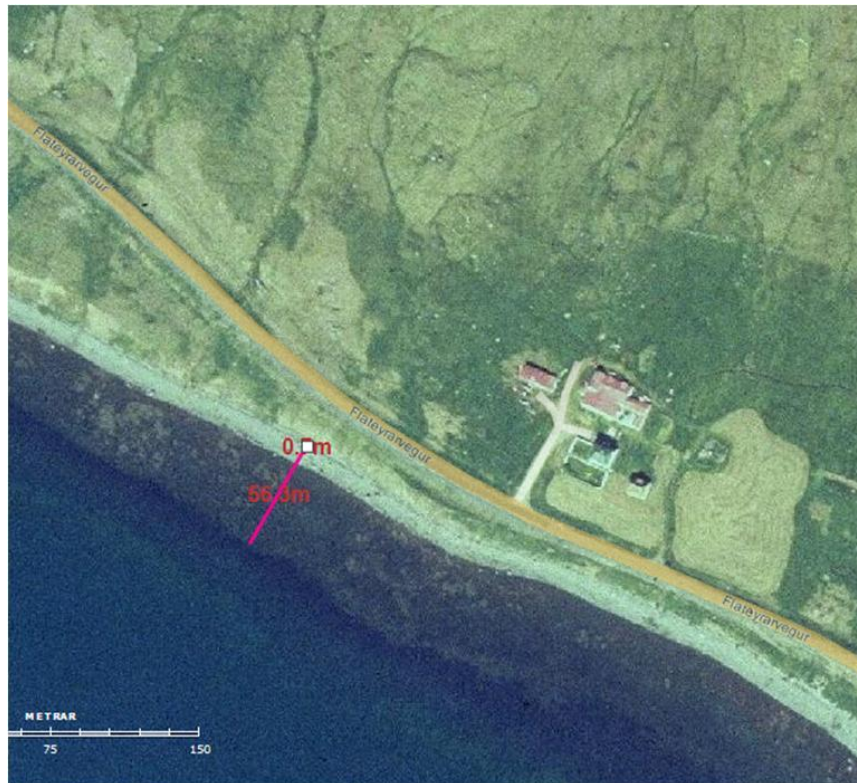
Figure 4.1 Example of beach width measurement using an orthophotograph (LoftMyndir)

Beach width affects coastal vulnerability by acting as a buffer, dissipating wave energy: the wider the beach width, the greater its capacity to dissipate wave energy and reduce the impacts of extreme weather events and RSLR. Beach width will be determined using orthophotographs at 0.5m resolution provided by the company Loftmyndir (Aerial Photography)¹. Orthophotographs are useful tools to measure such a parameter, coupling the spatial attributes of map with the visual attributes of a photograph. It should be noted that orthophotographs do not differentiate from high water mark and low water mark. After consulting with the Icelandic Marine Institute, it was agreed that given the region's steep relief and relatively low tidal range of 2.1-3m, that the difference in beach width would be fairly insignificant. An example of beach width measurement being taken is shown in Figure 4.1.

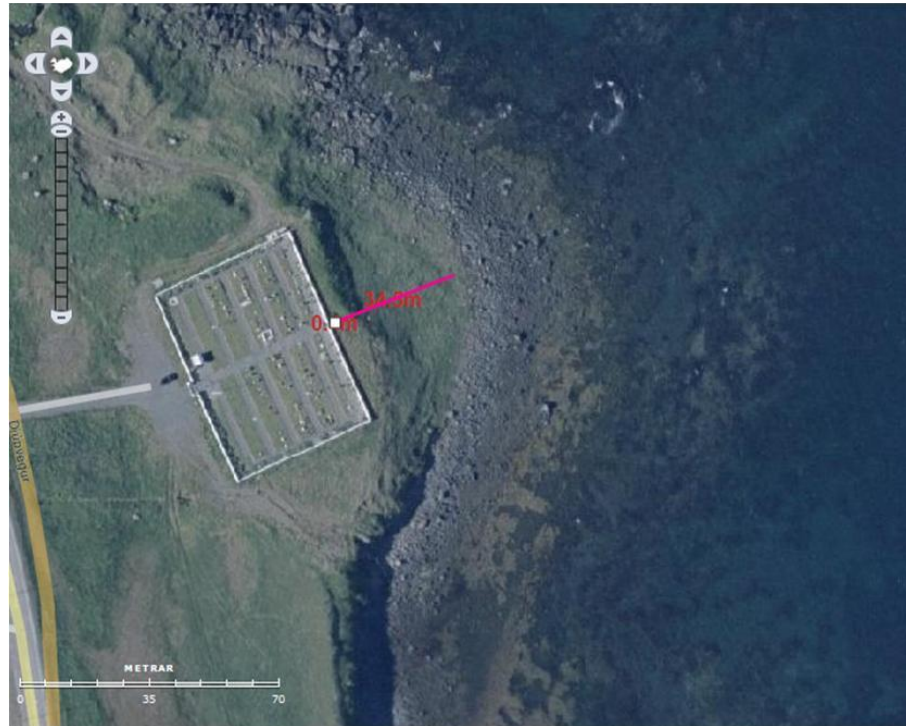
Figure 4.2 Example of distance of vegetation behind back beach measurement using an orthophotograph (LoftMyndir)

better reflect the vulnerability of coastal settlements in the Westfjords, it was deemed inappropriate to measure vegetation beyond that of the nearest infrastructure (often the road). If no infrastructure was present, then the parameter was measured to the point where visible signs of vegetation ended. An example of this parameter being measured can be seen in Figure 4.2.

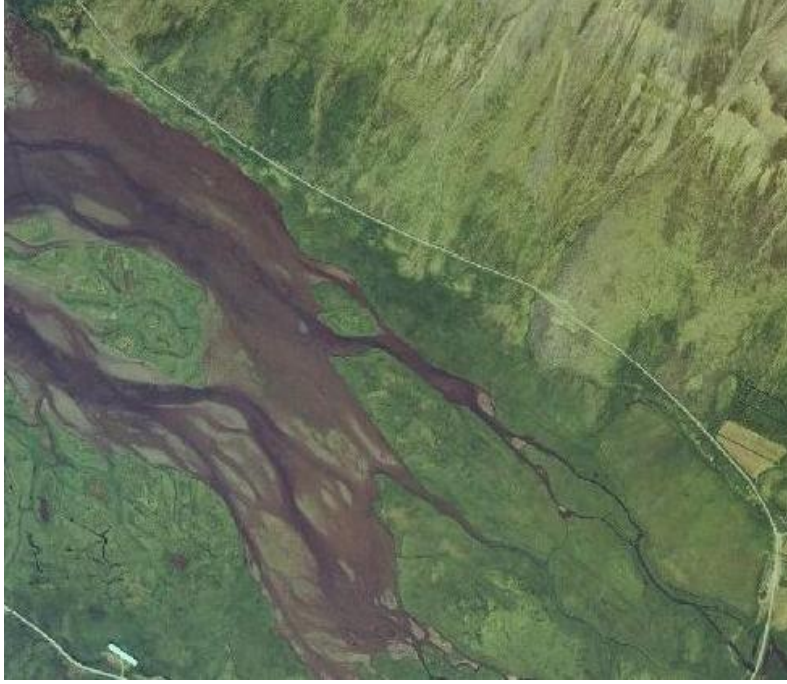
Figure 4.5 Example of estuary presence in Önundarfjörður

Where rivers meet the coast are areas that are particularly dynamic and sensitive to coastal processes (Palmer et al., 2011). For the CVI to incorporate this factor, a score of 4 was added if the coastal section possessed visible signs of an estuary. A visual examination of the orthophotographs was undertaken to determine estuary presence.

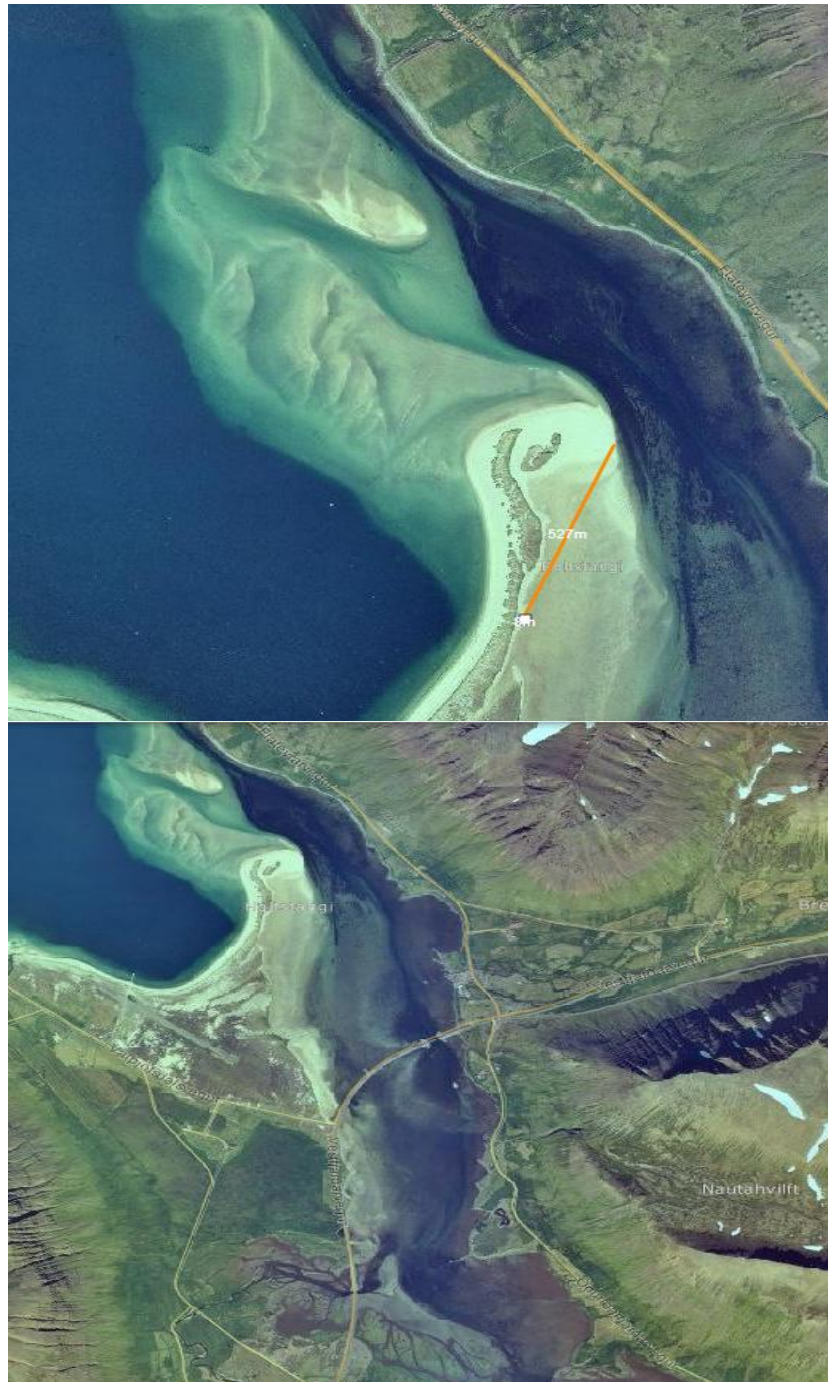
Figure 5.2 Beach width measurement for coastal section 142 and upper reaches of Öfundarfjörður. Top: the beach width recorded for the coastal section represented by cell 142. Left; further in-fjord, a cluster of the largest beach widths were recorded, as Holtstangi beach acts as a buffer, allowing sedimentation to gather (Loftmyndir)

Coastal section 142 recorded the highest width: 525.7m. This coastal section occurred well within Önundarfjörður, where Holtstangi beach is located. Indeed, there is a notable cluster of higher beach width measurements for coastal sections 129 to 146. The presence of Holtstangi beach dissipates the wave energy entering into the upper reaches of the fjord, allowing for more sedimentation to settle behind it. Figure 5.2 present orthophotograph images of these areas.

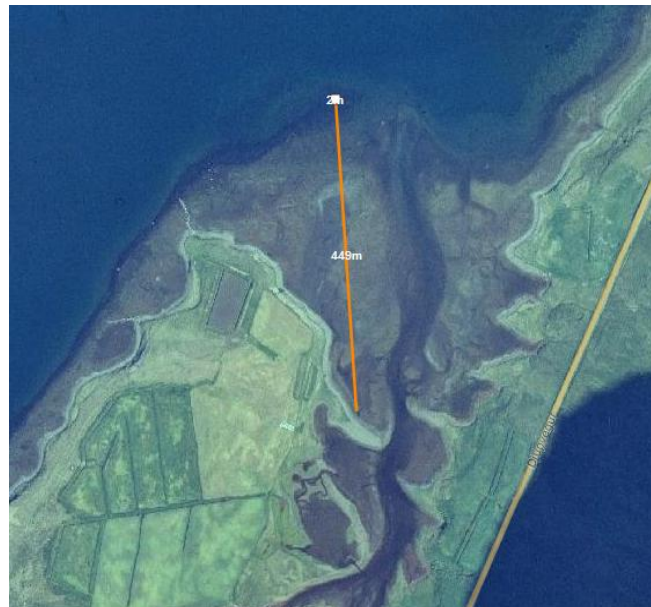
Figure 5.3 Beach width measurement for coastal section 10 (Loftmyndir)

One notable outlier can be observed in the measurement for coastal section 10, where a considerably higher width was recorded than the measurements in close proximity to it. This is due to the transect being located near an estuary mouth where sedimentation had built up (see Figure 5.3).

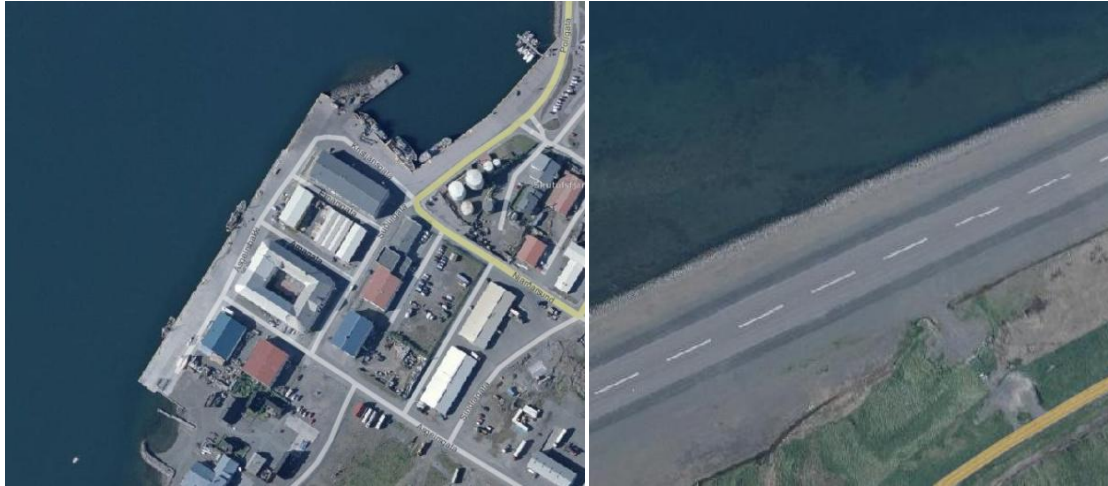
Figure 5.4Ísafjörður harbour and Ísafjörður airport runway (LoftMyndir)

The lowest beach width measurements recorded were 0m for coastal sections 37, 38, 45 and 47. This was due to transects being located at notable points of artificial infrastructure, namely the Ísafjörður harbour and the runway at Ísafjörður airport (See Figure 5.4).

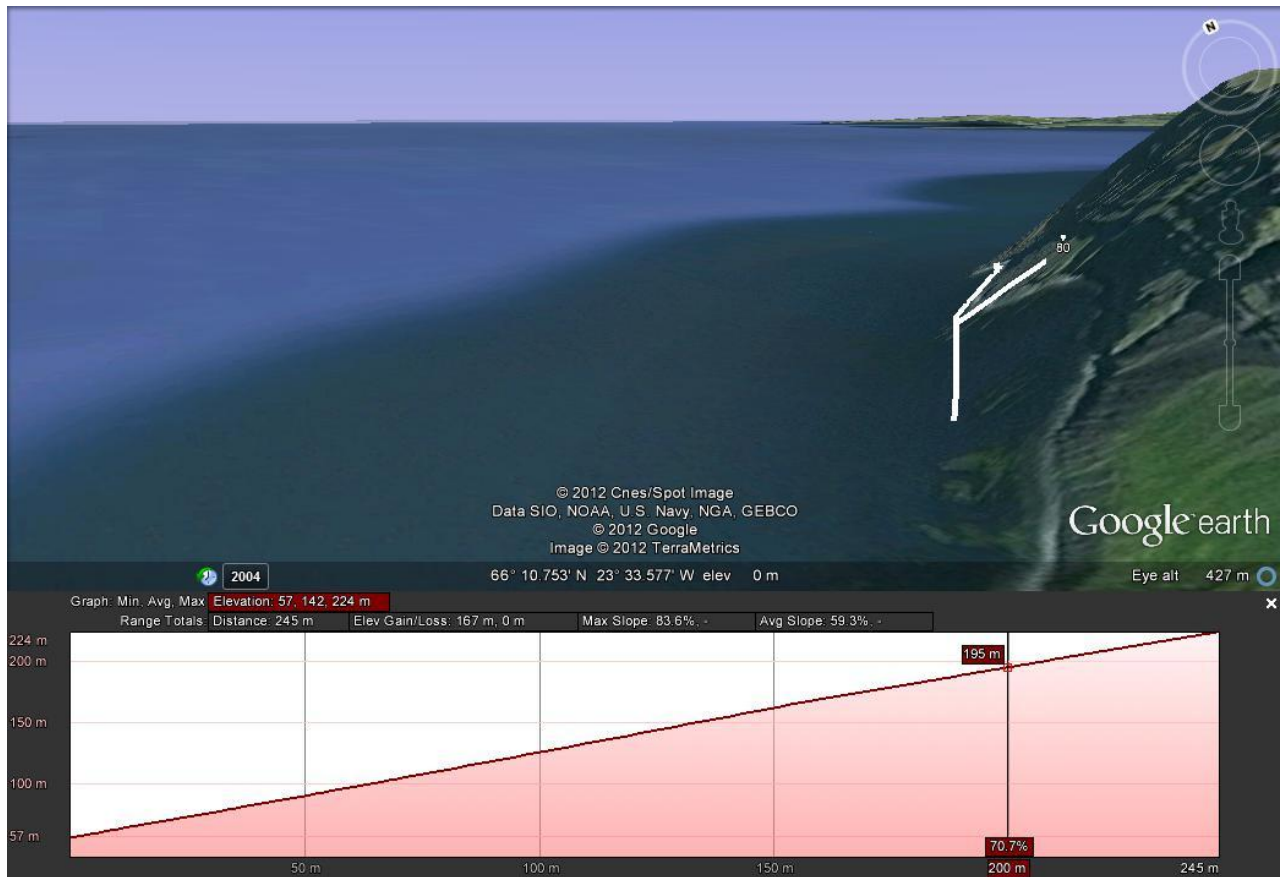
Figure 5.7 Coastal slope measurement for coastal section 80. Note: due to the precision of the STRM data, the bottom elevation value is not necessarily 0m at the shoreline. This elevation value is subtracted to provide a better indication of coastal slope(Google Earth)

There is a considerable disparity between the highest % coastal slope measured and the lowest. The average coastal slope was calculated as 18.77%, however because of the large disparity between highest and lowest, it is not indicative of the coastal slope for the whole region. The mid-range spreads across a large number of measurements, ranging from 5.15-32%. As Figure 5.6 shows, clusters of high coastal slopes can be observed, often being found in uninhabited stretches of coastline where the fjord walls are particularly steep: Stigahlíð, (coastal sections 63-75), Sauðanes (coastal sections 110-121) and Skagafjall (coastal sections 169-175). An example of one of the steeper slope measurements is presented in Figure 5.7.

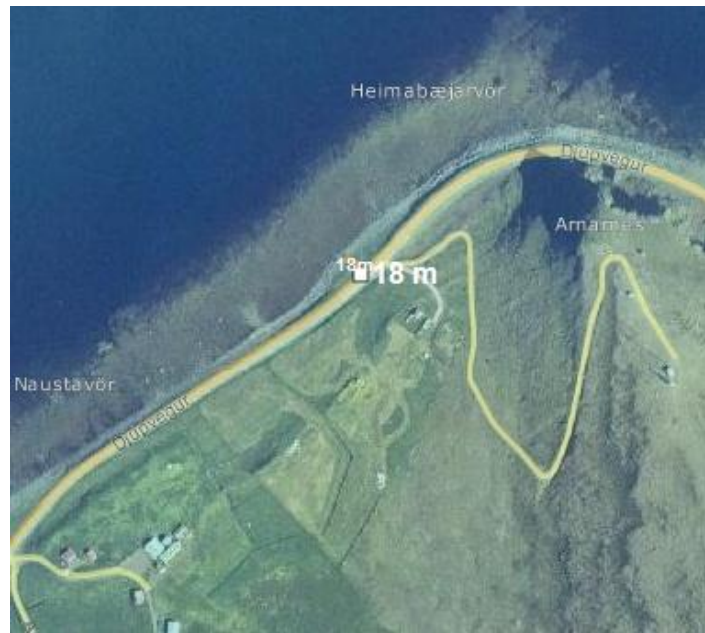
Figure 5.14 Distance of vegetation behind back beach measurement for coastal section 31(LoftMyndir)

A large disparity was found in the measurements for this parameter. The average measurement was 73.16m. The mid-range (between the 25% and 75% percentile) ranged from 0-104.2m. 69 transect measurements (28.75% of the total study area) showed no signs of vegetation from the back beach. That distance of vegetation was measured from the back beach to the nearest infrastructure was another significant influence, as much of the coastal infrastructure was found relatively close to the shoreline, therefore not allowing for great distances of vegetation to exist before the coastal road, if at all. An exemplar of this can be seen in Figure 5.14, where a measurement of 18m was recorded. However, if the road had not been present, a higher measurement would have been recorded.

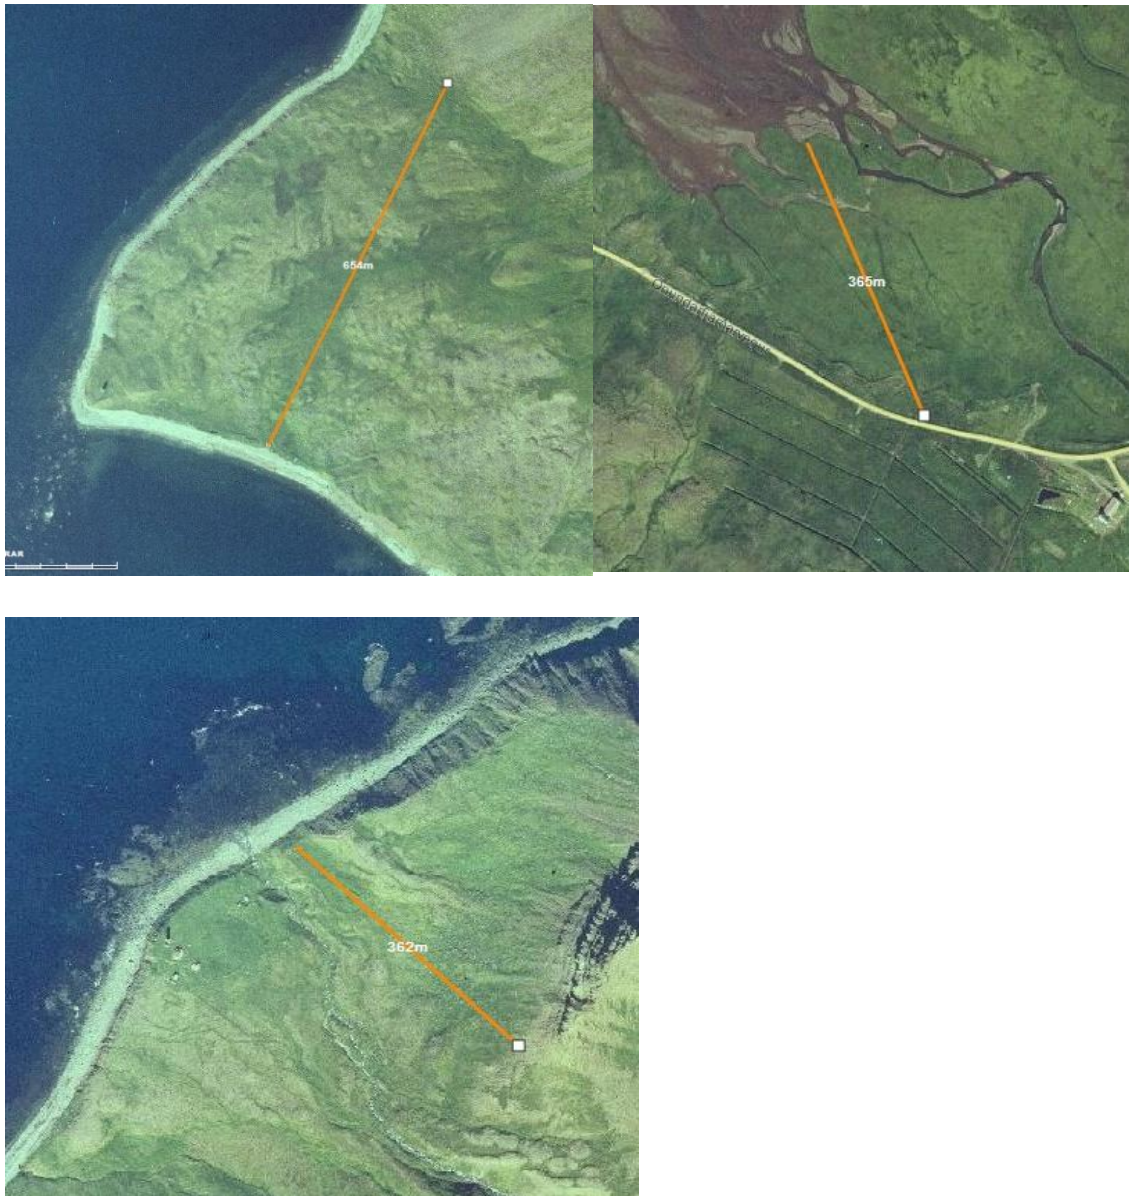
Figure 5.15 Examples of the highest measurements for vegetation behind the back beach. From top-left, transect measurements for coastal sections 168, 137, and 81 (Loftmyndir)

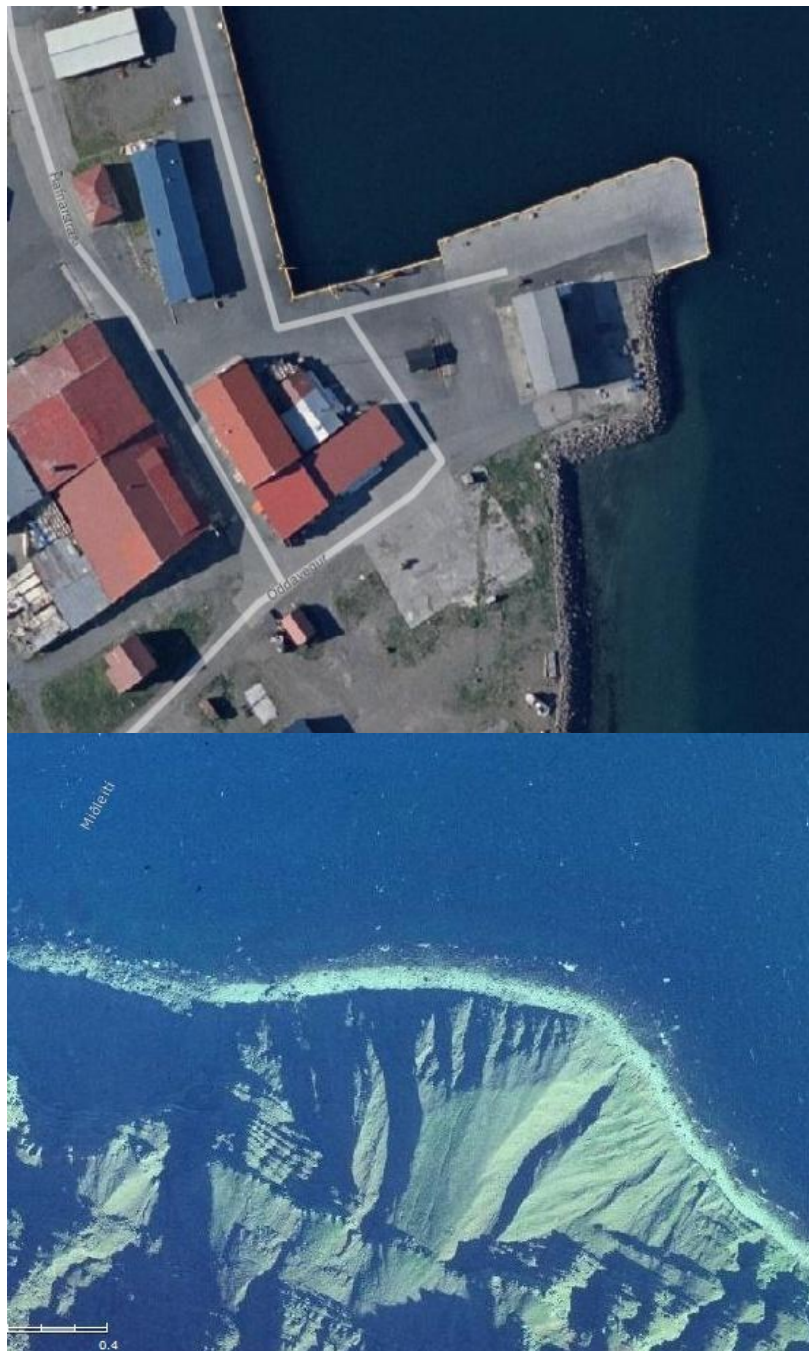
Figure 5.16 Examples of 0m of vegetation behind the back beach recorded, left; coastal section 125, right; coastal section 73(Loftmyndir)

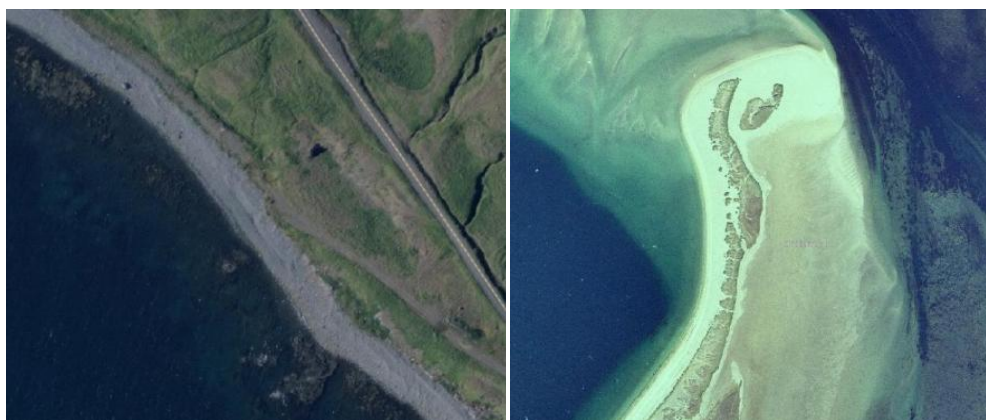
Figure 5.18 Examples of % rock outcrop; Left, coastal section 124 where a high percentage of rocky outcrop is present. Right, Holt beach where minimal rocky outcrop is present (coastal section 141-143(LoftMyndir))

Of all the physical parameters, measuring the percentage of rocky outcrop was the most difficult. This was mainly due to the difficulty in differentiating between large, mobile rocks that constituted much of the coastline's beaches and identifying what was rocky outcrop. However, a reasonable estimation could be taken. Overall, 103 transect measurements were found to have '20-50%' rocky outcrop, (42.9% of the total) and 66 were found to have '10-20%' rocky outcrop (27.5% of the total). The percentage rocky outcrop was fairly evenly spread across the study area, with some clusters of coastal sections recording either <10% and >50%. Generally, the areas that scored >50% were found on the shoreline of towns where there was no beach visible, only a harbour or sea wall (e.g. cells 45-48). As the parameter was chosen to help signify the susceptibility to erosion, it was decided that for these occurrences the highest rocky outcrop estimation should be allocated, as such infrastructure is not an erosion risk. As the graph in Figure 5.17 shows, there is one notable cluster of cells allocated with >10% rocky outcrop (cells 129-145). This is the region where the sandy beach of Holt is located with an estuarine region situated behind it (as shown in part of Figure 5.18).

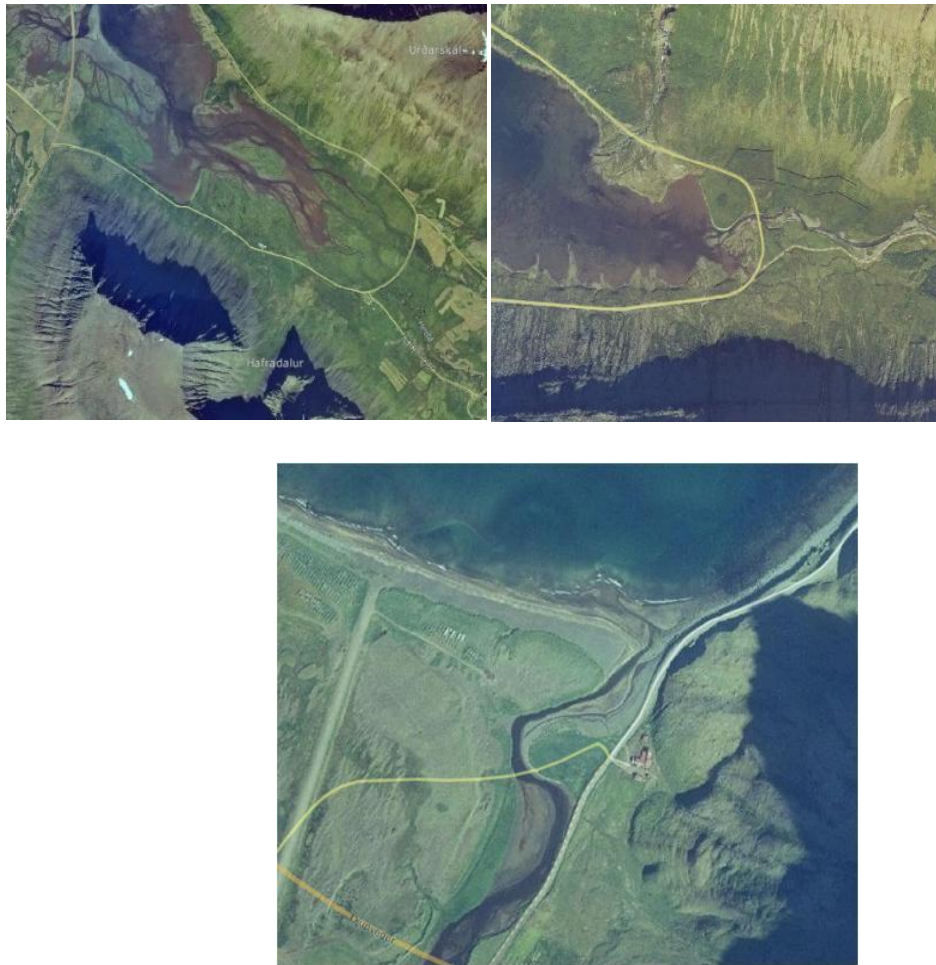
Figure 5.19 Examples of estuaries found in the study area. From top-left, clockwise; coastal sections 136-139, coastal section 98 and coastal section 61(LoftMyndir)

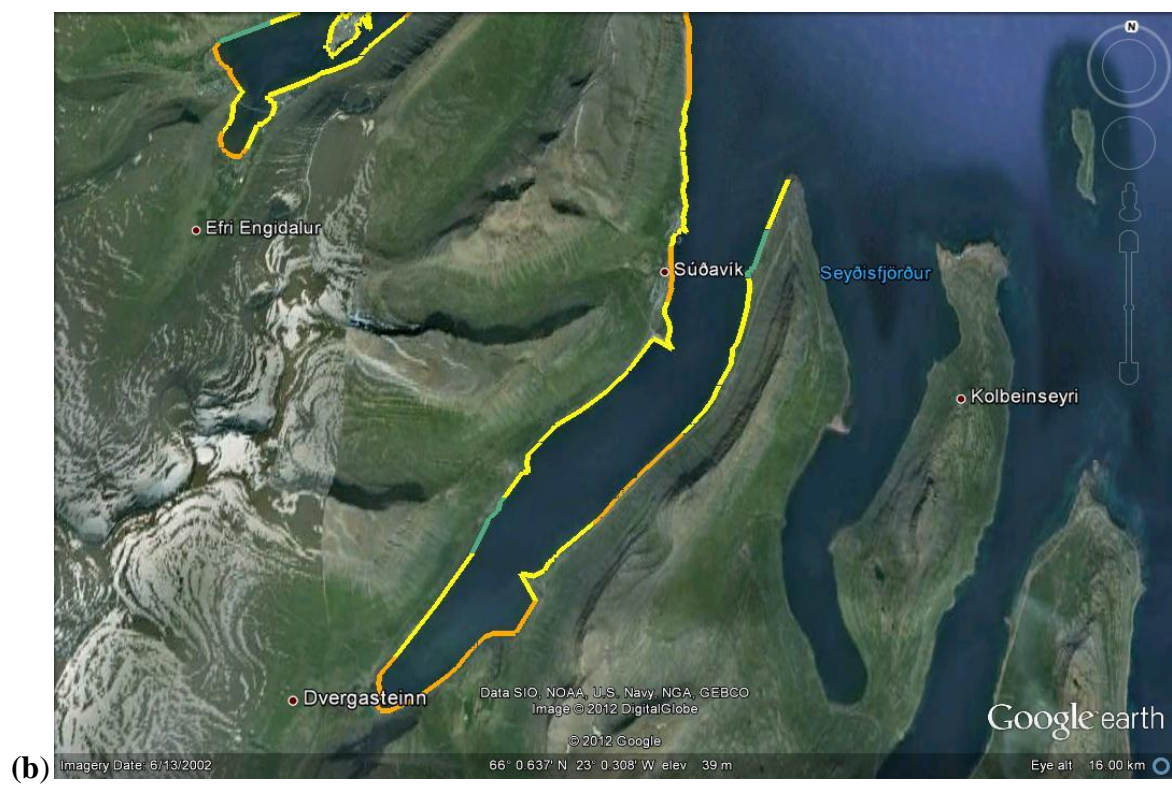
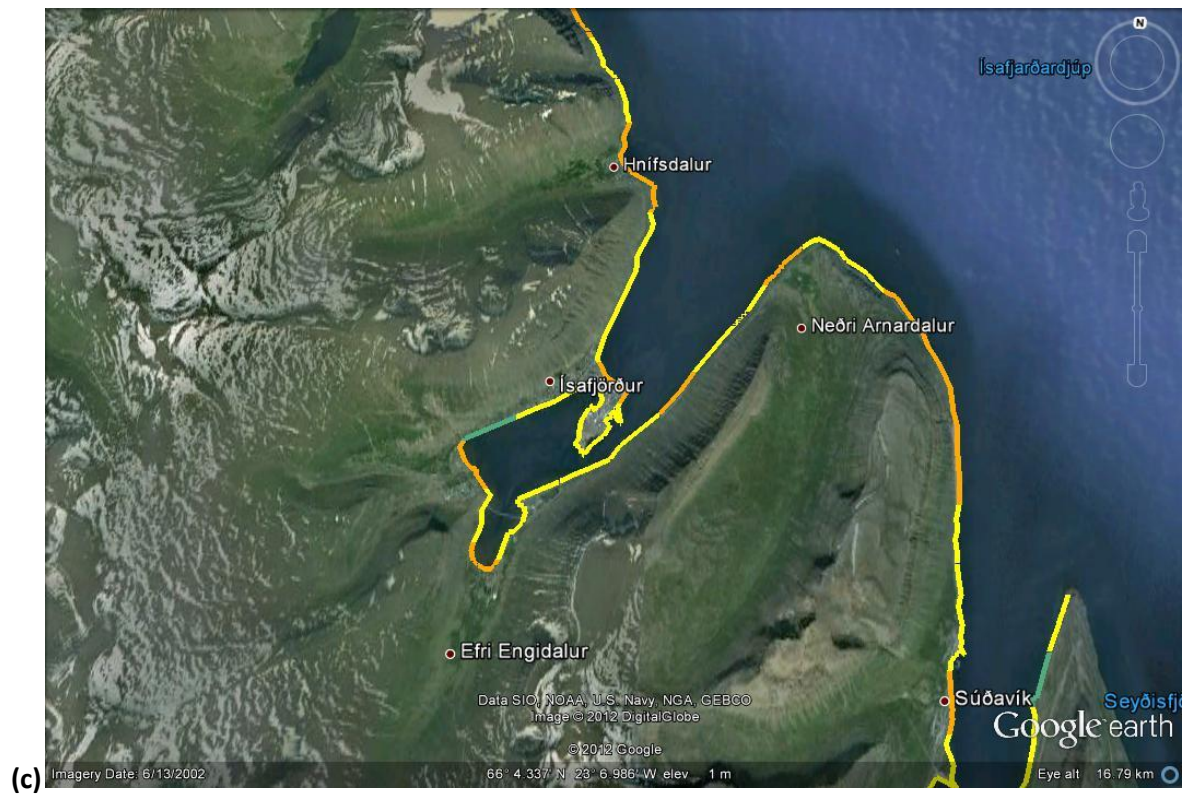
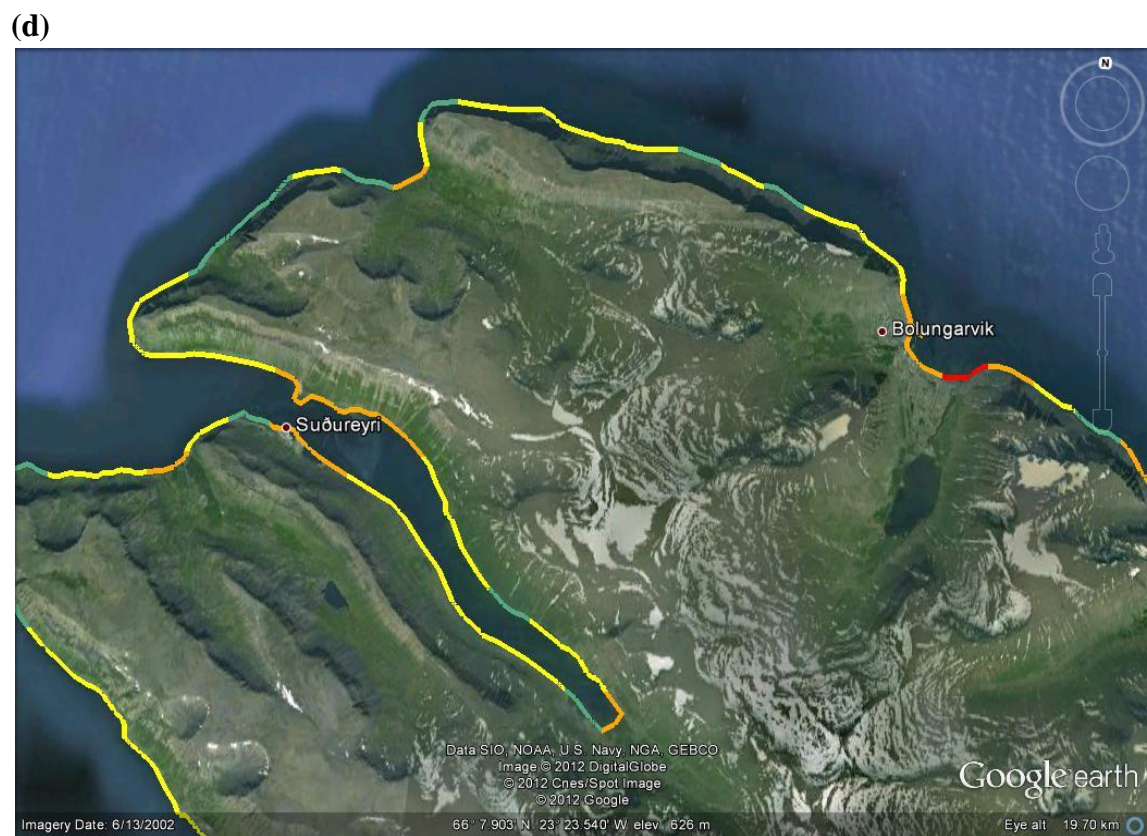
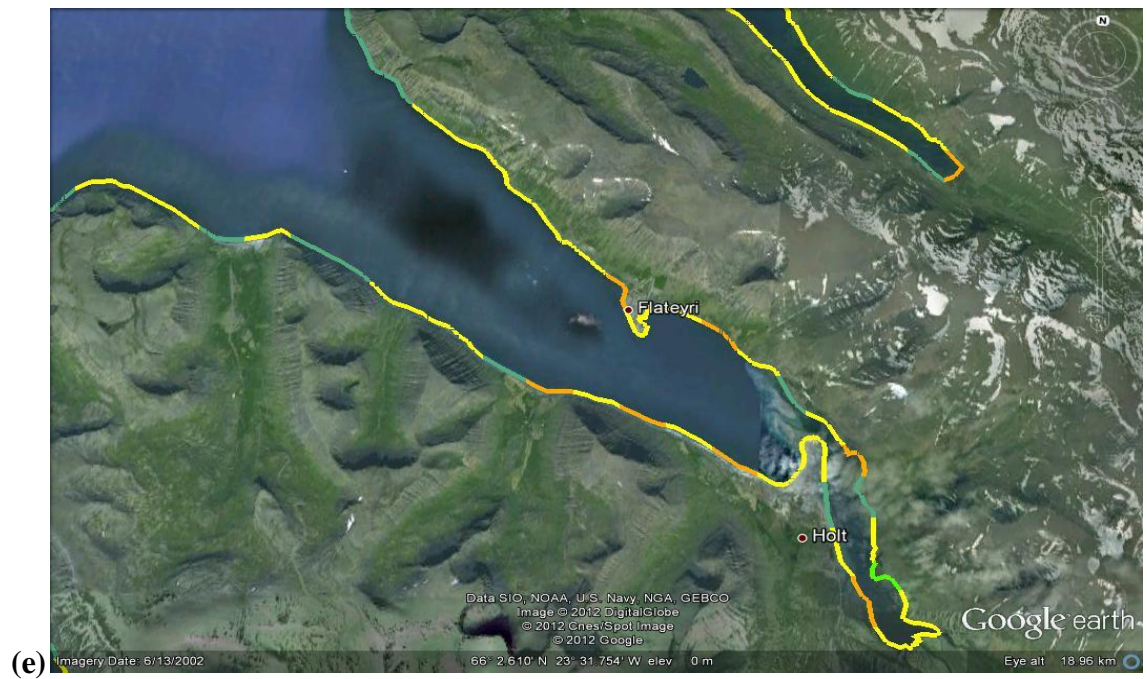
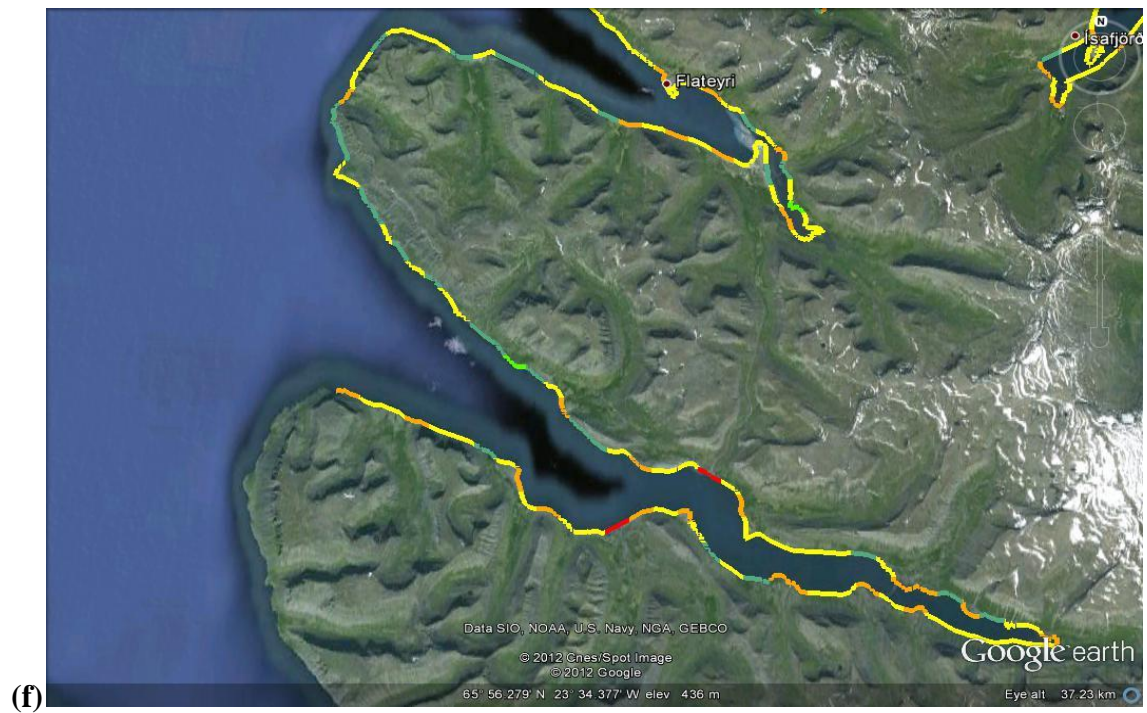
Figure 6.3 visually represents the CVI scores found along the coastline, colour-coding each 1km with its assigned vulnerability ranking. The few pockets of red emphasising how the areas deemed 'very high' were few and scattered across the study area.

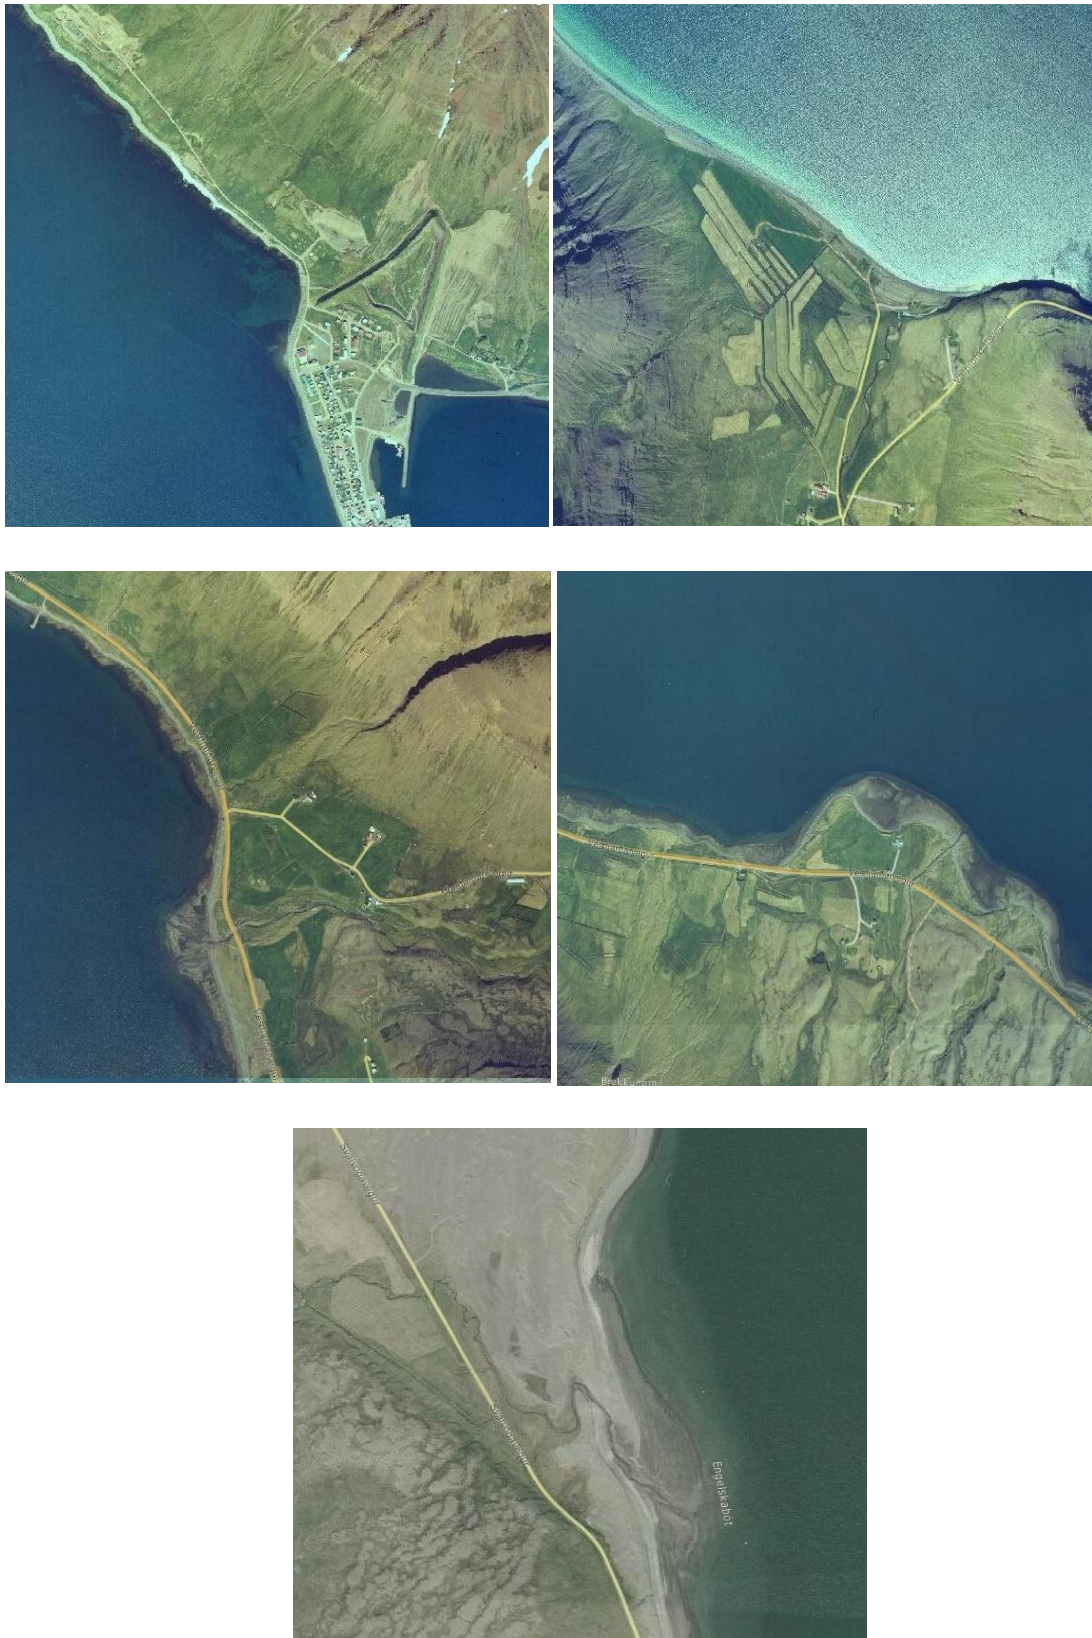
Figure 6.5 Orthophotograph images of coastal sections scoring '22'. From top left; 124, 149, 192, 219 and 232 (LofnMyndir)
