Applying a Coastal Vulnerability Index (CVI) to the Westfjords, Iceland: a preliminary assessment

University of Akureyri
Faculty of Business and Science
University Centre of the Westfjords
Master of Resource Management: Coastal and Marine Management
Ísafjörður, June 2012

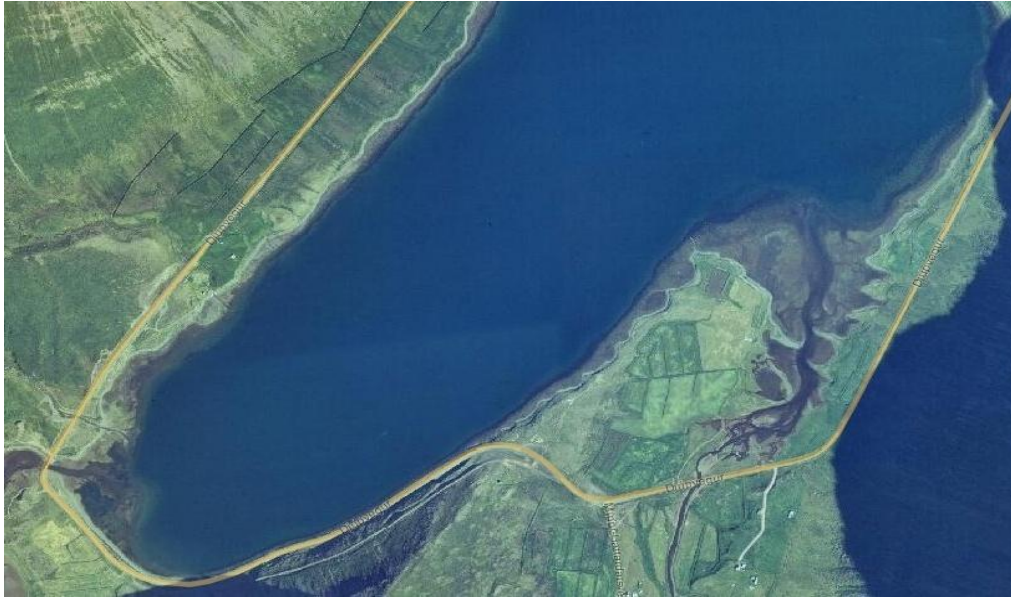
Figure 6.6 Orthophotograph image of coastal sections 10-13 (LoftMyndir)

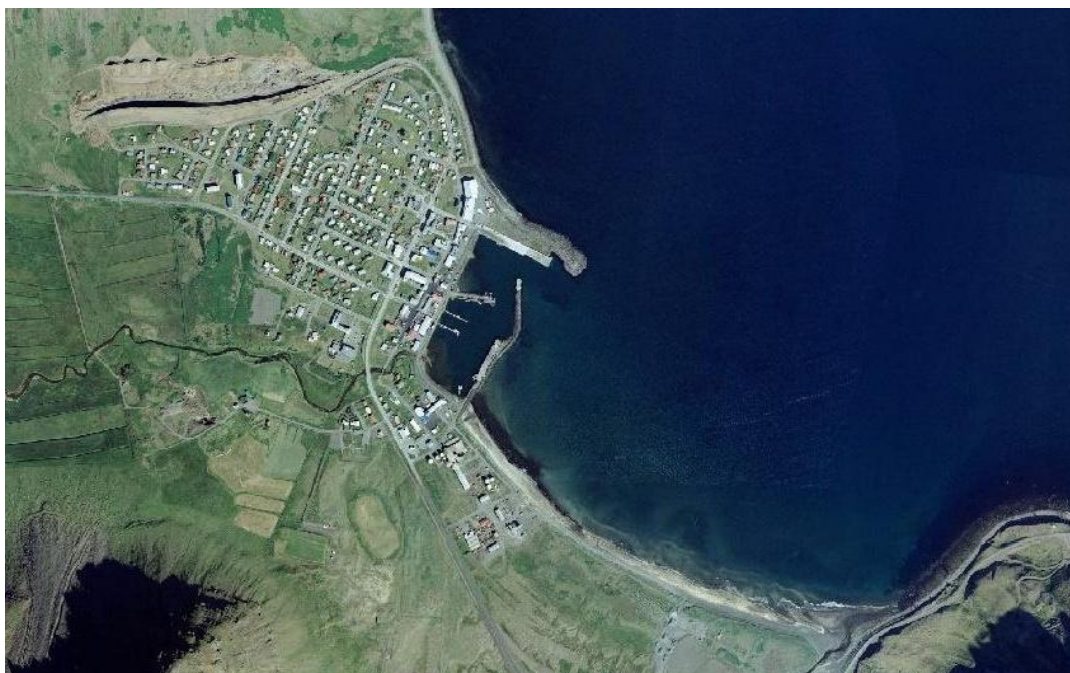
Figure 6.8 Orthophotographimage of coastal sections 60-63(LoftMyndir)

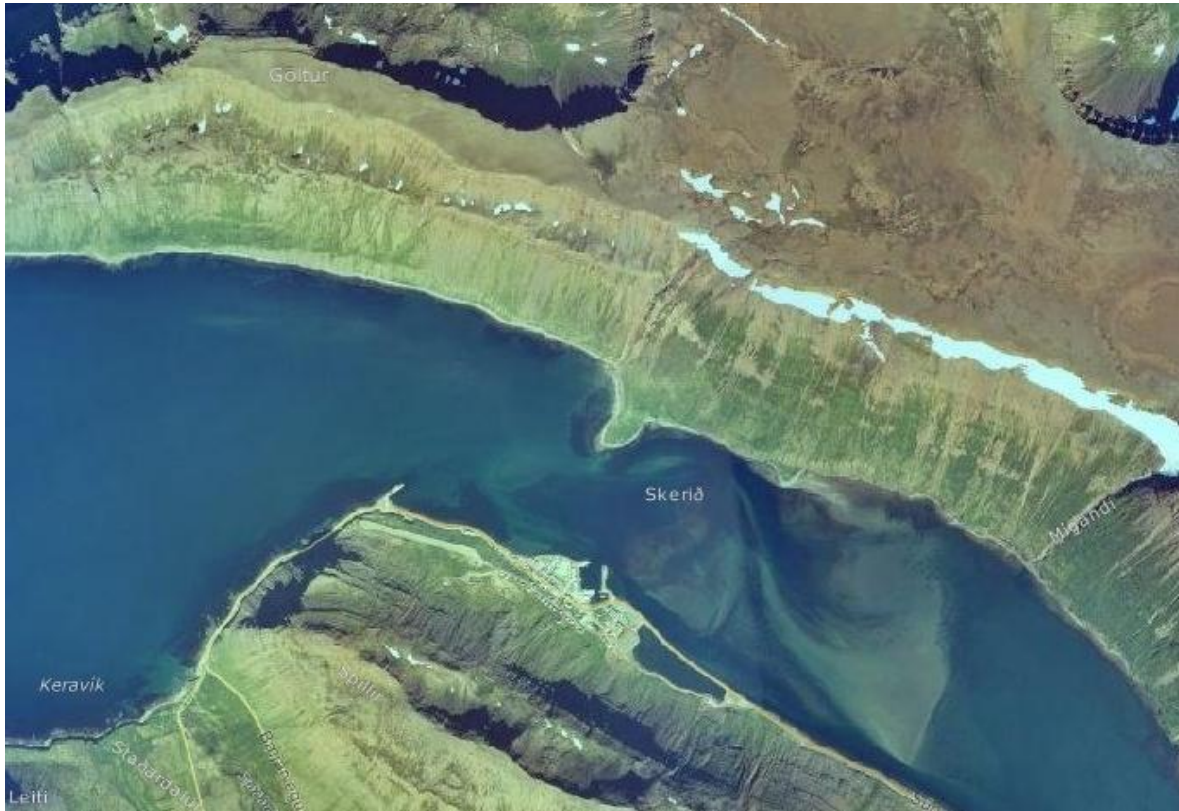
Figure 6.9 Orthophotograph image of coastal sections 88-91 (located on the northern coastline of the fjord) (LoftMyndir)

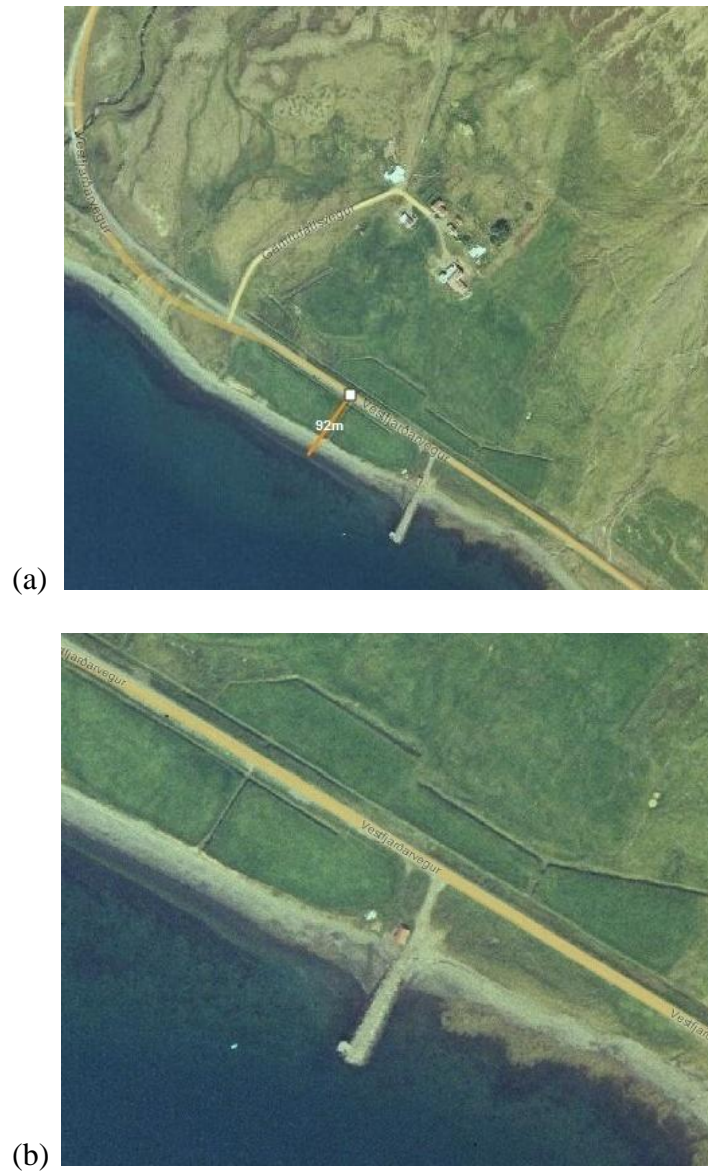
Figure 6.11 Orthophotograph images of socio-economic features present in coastal section 190. (a) Vestfjarðarvegur, (b) boat launch site (LoftMyndir)

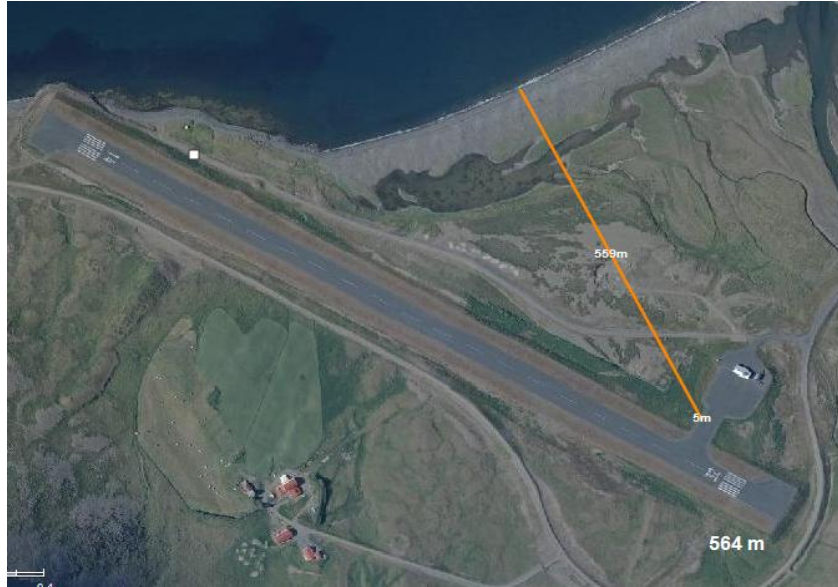
Figure 6.12 Orthophotograph images of the Pingeyri airstrip, ~550m inland from the shoreline at the western edge of coastal section 227 (LoftMyndir)

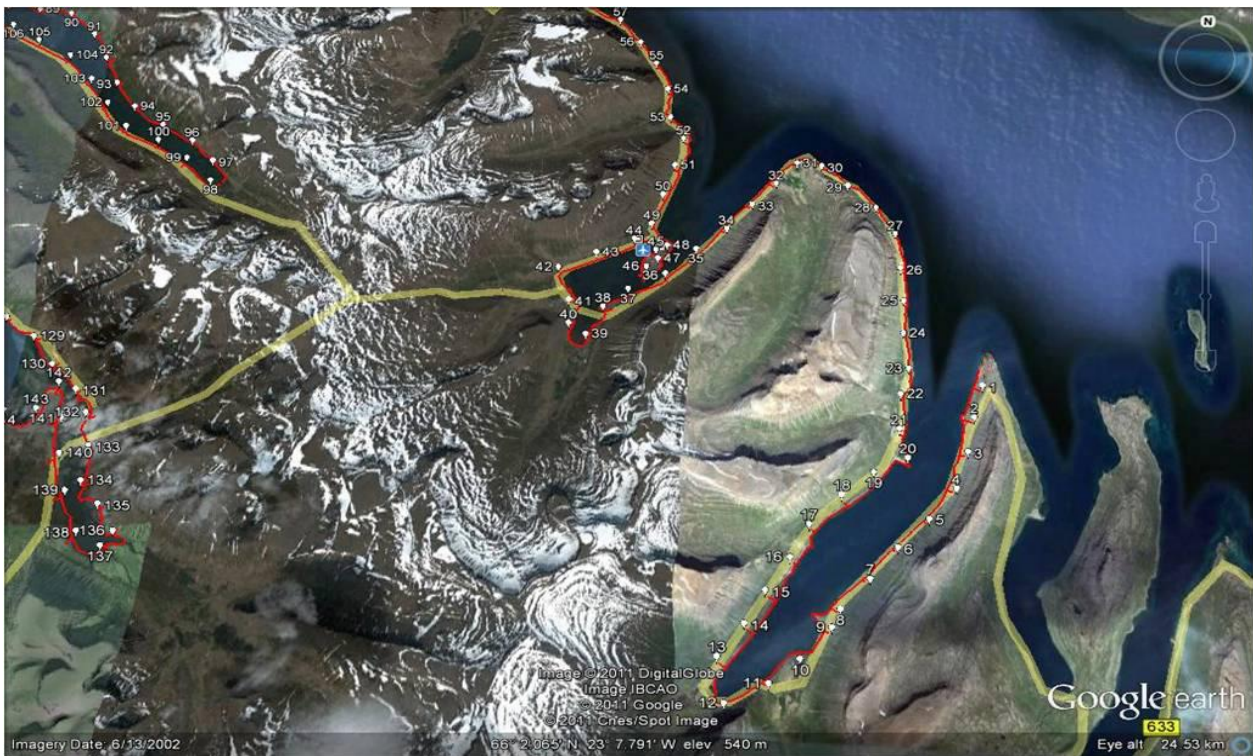
Transects1-57

Transects measurements across the study area(Google Earth)
