Volcanogenic floods at Sólheimajökull. Hazard identification,
monitoring and mitigation of future events

90 ECTS thesis submitted in partial fulfillment of a
Magister Scientiarum degree in Geography

Faculty of Life and Environmental sciences
School of Engineering and Natural Sciences
University of Iceland
Reykjavik, June 2015

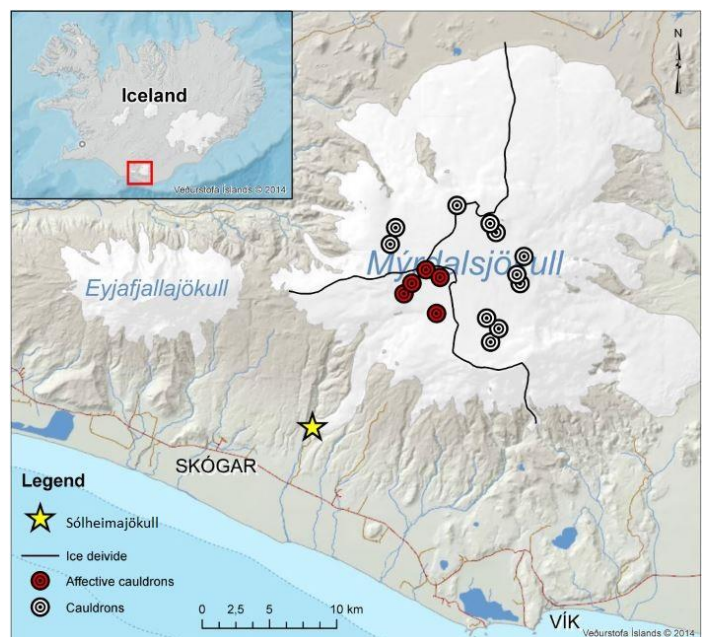
Figure 1: Overview map of the study area showing the location of cauldrons, the red dots mark the cauldrons impacting Sólheimajökull. The yellow star marks Sólheimajökull and the location of the tourist area. The Ice divides represent if melt water will flow south, east or west (Björnsson, Pálsson, & Guðmundsson, 2000).

The caldera of Katla has three main drainage paths that are valleys cut through the ice covered caldera rim. The water divide shown in Figure 1 is very simplistic showing only if the water beneath the glacier will flow South, East or West but cannot anticipate through which outlet glacier the water will flow. These divides have been identified by the work of the glacier group at the Institute of Earth sciences (IES) (Björnsson, Pálsson, & Guðmundsson, 2000). A more detailed map by the glacier group exists, showing the watershed for each underlying river system, but for this work the simplistic watershed is sufficient. The water flow under a glacier will not in every case follow gravity as the pressure above from the glacier may divert the flow. Thus when the glacier thickens or gets thinner the flow channels may change over time. The main flood pathways of volcanogenic floods are to the east down Kötlujökull to the river Múlakvísl, to the west down Entujökull to the river Markarfljót and to the southwest down Sólheimajökull to the river Jökulsá á Sólheimasandi (referred to as Jökulsá hereafter) as can be seen in Figure 2.

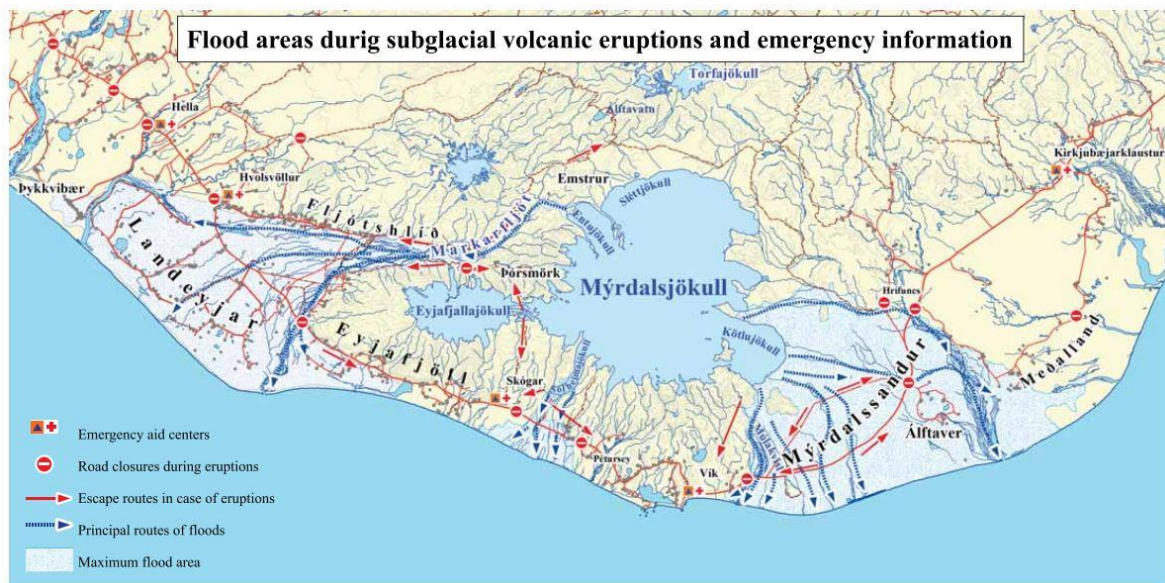
Figure 2: The three main flood routes from Mýrdalsjökull. Map created for the ICP showing evacuation centers and locations of road closures during volcanic eruptions of Katla and Eyjafjallajökull (Ríkislögreglustjórnin, 2016).

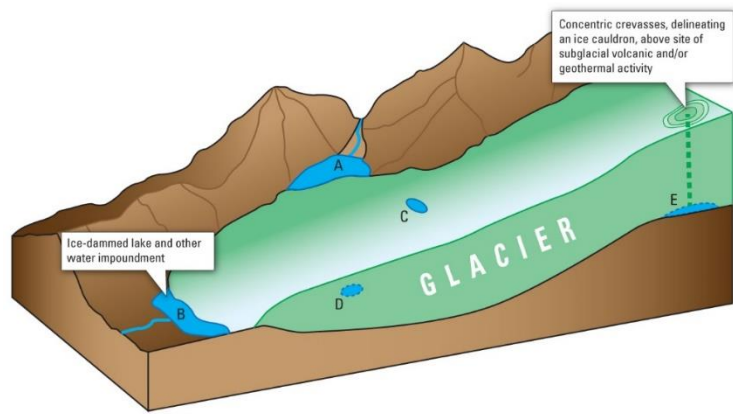
Figure 4: Illustration showing the different forms of water accumulation (<http://pubs.usgs.gov/pp/p1386a/gallery2-fig86.html>).

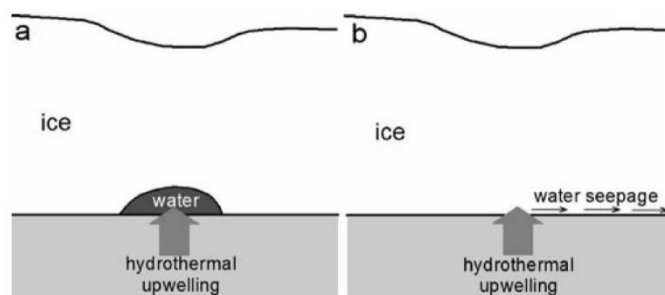
Figure 5: Illustration showing the two main processes causing the formation of cauldrons (Guðmundsson M. T., Högnadóttir, Kristinsson, & Guðbjörnsson, 2007).

1. Floods caused by subglacial geothermal systems. These floods happen as geothermal systems melt the bottom surface of the glacier forming either a reservoir of water that drains in a flood event once the water volume is great enough to lift the glacier or where continuous drainage is allowed as shown in Figure 5. Typically water seepage events

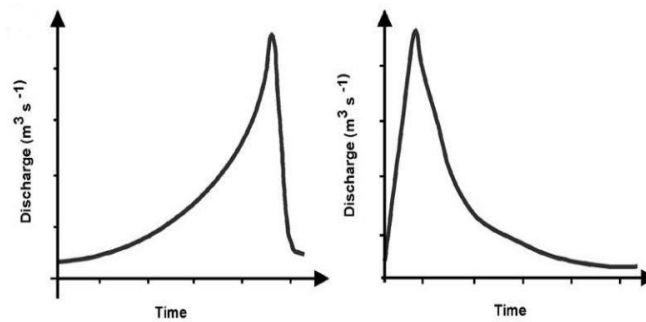
Figure 6: Hydrographs showing two typical characteristic time evolutions of different floods (Björnsson H. , 2002).

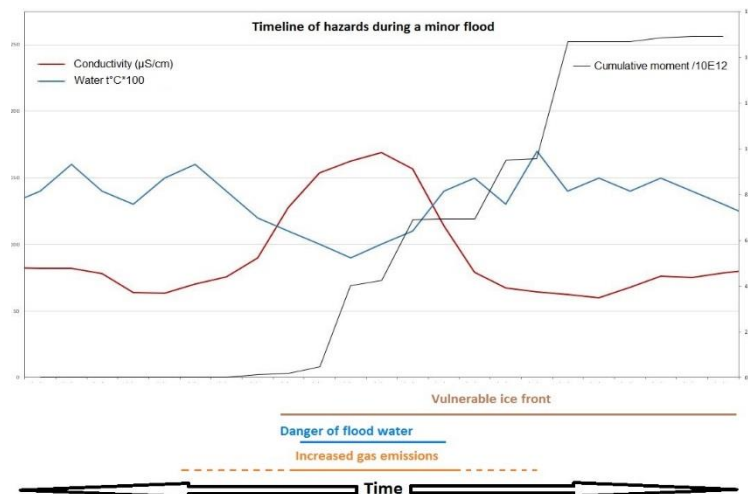
Figure 7: A schematic timeline of the different hazards to be expected for a minor flood. The timeline includes the real-time data including electrical conductivity, water temperature and cumulative seismic moment released within the catchment area of Sólheimajökull in the 2014 minor flood. The conductivity peak lasted for 9 days from the start of the increase to when the concentration reached background levels again.

Timelines can be created to show the approximate sequence of the hazards associated with the different size-groups of floods as shown in Figure 7 for minor floods. The key monitoring networks and the timescale they work in can also be included in such schematics.

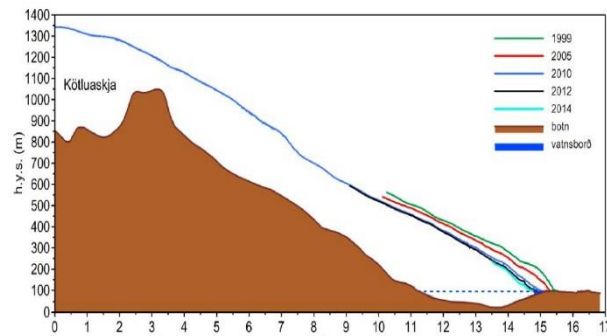
Figure 8: Vertical profile of Sólheimajökull, Source taken from Guðmundsson 2015 data from Mackintosh (1999) and Björnsson (2000).

Due to Sólheimajökull's short subglacial flow distance (Figure 8) and the fact that all its cauldrons are seepage type cauldrons, there are currently two operating monitoring systems available. These are the two established networks of the IMO (hydrological and seismic). The airborne gas measurements that have until now been at a development state can in the future become a real-time monitoring tool. The gas measurements share most logistical needs with the other systems allowing for remote setup of instrumentation that can gather data in real-time. These techniques can be displayed on a timeline to illustrate their affective timely detection as seen in Figure 25. As gas has not been measured prior to volcanogenic floods the timeline illustration in Figure 25 displays a dotted line before the flood starts even though reports of people smelling gas preceding volcanogenic floods exist.

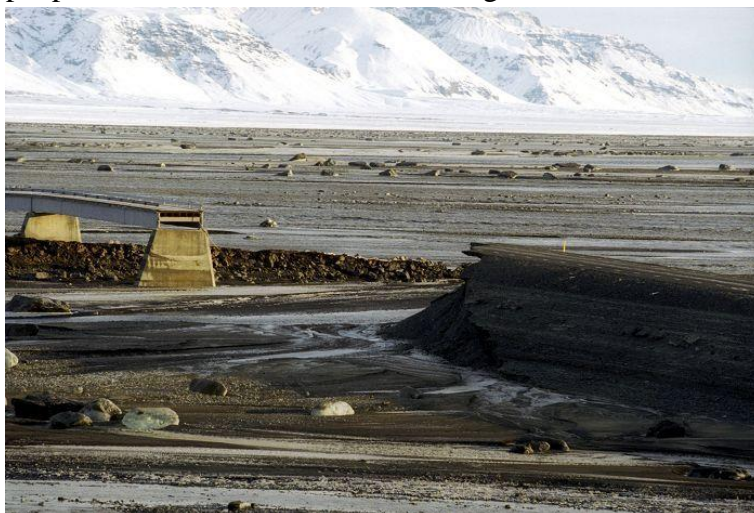
Figure 9: Skeiðarárbrú after the Jökulhlaup in 1996 (Fréttablaðið, 2011).

water. Injury or death may also occur through direct contact of large objects carried by the flood (Pagneux & Roberts, 2015). Flood water can also damage infrastructure like roads, bridges (Figure 9), power lines and houses. They can also wash away farmland leaving a slushy layer of rock, ice and clay once the flood has

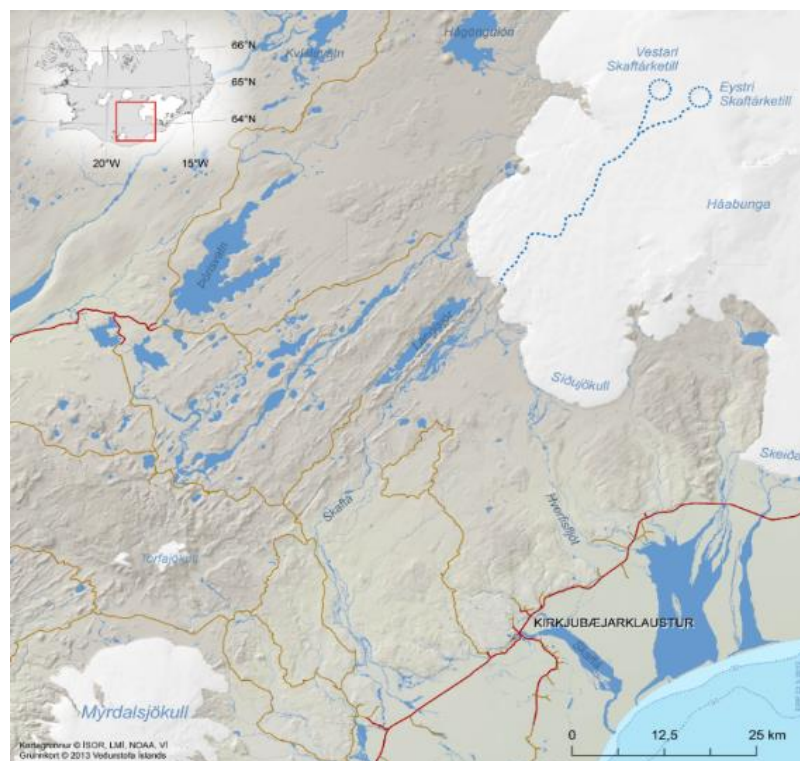
Figure 10: Subglacial flow paths of water draining from the Skaftár cauldrons in Vatnajökull (Veðurstofan, 2015).

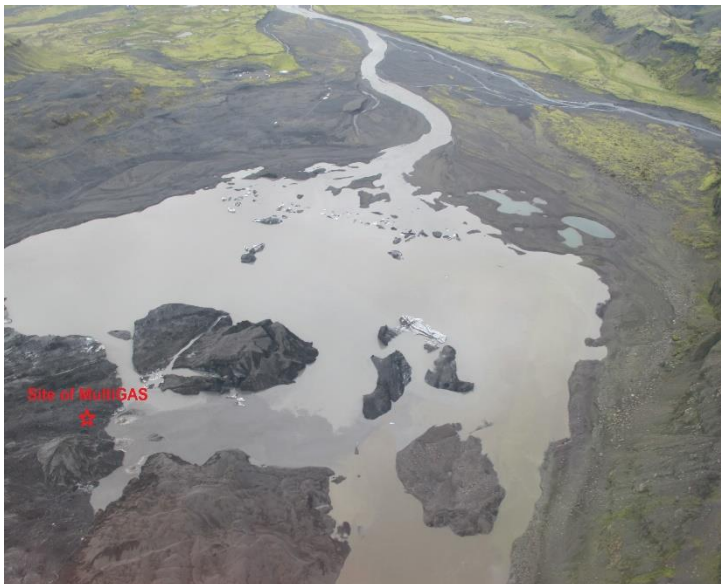
Figure 11: The minor event of July 2014. The darker water close to the ice margin is the geothermal water. Site of gas instrument is marked in red

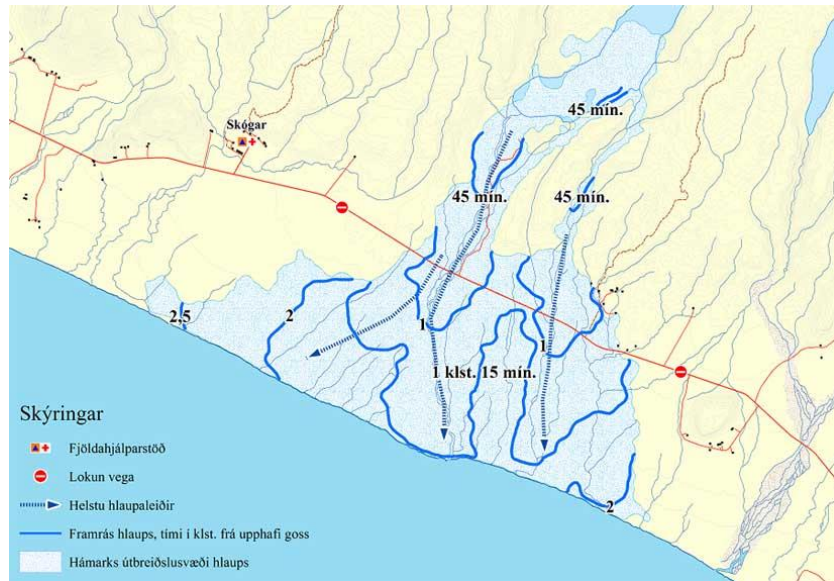
Figure 12: Flood hazard map by Almannavarnir. Time on map indicates arrival of flood water from initiation of eruption (Almannavarnir, 2016b).

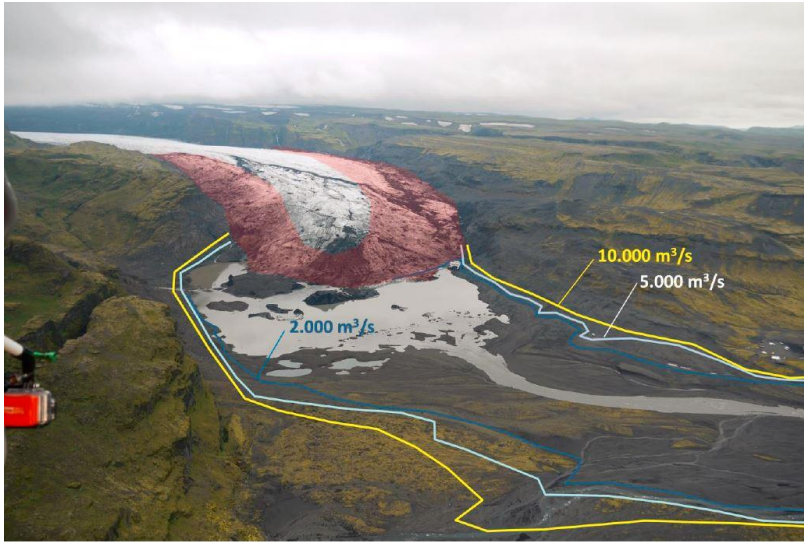
Figure 13: An aerial photograph showing the extent of different flood scenarios down Sólheimajökull. The sides of the glacier are red as it is likely that the flood water may break out from the glacier surface in those areas. (Guðmundsson M. T., 2015).

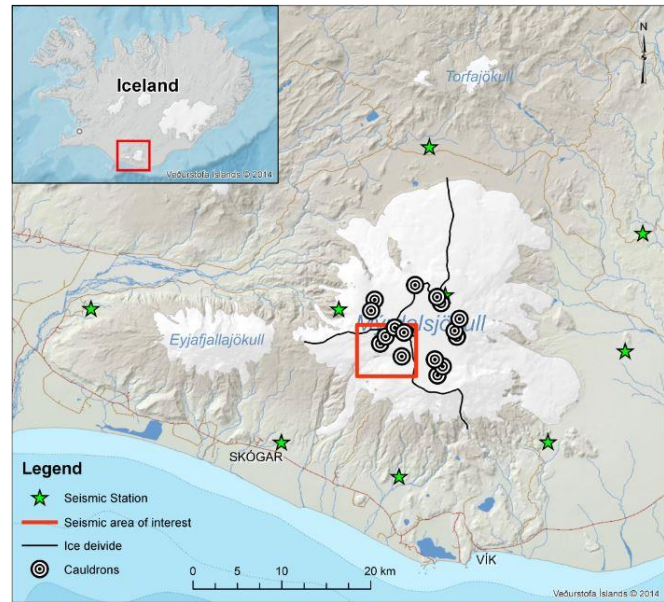
Figure 20: Overview of area of seismic interest in the catchment area of Sólheimajökull showing the location of seismic stations around Katla.

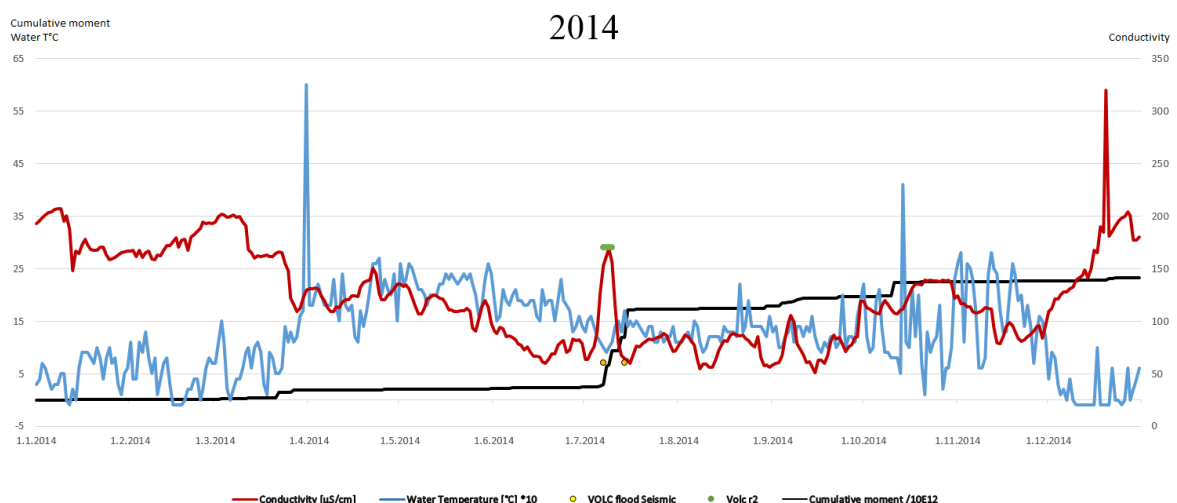
Figure 22: Subset of time series of data used to identify floods. The green points indicate times when the rise in conductivity and drop in water temperature meet the thresholds to distinguish a flood. The yellow points indicate when the increase of seismic moment meets the threshold.

In the subset of data seen in Figure 22 it can be seen that the change in conductivity during a minor flood event is less than the variance in conductivity for the year of 2014. What is however important is that the rate of change during the flood event is greater, with the pulse lasting a few days. The increase in the seismic moment is also conclusive as the energy release throughout the year is relatively low but during the flood it is elevated. Furthermore the water temperature falls at the same time as the conductivity increases. All of these three factors can fluctuate on their own, as can be seen in Figure 22 with high spikes of both conductivity and water temperature, but when they all happen at the same time it indicates that a flood happened.

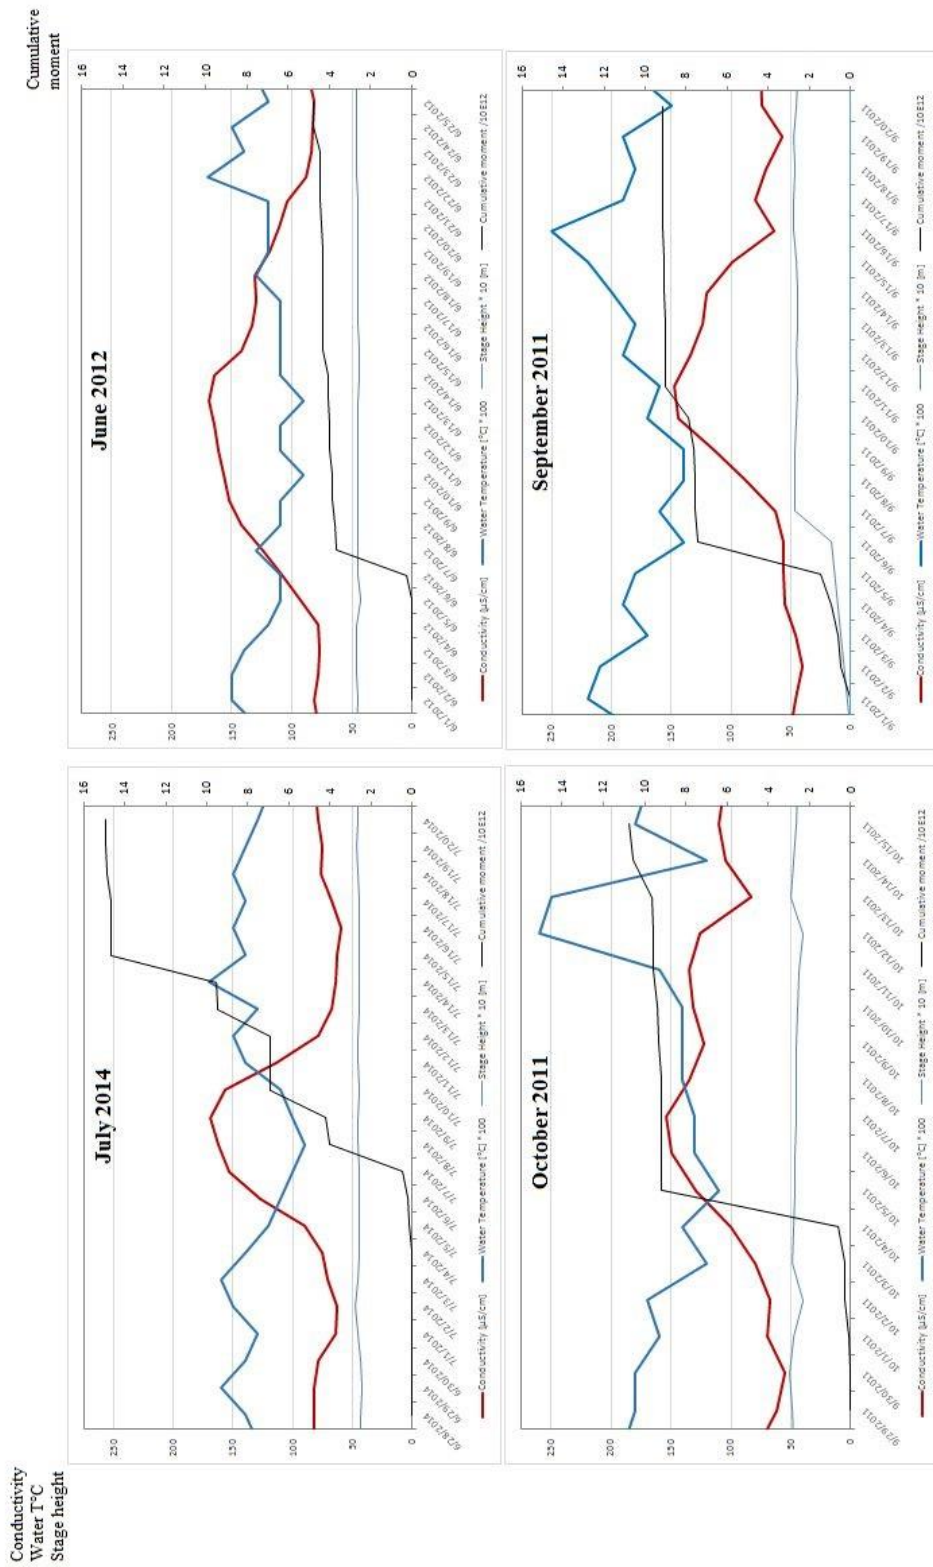
Figure 23: The four floods identified at Sólheimajökull from January 2009 to January 2016. Larger figures of these floods can be seen in Appendix D.

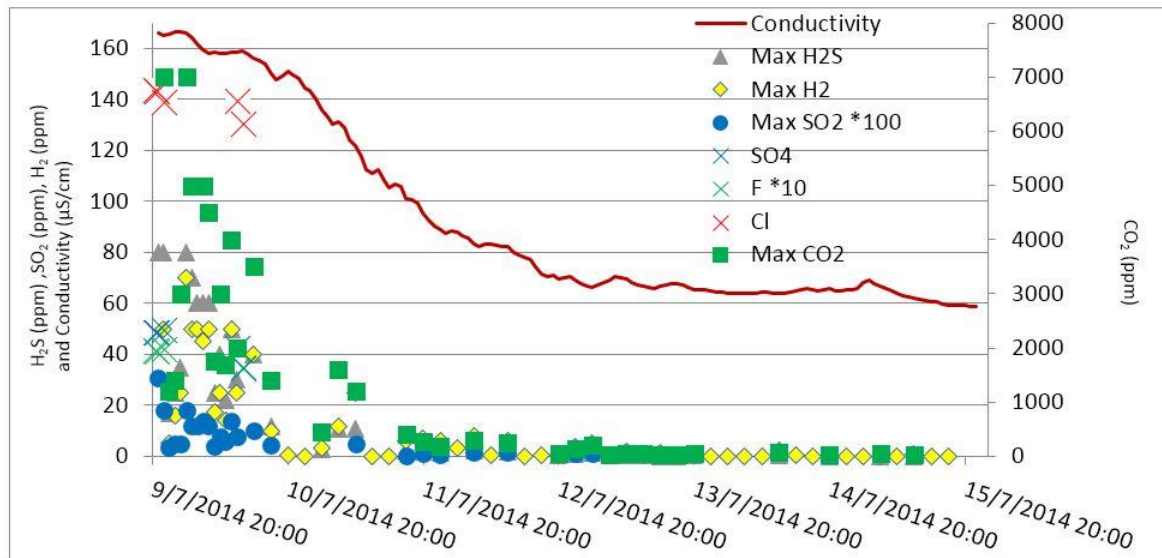
Figure 24: Gas concentrations during the July 2014 flood.

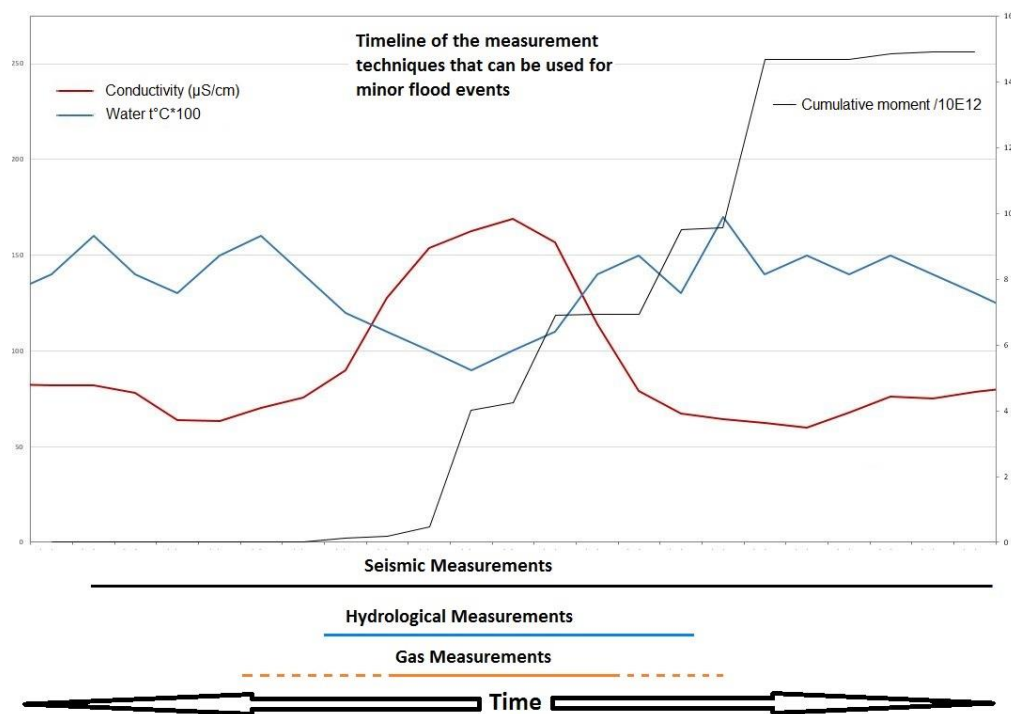
Figure 25: An example of the time period of different monitoring techniques that could be of use to an early warning system.

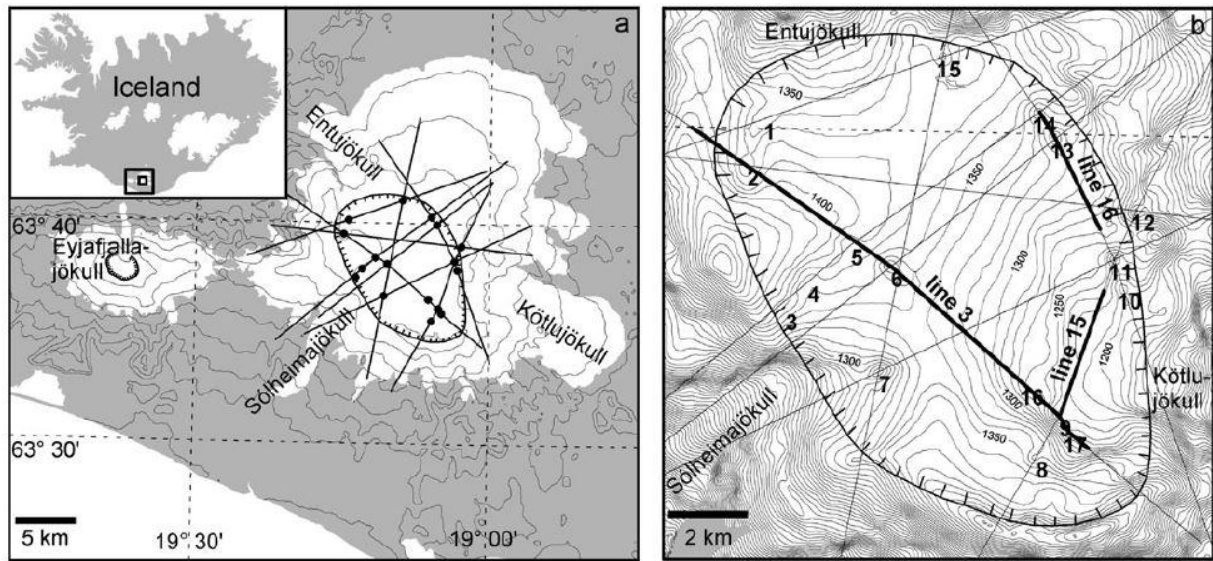
Figure 26: Flight lines over the cauldrons of Mýrdalsjökull (Guðmundsson M. T., Högnadóttir, Kristinsson, & Guðbjörnsson, 2007).

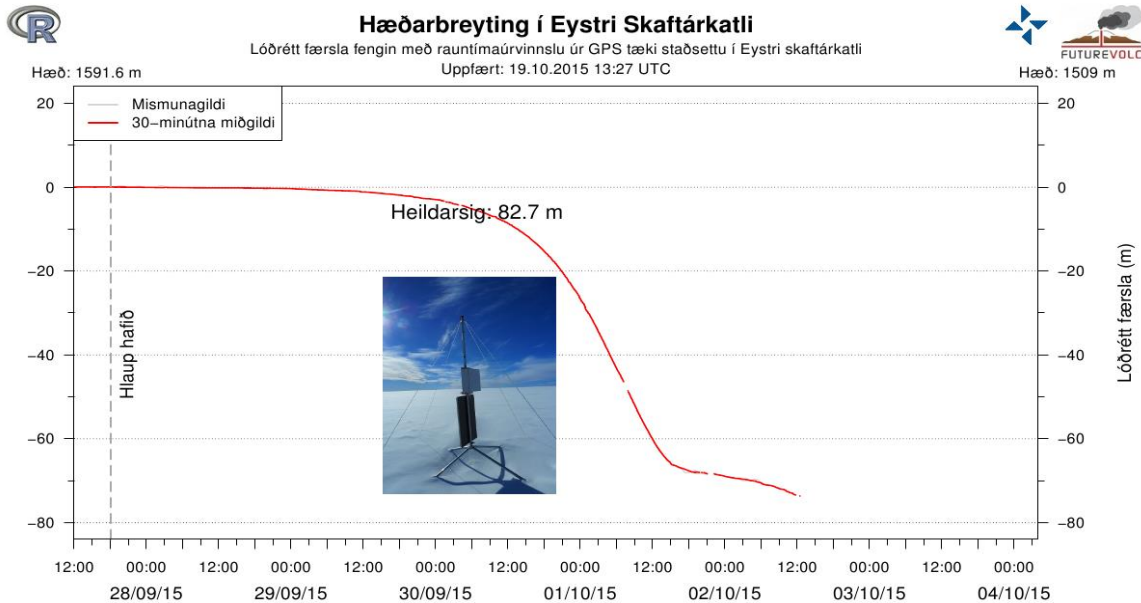
Figure 27: A plot showing ice subsidence of the eastern Skaftár cauldron in 2015 monitored by a GPS instrument in the cauldron. The event was forecasted by 4 days of warning.

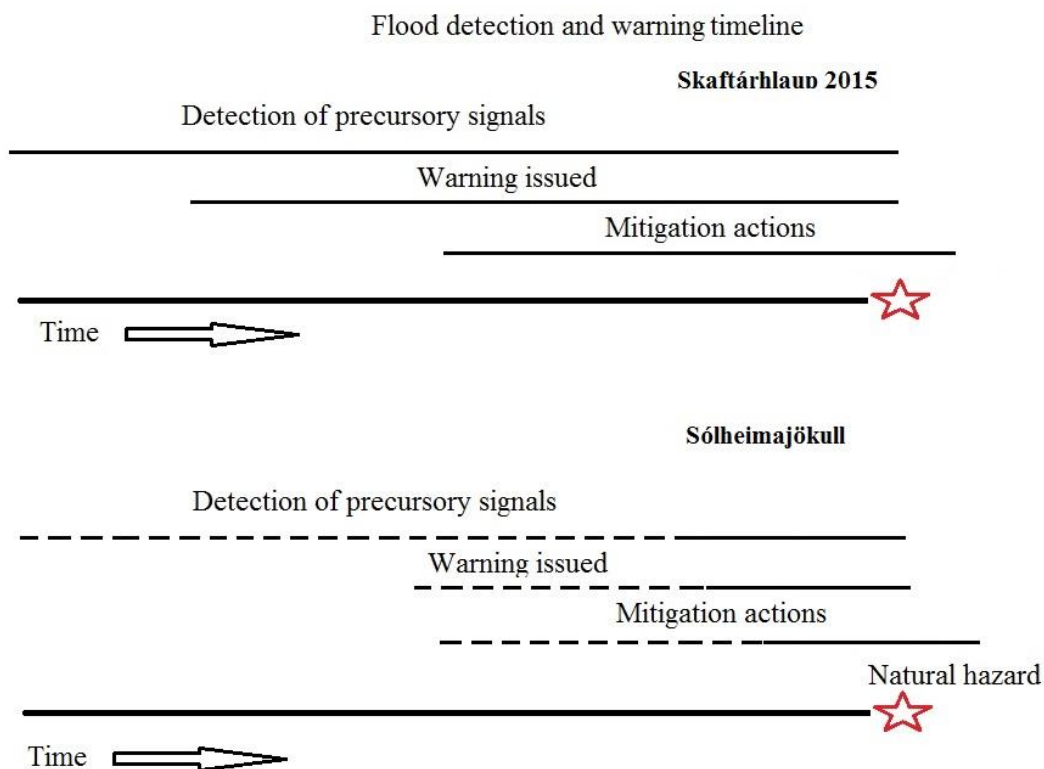
Figure 28: Proposed timelines of stages for flood events of Skaftá and Sólheimajökull.

timeline for this was created in Figure 28 to illustrate that the detection of an event could so late that the event may already have started before a warning is given.
