# **Lighting up the past**

*The use of light at Skálholt*

**Ritgerð til BA-prófs í Fornleifafræði**

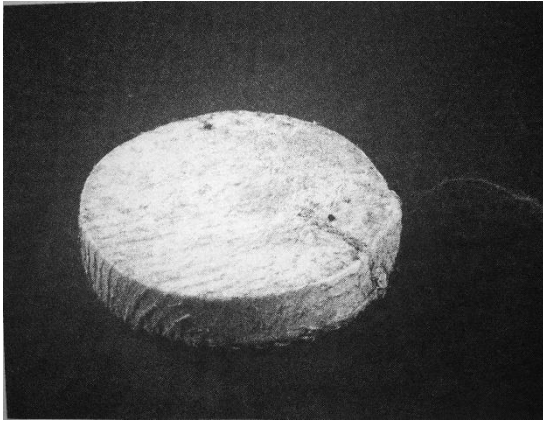
Image 4 - A typical screen window (*skjágluggi*).  
(Ágústsson, 1998, 64)

that were found in the Icelandic turf houses were the so called *skjágluggi* or screen windows. These screen windows were a bracket with either intestines or fish skin stretched upon them (Ágústsson, 1998, 65) and did not omit a lot of light through and were not transparent (Ólafsson, 1987, 347). There does not seem to have been any order on where windows were placed on buildings, rather that they were placed where it was deemed convenient (Sveinsson, 1791,

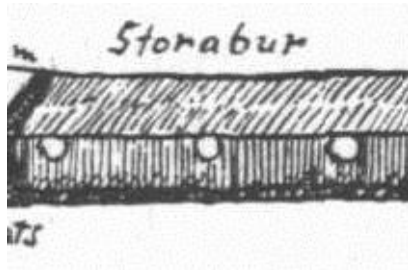
Image 5 - Possible screens on the Stórabúr building on the 1745/46 map

There are limitations when it comes to doing research like this. Not all windows were made of glass. A type of windows used in turf buildings up into the middle of the 19<sup>th</sup> century were the so-called *Skjágluggi* or screen windows. It is possible that these screens are displayed on some buildings in the early 18<sup>th</sup> century plan of Skálholt, but being made from organic material, these have not survived.

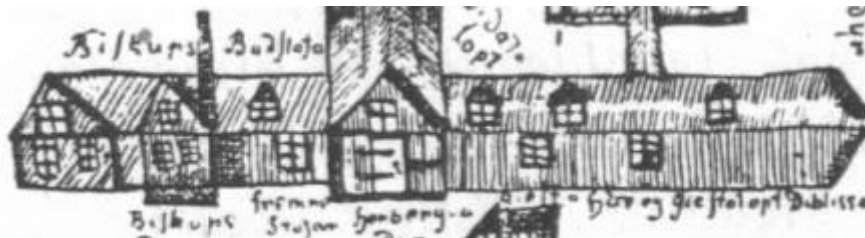
Image 6 - Buildings with upper floors on the 1745/46 map

Some of the rooms may have had an upper floor associated with them which could have had windows as well. This could have a considerable effect on the results by over-representing the window glass in the archaeological data. The only possible source for the upper floors is the 1745/46 map which might not be a reliable source, even so this will be taken into account in the results.

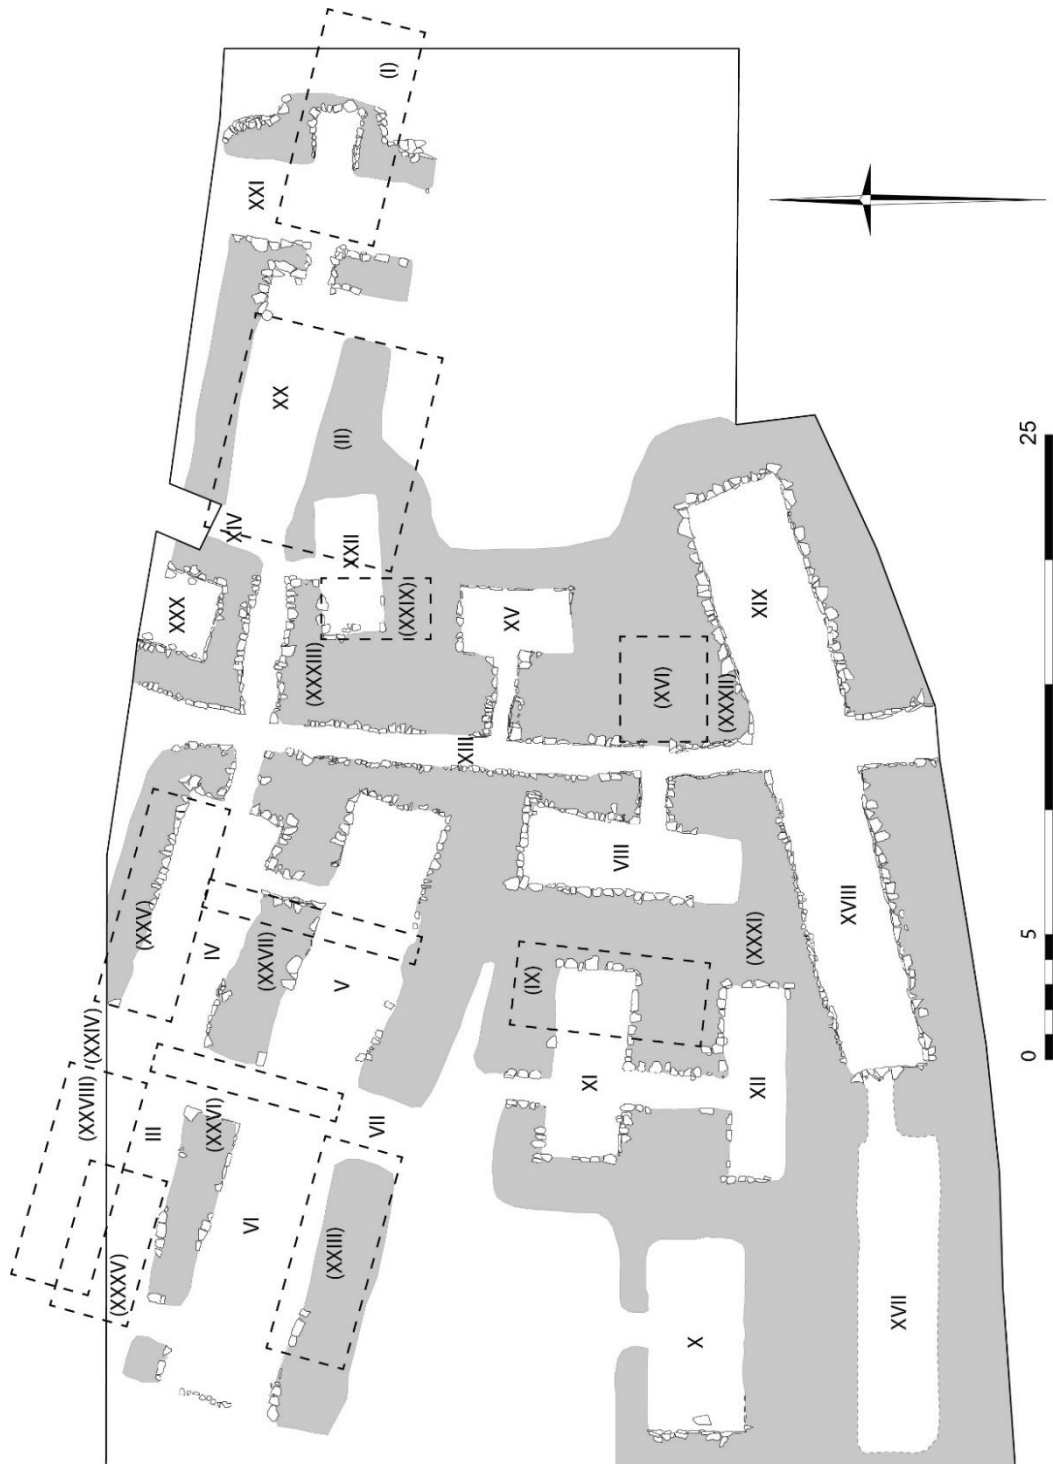
Image 8 - The structure plan of the Skálholt compound from the 2002-2007 excavations. Acquired from Gavin Lucas.

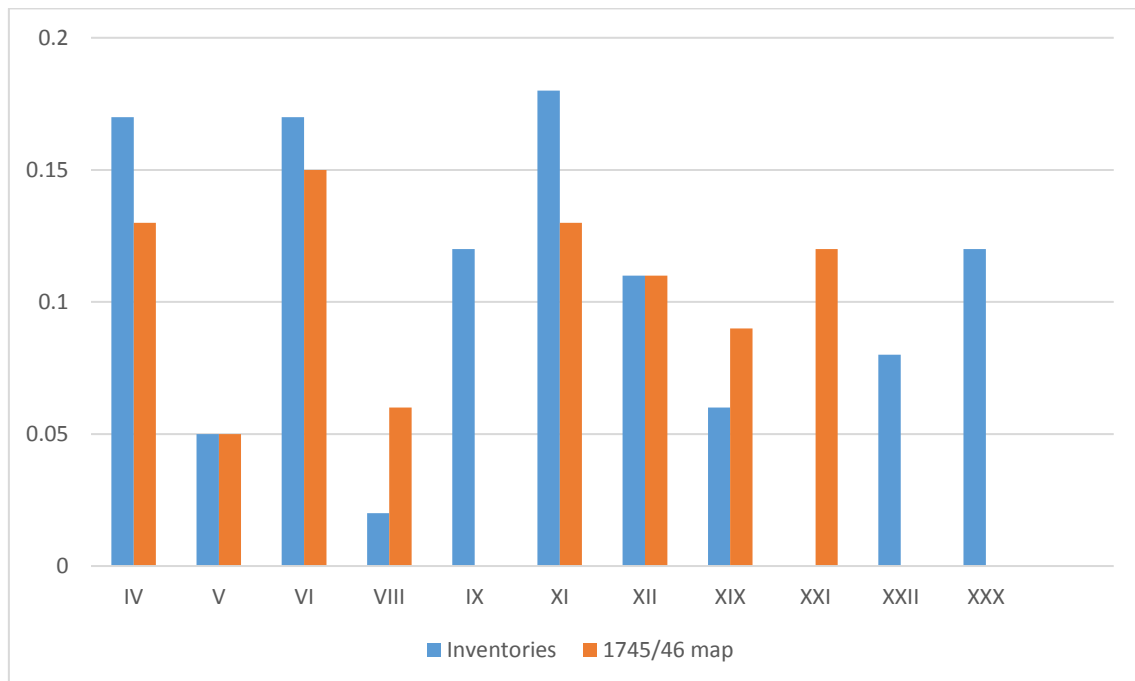
Graph 1 - A comparison of the ratio between the 1745/46 map and the inventories. The graph does not depict the rooms which were described to have no windows according to the map or the inventories.

When comparing the documentary sources the difference between the inventories and the 1745/46 map is very little, with the exceptions of rooms XXI, XXII, IX, XVI and XXX, which are not depicted on the map.

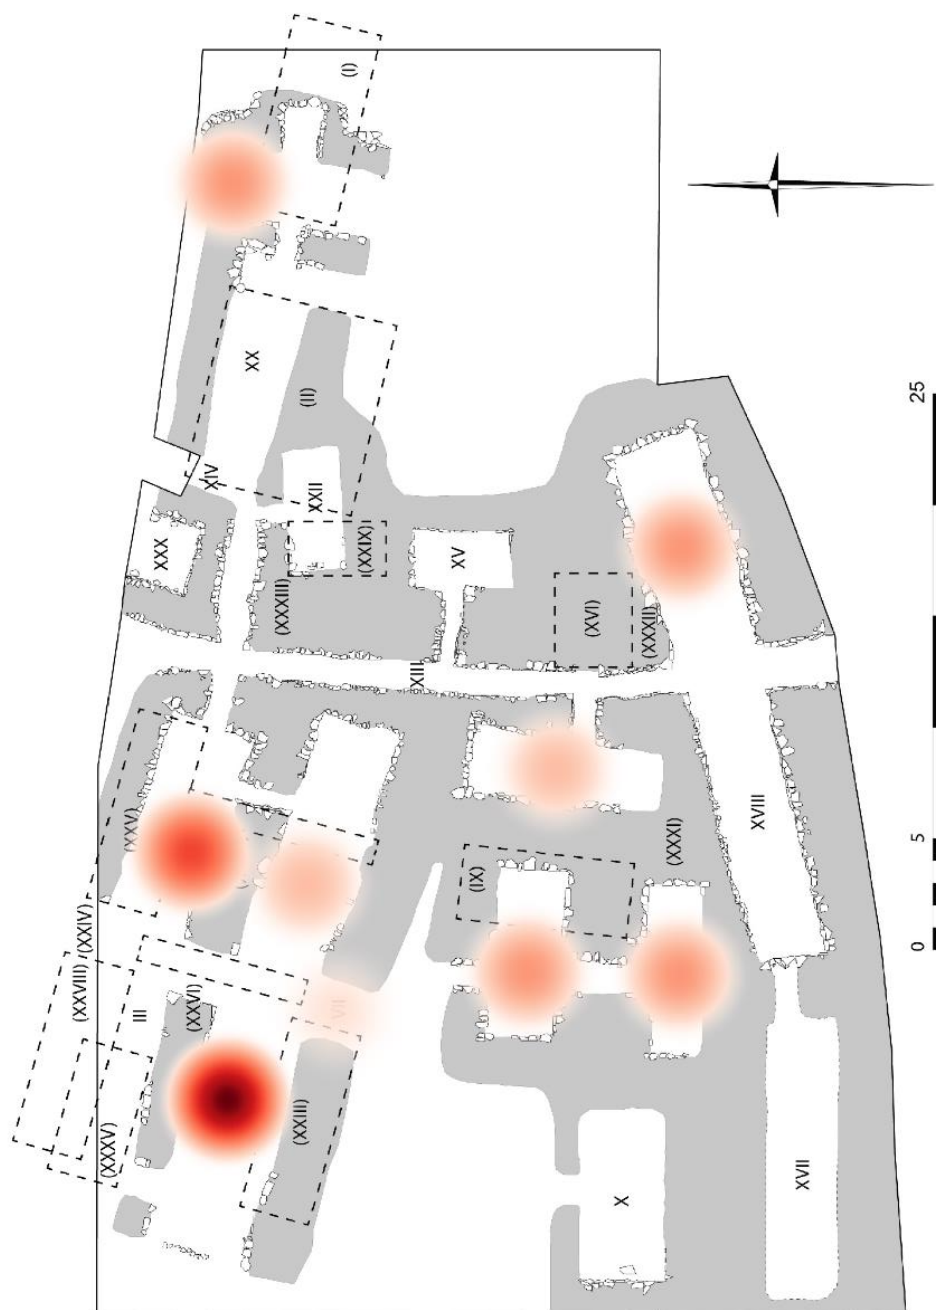
*Image 10 - A heatmap showing the distribution of windows based on the 1745/46 map. The colour grows darker with the number of windows.*

When calculating the ratio of windows associated to each room according to the map the windows were simply counted.

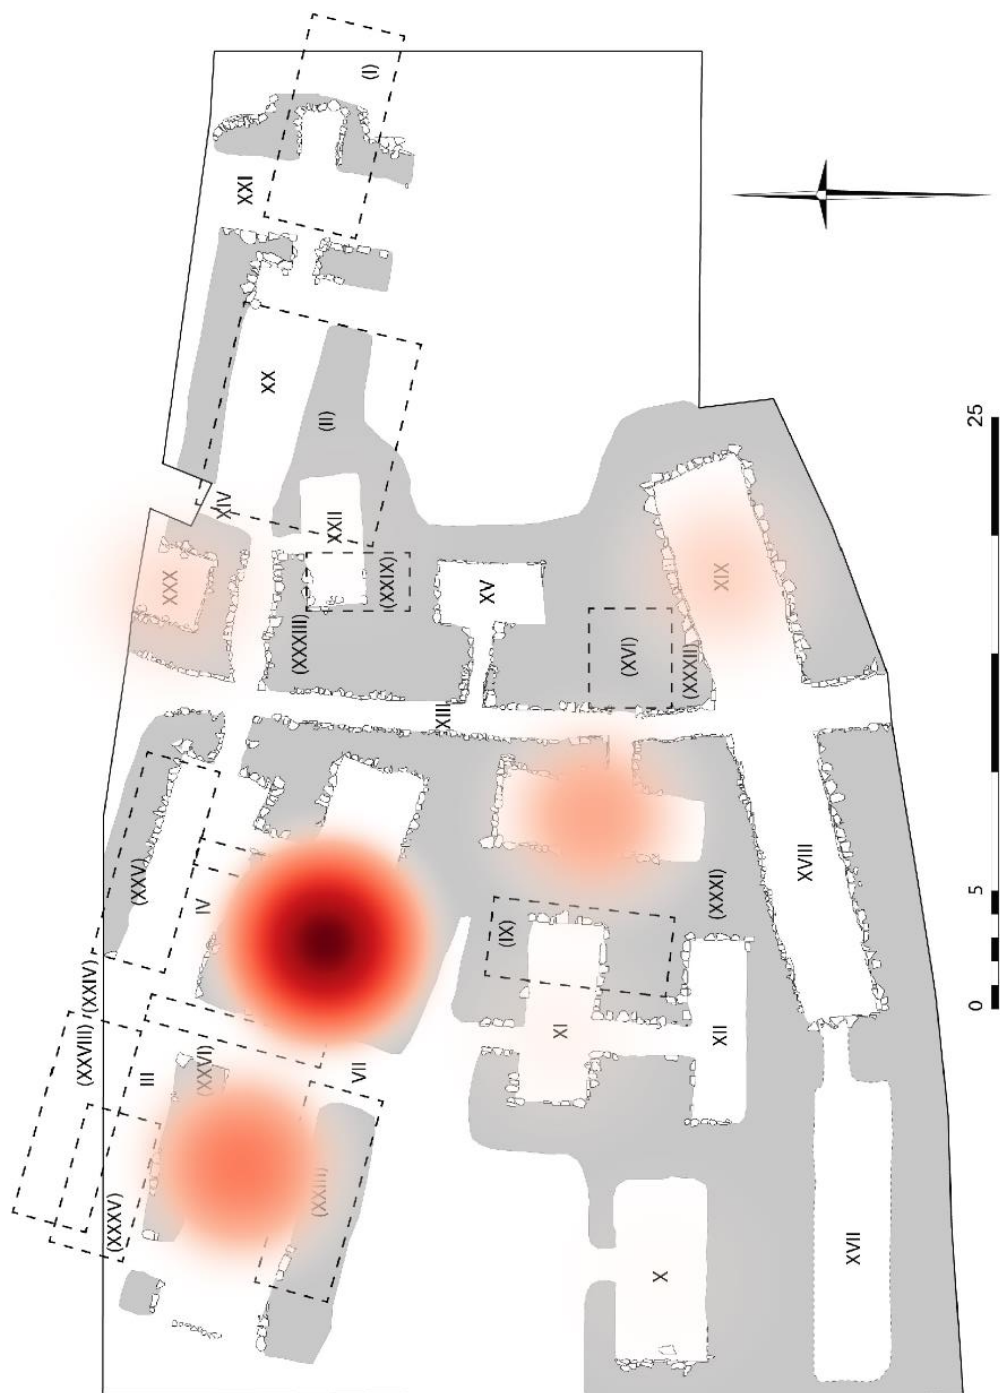
*Image 11 - A heatmap showing the distribution of the weight of the window glass excavated. The colour grows darker the higher the weight is.*

There were a total of 856,3 grams of window glass excavated that was phased to 1720-1780. The window panes were on average 30x30 cm and weighing around 4 grams each. Looking at the 1745/46 map it can be assumed that most of the windows had either 4 or 6 panes. This means that the whole window weighed 16 or 24 grams.

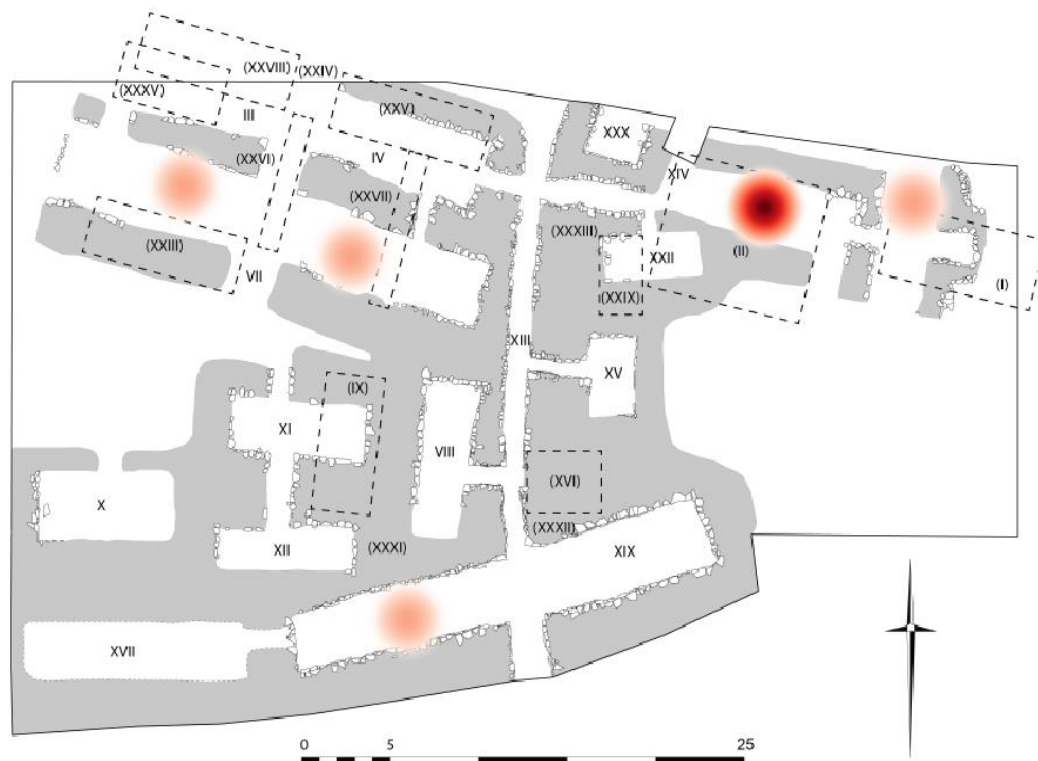
*Image 12 - A heatmap showing the distribution of the lighting equipment. The colour grows darker with the number of lighting equipment.*

There were a total of seven artefacts identified as lighting equipment excavated from the phase 1720-1780. Three of them were found in the school dormitory, the rest was spread out in the compound.

It is interesting that most of the lighting equipment was found in rooms associated with the school. These spaces do not seem to have many, or even any, windows associated with them and were used by students who presumably needed the light source the most.

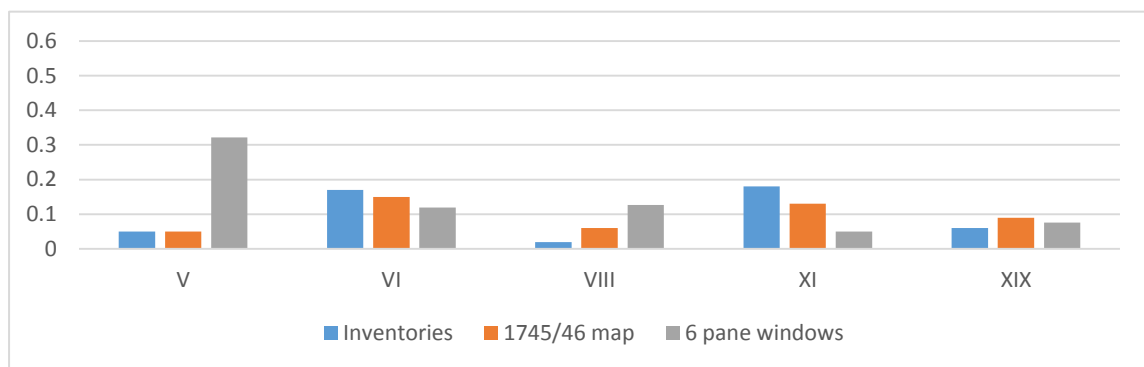
*Graph 2 - A comparison of the ratio between rooms if the windows had 6 panes*

It is very likely that the size of the windows would have differed between rooms, some having 4 panes, others having 6 panes or some could have had even more. It is also very probable that some of the rooms had mixed window sizes. The following graphs show a comparison of the ratios of windows to m<sup>2</sup> between the rooms where window glass was excavated.

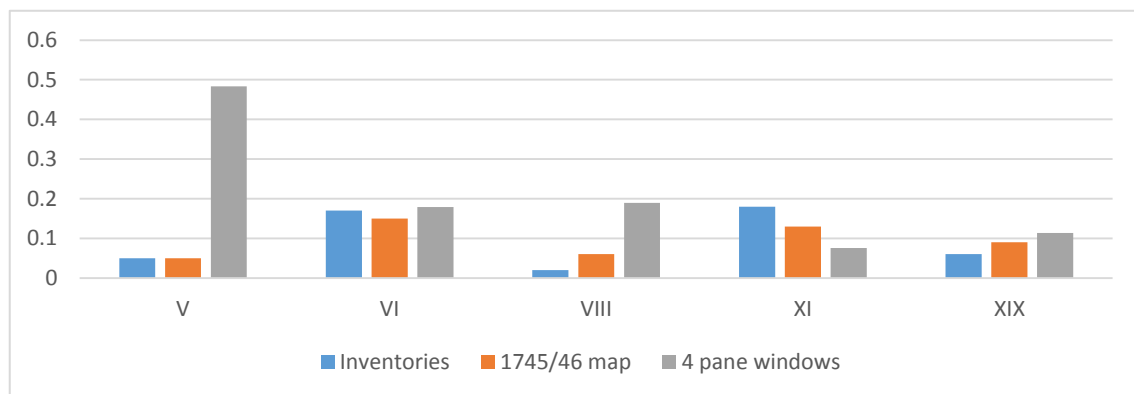
*Graph 3 - A comparison of the ratio between rooms if the windows had 4 panes*
