Corrosion Behaviour of Materials in H₂S Abatement System for Geothermal Power Plants

60 ECTS thesis submitted in partial fulfillment of a
Magister Scientiarum degree in Mechanical Engineering

Faculty of Industrial Engineering,
Mechanical Engineering and Computer Science
School of Engineering and Natural Sciences
University of Iceland
Reykjavik, October 2015

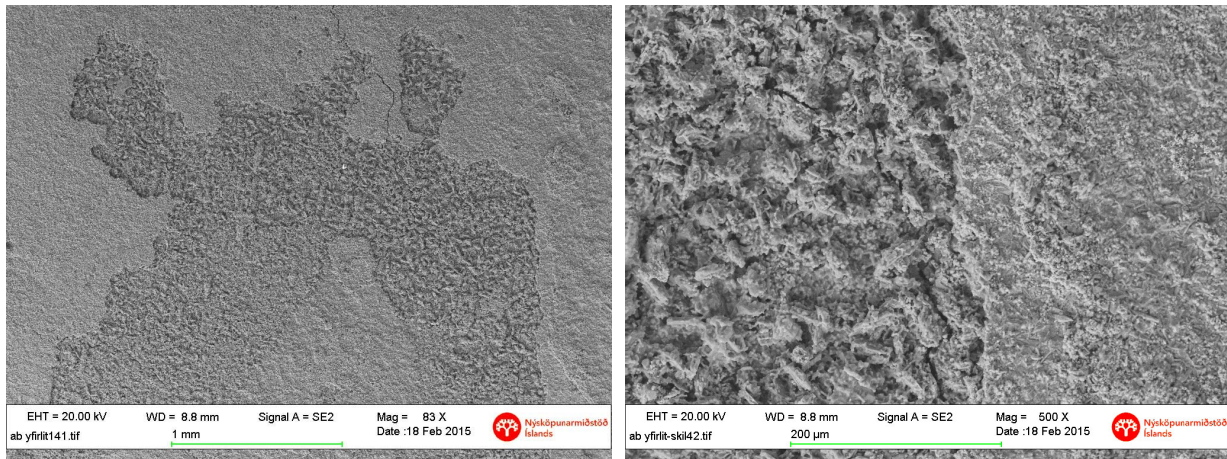
For chemical composition analysis on the corrosion and scaling layer as well as microstructural examination, SEM and XEDS were used. SEM and XEDS was used on two out of three coupons to analyze the corrosion products on the surface before they were cleaned for corrosion measurement or cut and molded into bakelite. The corrosion product on the highly corroded sample was compared to the normal corroded one. Examination on the corroded surface layer was carried out and the SEM showed that the corrosion layer on the carbon steel S235 was of two kinds, the inner surface of the layer is more porous than the dense outer surface, this is visible in Figure 6.4.

Figure 6.4: SEM images of the surface of carbon steel S235.

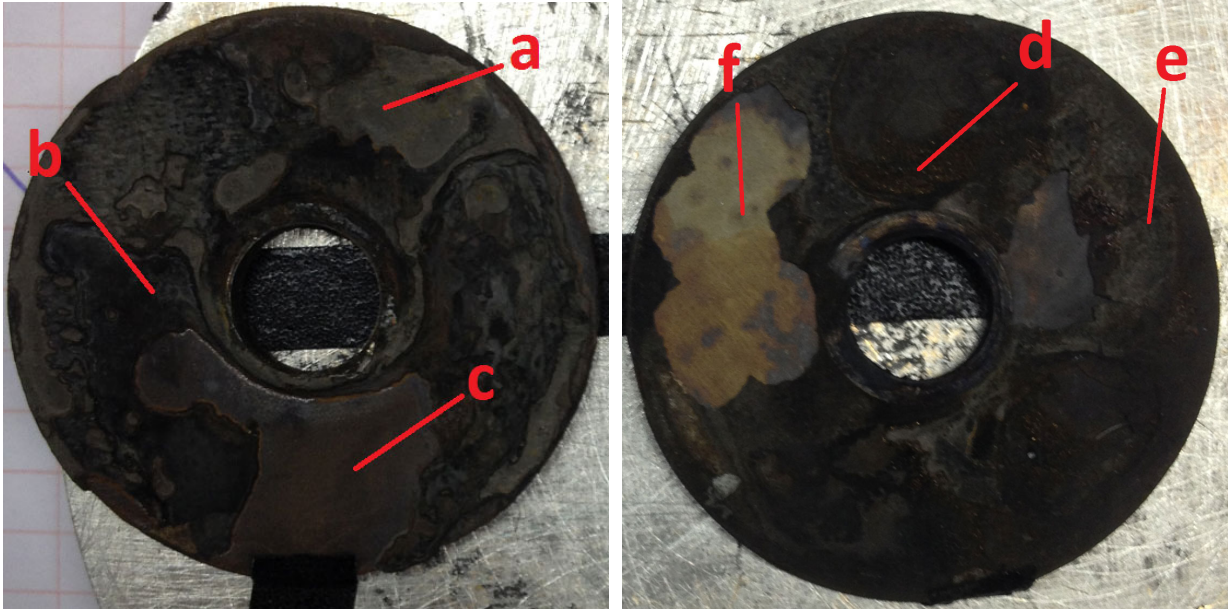
Figure 6.5a shows the areas tested for chemical analysis on S235 carbon steels. The sample on Figure 6.5a, which is the highly corroded sample and the sample on Figure 6.5b which represents a regular corroded sample. Figure 6.6 and Table 6.3 show results for these selected parts of the samples.

Figure 6.5: Locations on the surface of carbon steel S235 samples where XEDS analysis were performed, highly corroded sample (a) and normal corroded sample (b).

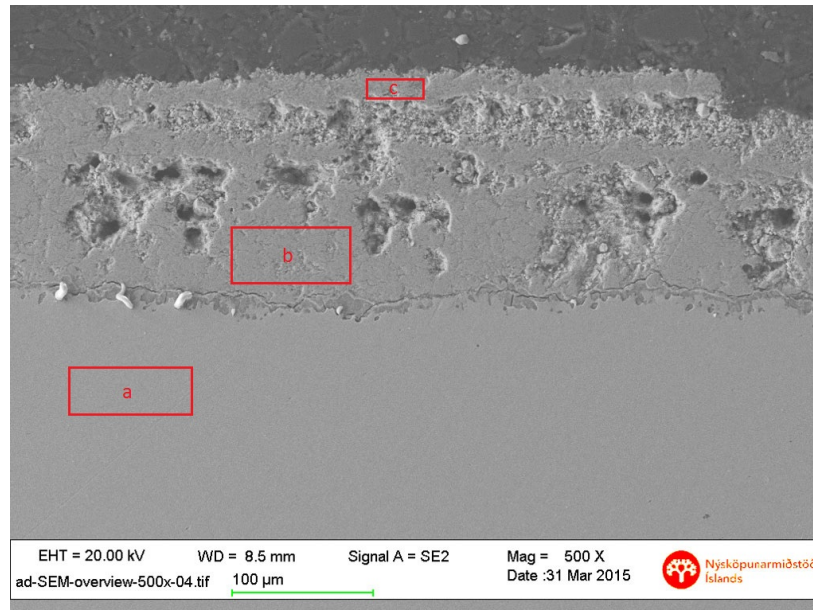
The sample from Figure 6.5b was cross-sectioned and examined further. Figure 6.7 shows an overview of the surface corrosion found in the carbon steel and the location selected

Figure 6.7: SEM image of the cross-sectioned carbon steel S235 where the chemical composition analysis were performed, the area indicated with a red box.

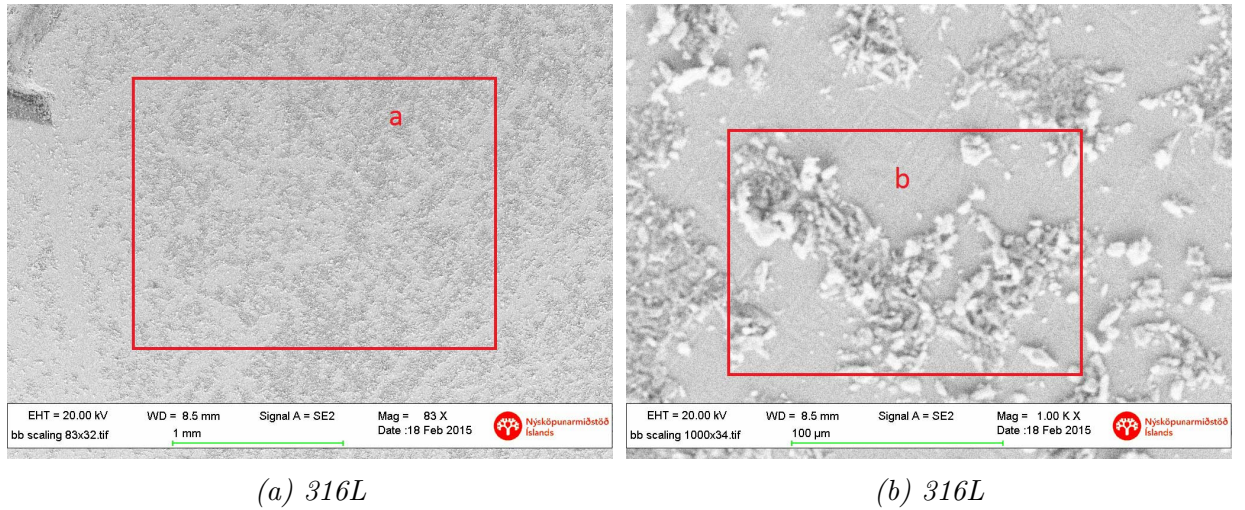
Figure 6.10: SEM images of the surface of austenitic stainless steel 316L where the chemical composition analysis were performed, the areas indicated with a red box.

Figure 6.10 shows that the scaling does not cover the surface completely. XEDS analysis were made on the surface. Chemical compositions of the surface of 316L is shown in Table 6.6.

Table 6.6 shows large amounts of sulfur (S) substances on the surface along with chrome (Cr), iron (Fe) and nickel (Ni). Much of the area analysed is bare metal. Therefore, the scaling was further investigated in Figure 6.11 for the stainless steel 316L. Chemical compositions are listed in Table 6.7.

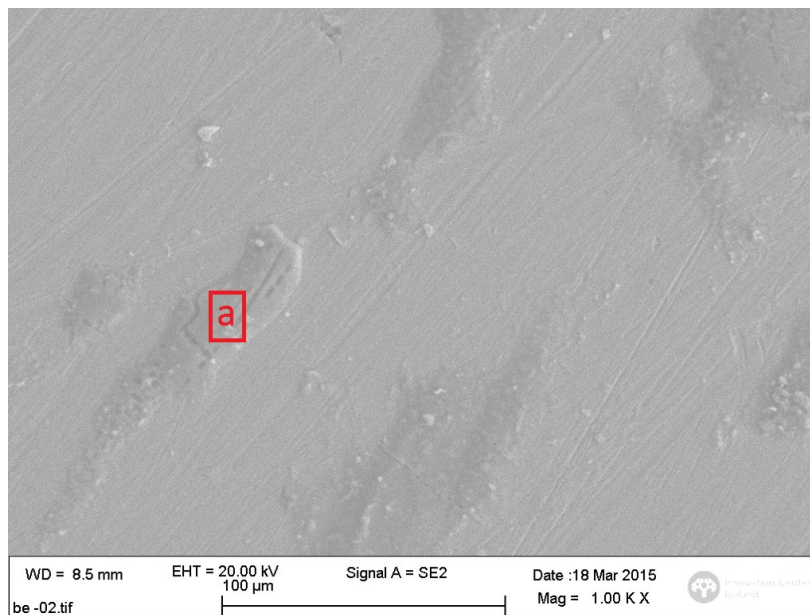
Figure 6.11: SEM image for more precision XEDS examination on the scaling layer of 316L.

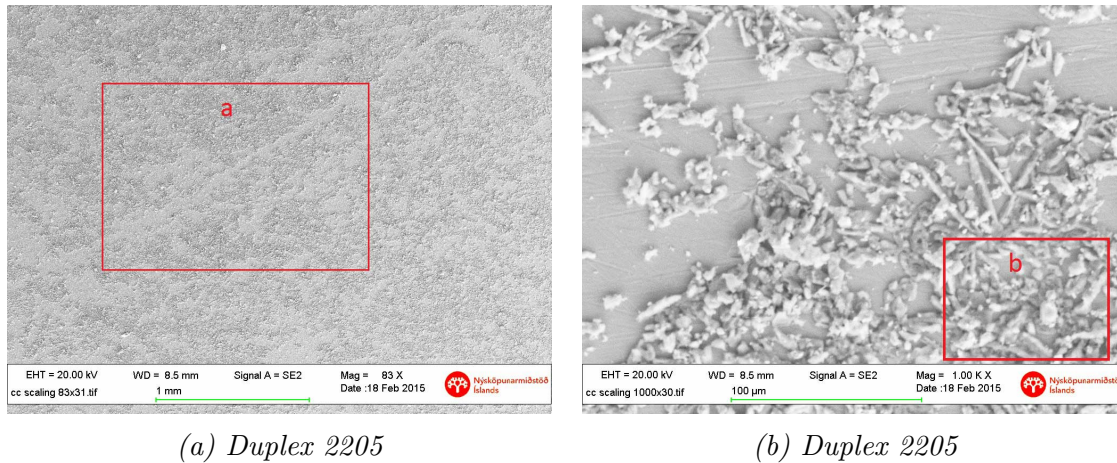
Figure 6.13: SEM images of the surface of duplex stainless steel 2205 where the chemical composition analysis were performed, the area indicated with a red box.

Table 6.9 shows that the layer on the surface mostly consists of sulfur (S), chrome (Cr), iron (Fe) and some amount of nickel (Ni). 2205 is a higher graded material than 316L and therefore, as for 316L, the scaling layer is believed to be pure sulfur.

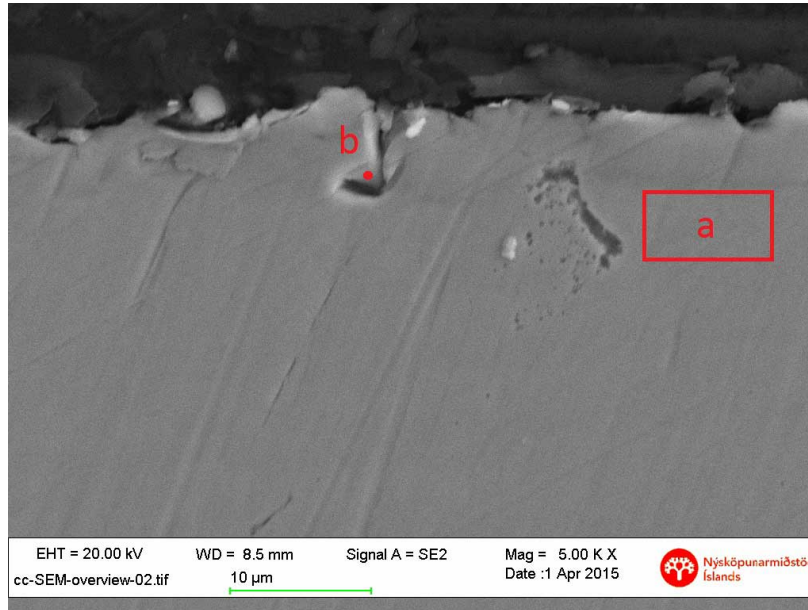
Duplex 2205 was cross-sectioned and viewed in SEM. Similar as for the 316L, the cutting procedure generated a lot of heat that resulted in a smoke and sulfuric smell. Figure 6.14 shows the sample and the locations chosen for chemical composition analysis. It can be seen in Figure 6.14 that the surface is rough and uneven. It is believed to be artefacts from loose material as discussed for 316L. Figure 6.14 and Table 6.10 show locations and chemical composition analysis for Duplex 2205.

Figure 6.14: Cross-sectioned SEM image of duplex stainless steel 2005 where the chemical composition analysis were performed, the areas indicated with a red box and a point.

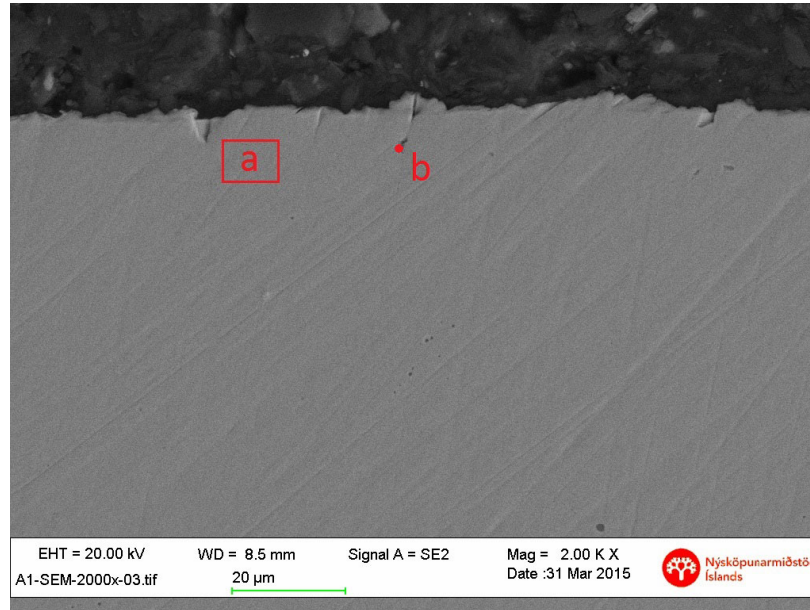
Figure 6.16: Cross-sectioned SEM image of U-bent 316L where the chemical composition analysis were performed, the areas indicated with a red box and point.

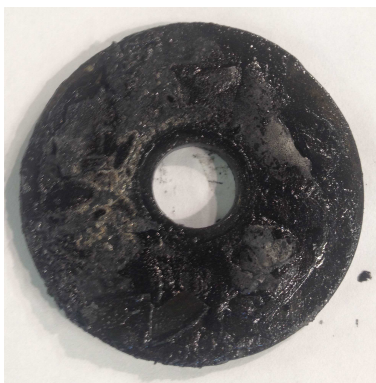
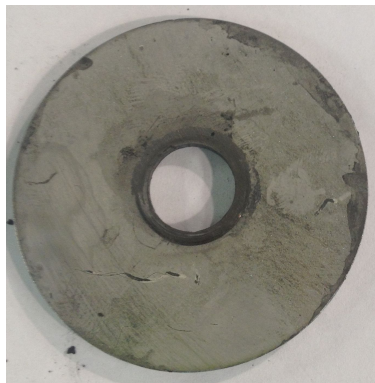
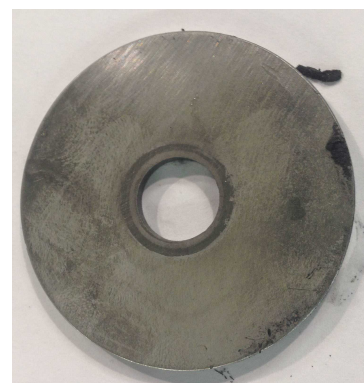
Figure 6.17: Coupons after they were collected from the absorption tower.

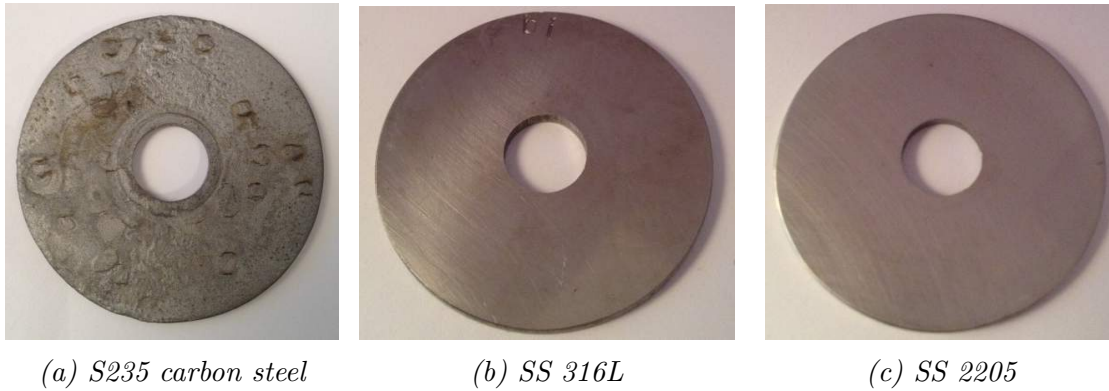
The stainless steels showed similar results as for the first test, a scaling layer that can easily be cleaned off was visible and no sign of corrosion. Prior cleaning it seemed like the same results were expected for both 4 weeks testing, cleaned specimens can be seen in Figure 6.19. However, the corrosion layer on S235 hid an interesting result where it seemed like that surface damages due to HIC on carbon steel S235 were much more severe for this test than the first one.

Figure 6.19: Coupons after they were chemically cleaned.

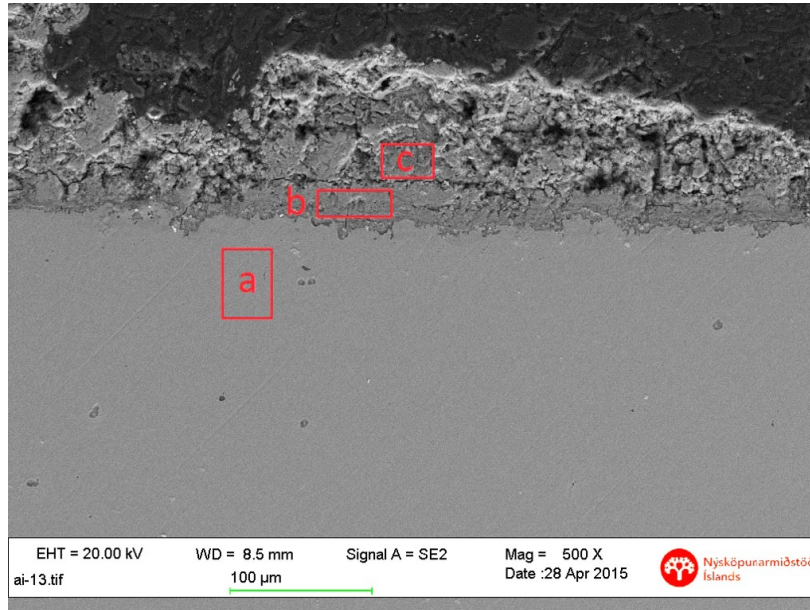
Carbon steel S235 was again lacking in performance, showing thick corrosion layer and clear signs of hydrogen induced cracking (HIC). The corrosion products were examined and Figure 6.21 shows the corrosion and the locations for chemical composition analysis. The analysis are listed in Table 6.15

Figure 6.21: Cross-sectioned SEM image of carbon steel S235 coupon where the chemical composition analysis were performed, the areas indicated with a red box.

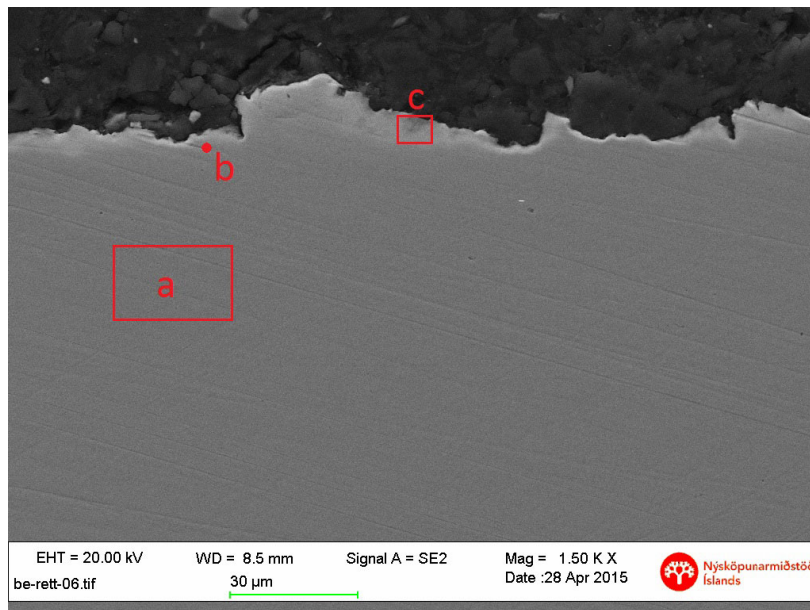
The stainless steel 316L showed no signs of corrosion damages as can be seen from the following SEM and XEDS analysis below. Heat was generated while cutting the sample and a sulfuric smell rose from the smoke. It was believed that the thin scale on the surface of the specimen could have evaporated. Figure 6.24 shows the locations for chemical composition analysis. The analysis are listed in Table 6.17

Figure 6.24: Cross-sectioned SEM image of stainless steel 316 coupon where the chemical composition analysis were performed, the areas indicated with a red box and point.

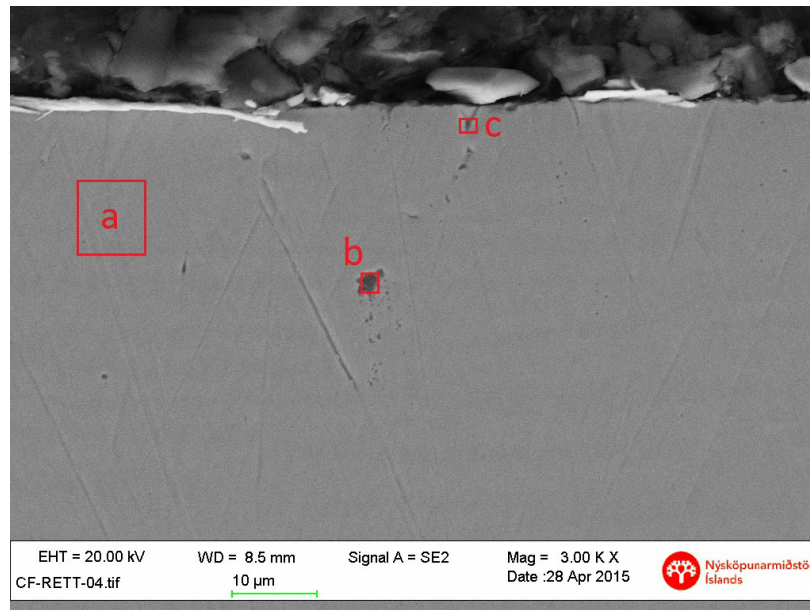
Figure 6.25: Cross-sectioned SEM image of duplex stainless steel 2205 coupon where the chemical composition analysis were performed, the areas indicated with red boxes and point.

Table 6.18 shows that for location b there is high silica amount and some carbon (C) content, suggesting that there might have been a scratch of some kind that might have been filled up with silica and bakelite from polishing. Analysis show that that was believed to be a crack or a pit initiation in location c is possibly an artefact or a flaw in the material. No traces of corrosion products or cracks were found on the sample.

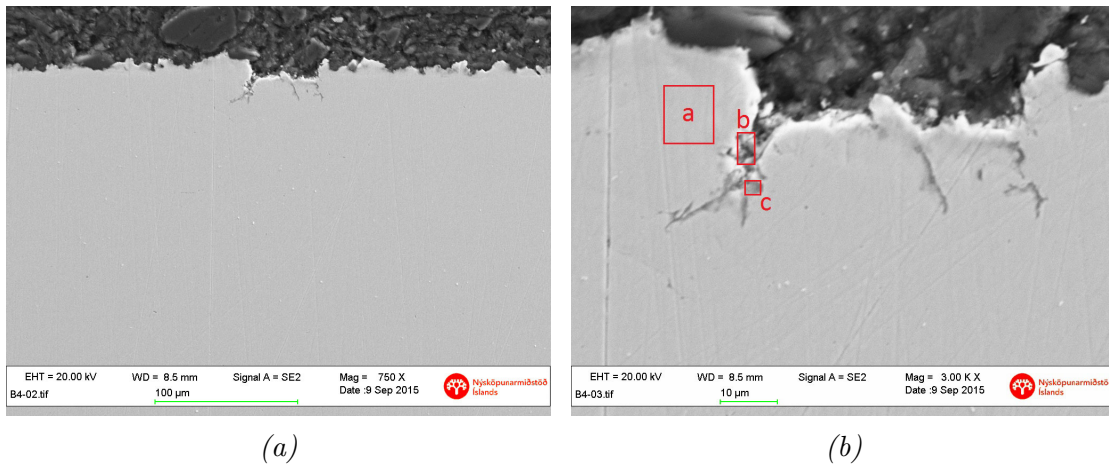
Similar to previous test, alot of heat was generated during cutting and preparing of the specimens for SEM. When examined in SEM, the stainless steel 304L showed cracks on the surface. Figure 6.26 shows the crack and chemical composition analysis are in Table 6.19

Figure 6.26: SEM images of the cross-sectioned 304L U-bent sample where the chemical composition analysis were performed, the area indicated with red boxes.

Table 6.19 shows that the crack is rich with sulfur (S), oxygen (O) and nickel (Ni).

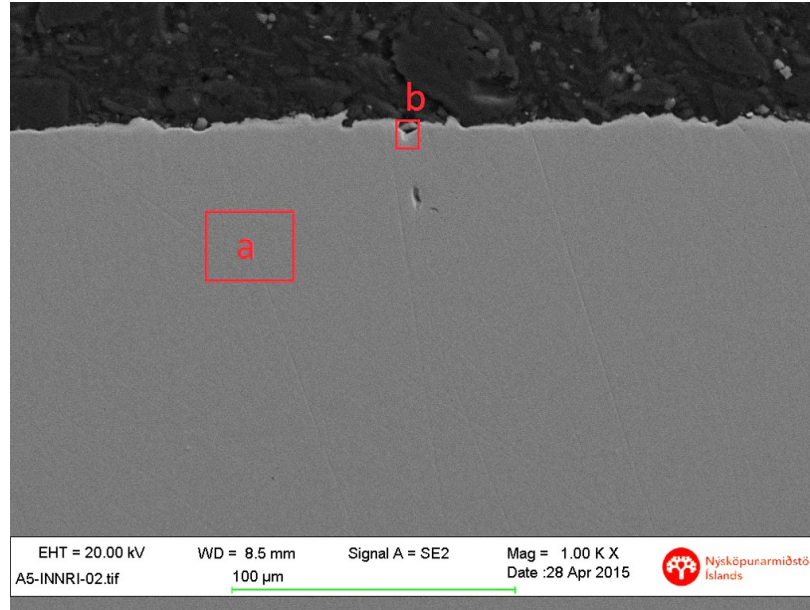
Figure 6.27: SEM image of the cross-sectioned U-bent 316L sample where the chemical composition analysis were performed, the areas indicated with a red box.

Table 6.20 shows that high amounts of carbon (C) and silica (Si) were present, suggesting that the area selected in the picture is most likely an artefact. Only artefacts such as this on the picture were found, and no pits or cracks were present during inspection.

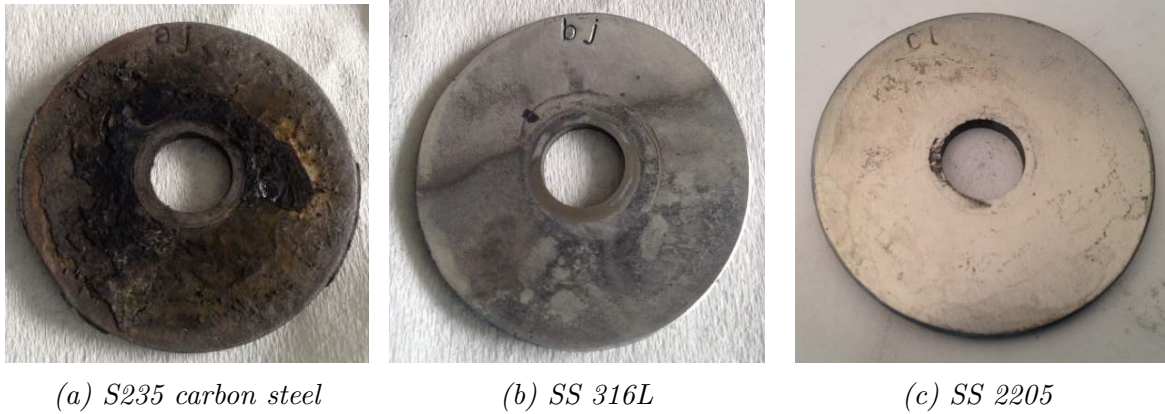
Figure 6.28: Coupons after they were collected from the absorption tower.

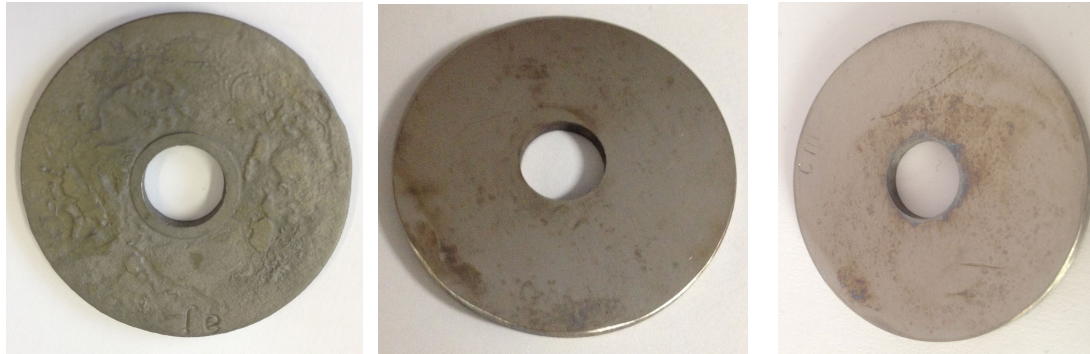
Specimens after cleaning can be seen in Figure 6.30. The scratches from polishing prior to the test were visible on the stainless steels and no signs of material degradation could be detected. Figure 6.31 shows the difference in corrosion for the carbon steel S235 coupons for this test, the Figure shows the samples with and without corrosion products on the surface.

Figure 6.30: Coupons after they were chemically cleaned.

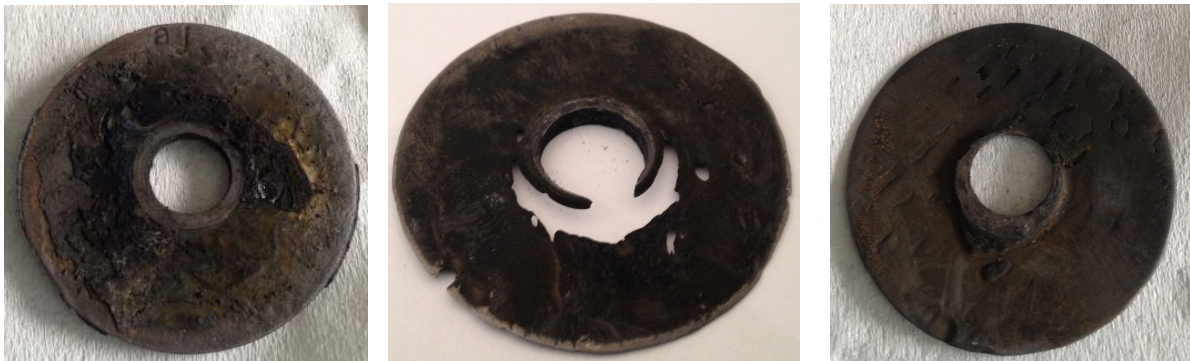
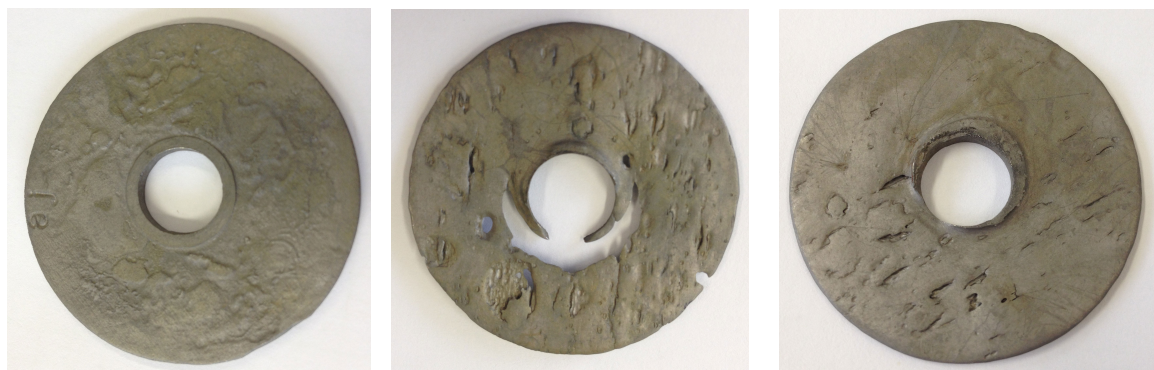
Figure 6.31: Comparison on S235 coupons before and after cleaning.

Cleaned specimens for weight loss measurement showed similar corrosion damages as found in previous experiments. The three carbon steel coupons used for weight loss measurement were all different in terms of thickness. Their thickness can be seen in Figure 6.29, coupons used were the first three from the left.

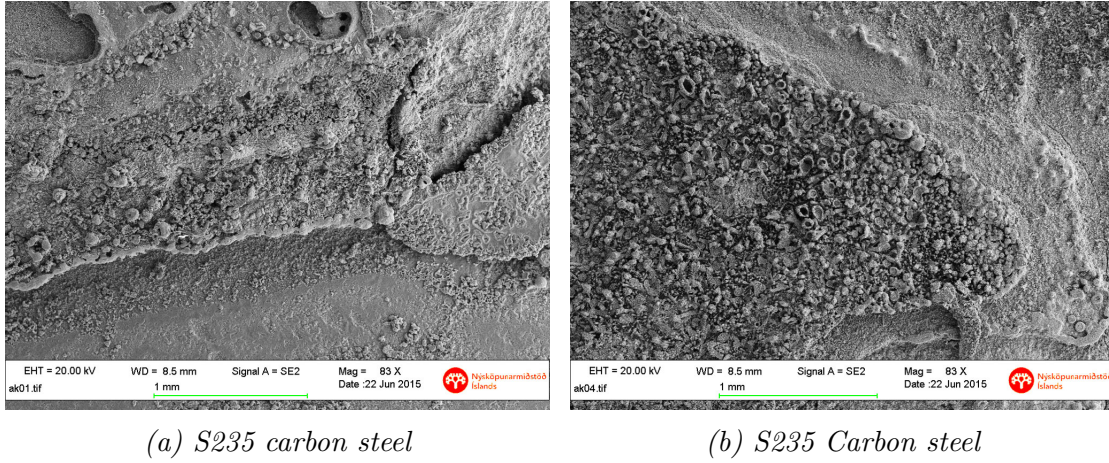
Figure 6.32: SEM images of the surface of carbon steel S235 after 12 weeks testing.

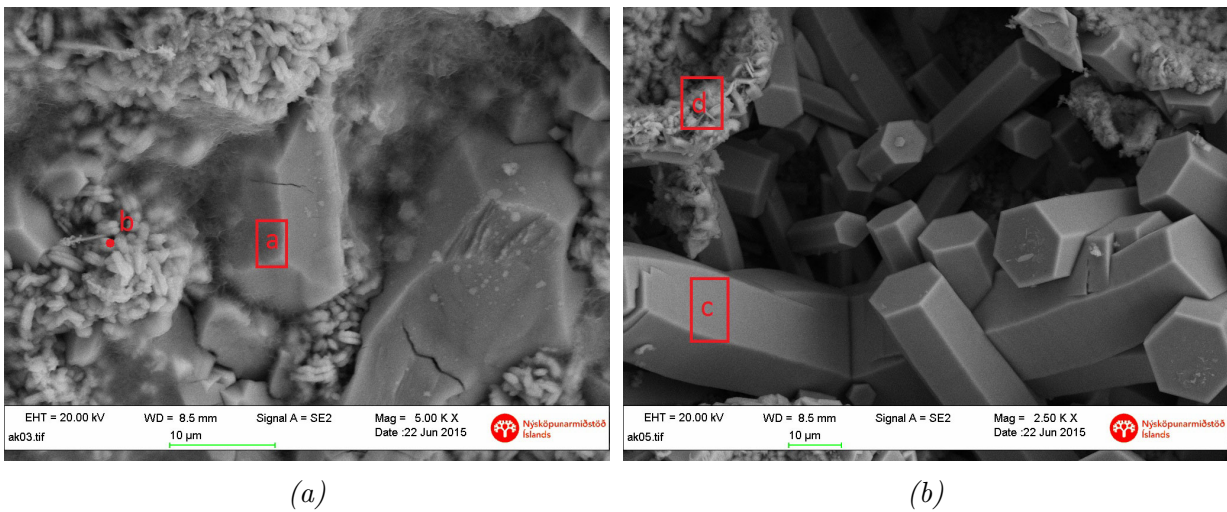
Figure 6.33: SEM images of the corrosion products on the surface of carbon steel S235 after 12 weeks testing. Chemical composition analysis were performed, the areas indicated with red boxes and a point.

Table 6.23 shows the microstructure of the iron sulfides, location a and c. Location b and d might be showing the microstructure of the iron oxides, although some amount of sulfur can be seen in location b. The S235 coupon sample from Figure 6.33 was cross-sectioned and examined further. Figure 6.34 shows the selected locations for chemical composition analysis and the analysis are listed in Table 6.24

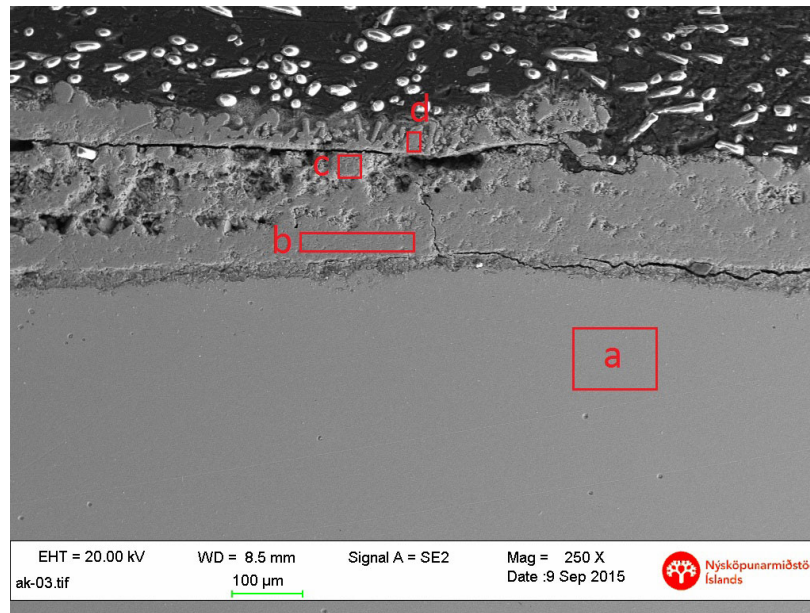
Figure 6.34: Cross-sectioned SEM images of carbon steel S235 where the chemical composition analysis were performed, the areas indicated with red boxes.

Table 6.24 shows that oxygen (O) and sulfur (S) were present in the corrosion product. The corrosion was believed to be iron sulfides and iron oxides. HIC damages were present in the middle of the coupon. Figure 6.35 shows the HIC damages and the locations for chemical composition analysis. The analysis are listed in Table 6.25

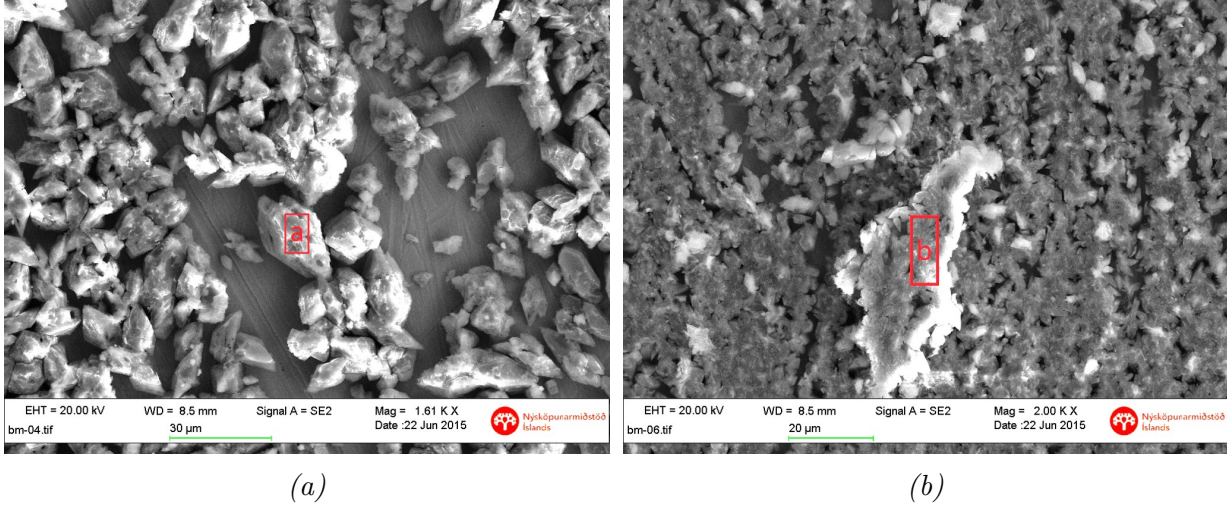
316L sample was surface analysed before it was cross-sectioned . Figure 6.37 shows the surface of the specimen where the scaling is clearly noticed. The surface was not fully covered with the scale, as the bare metal could be identified. XEDS analysis was made on the surface to identify the chemical composition of the scaling on the 316L sample. Figure 6.37 and Table 6.26 show the chemical composition analysis and locations from the surface analysis. Figure 6.37 shows that the scaling is not covering the whole surface of the specimen.

Figure 6.37: SEM images of the surface of austenitic stainless steel 316L after the 12 weeks testing where the chemical composition analysis were performed, the areas indicated with a red box.

Table 6.26 shows that the scaling layer on the surface was mostly sulfur. Table 6.26 shows some amount of iron (Fe) in the scale that can be considered as corrosion products or iron sulfide (FeS) traces from the surrounding carbon samples. It was also possible that the XEDS was analysing the metal under the scaling layer because the layer was very thin. The 316L coupon was cross-sectioned and viewed in SEM. While cutting the specimen, care was taken that it would not heat to much. Cooling water could not be used as it was believed to clean the scaling layer of the sample. However, some sulfuric smell was detected coming from the sample and some heat generated in the sample. Figure 6.38 shows an overview of the samples surface as well as locations chosen for chemical composition analysis.

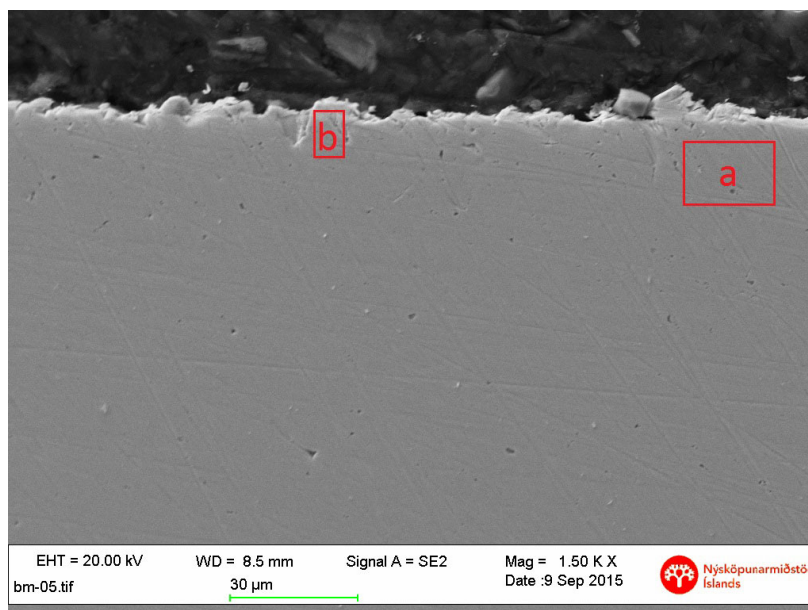
Figure 6.38: Cross-sectioned SEM image of the austenitic stainless steel 316L where the chemical composition analysis were performed, the areas indicated with a red box.

The chemical compositions shows that there might be some chromium oxide at the surface. No corrosion nor the scaling layer was found on the sample.

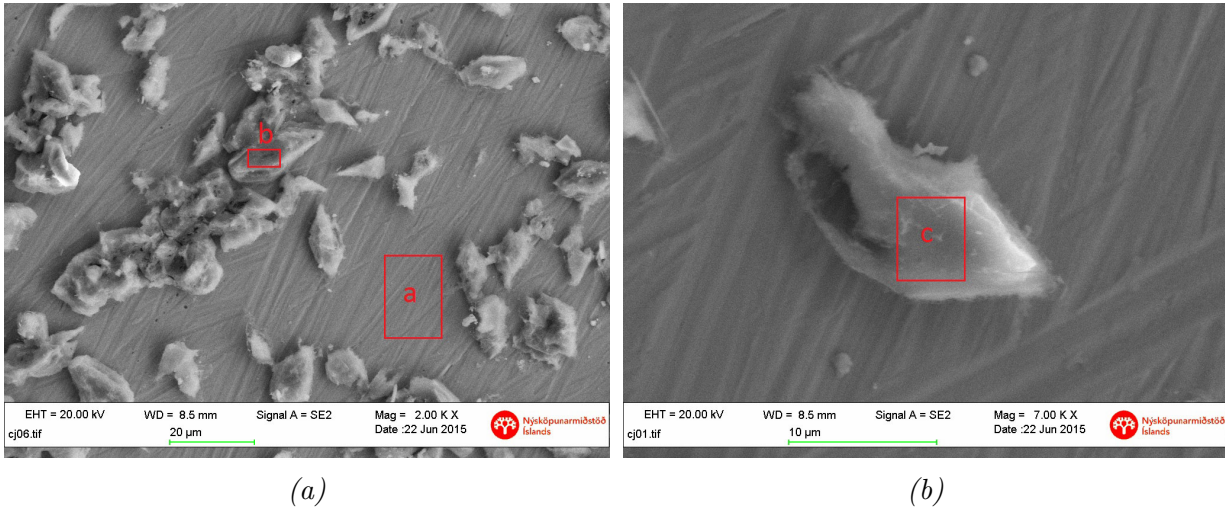
Figure 6.39: SEM images of the surface of duplex stainless steel 2205 after 12 weeks testing where the chemical composition analysis were performed, the areas indicated with a red box.

Table 6.28 shows the chemical composition from the surface analysis. The analysis show the sulfur deposits on the surface and the chemical composition analysis show that chromium (Cr), iron (Fe) and nickel (Ni) deposits are in the scale. That might indicate some corrosion products in the scale or that the XEDS measures went through the scale and into the metal because of how thin the scale was.

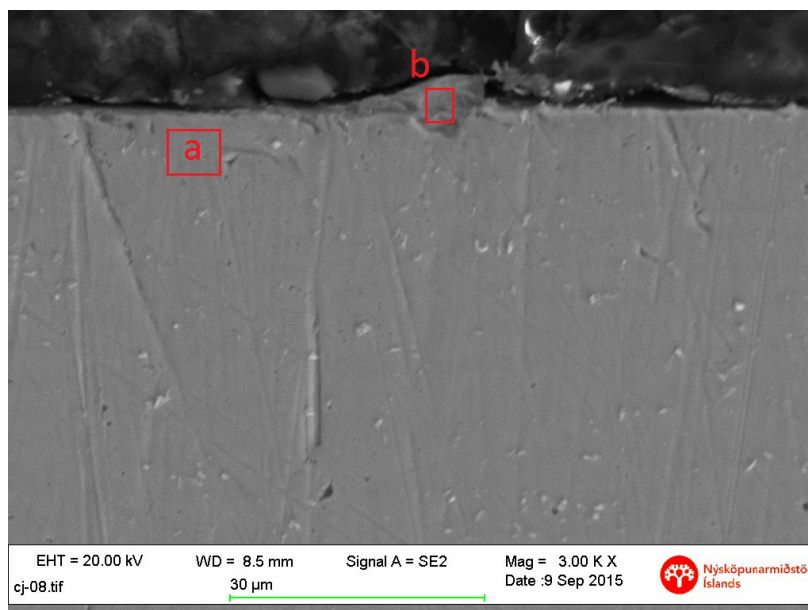
Figure 6.40: Cross-sectioned SEM image of duplex stainless steel 2005 where the chemical composition analysis were performed, the areas indicated with a red box.

Table 6.29 shows the chemical composition of the selected locations. No corrosion or pits could be found on the sample. However, the analysis from the artefact were believed to show that there were some chromium oxides present at the surface.

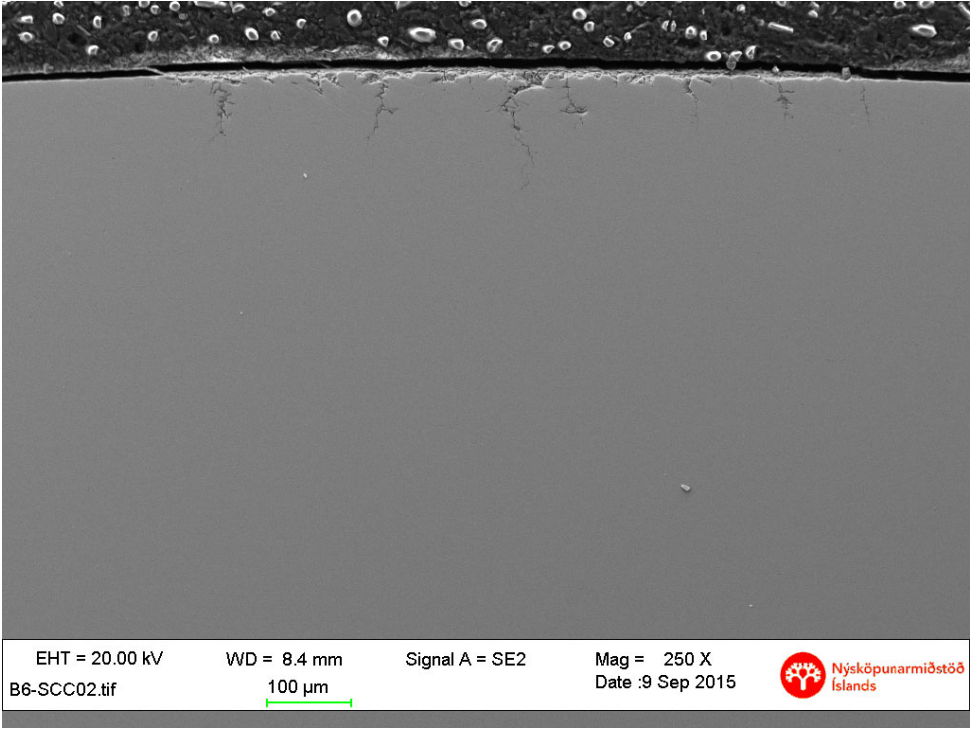
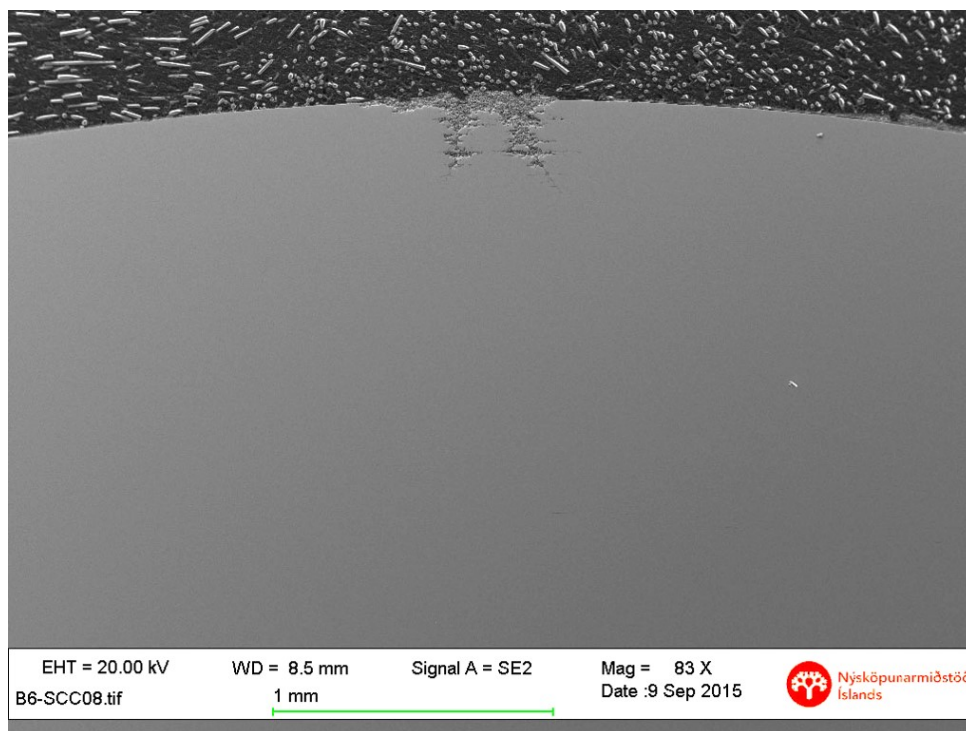
The austenitic stainless steel 304L continued to show cracks when examined with SEM. The cracks are much more severe, larger and distributed over a larger area compared to the 4 week cracks, the area can be seen in Figure 6.41. Figure 6.42 shows the selected location for chemical composition and the results are shown in Table 6.30.

Figure 6.41: SEM images of the surface of austenitic stainless steel 304L showing the distribution of the cracks over the tension region of the sample.

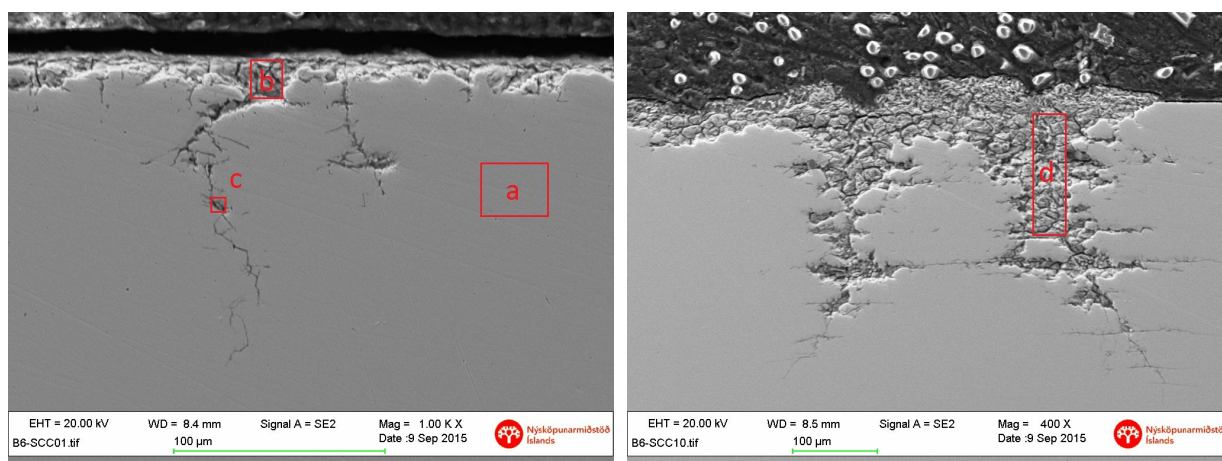
Figure 6.42: SEM images of the surface of austenitic stainless steel 304L sample after 12 weeks testing where the chemical composition analysis were performed in the cracks, the areas indicated with a red box.

High contents of sulfur (S), nickel (Ni) and oxygen (O) were seen in the corrosion products inside the crack. The analysis show that alloy underwent EIC cracking damages such as, SCC or SSC.

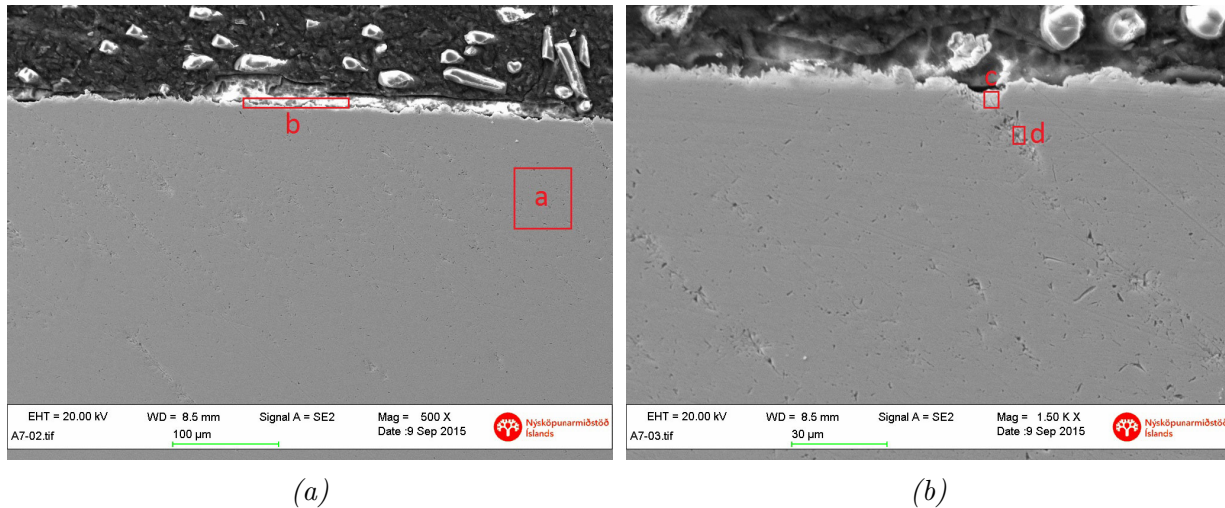
Figure 6.43: SEM images of the surface of U-bent 316L specimens after 12 weeks testing where the chemical composition analysis were performed, the areas indicated with a red box.

The chemical composition analysis show that the scaling on the surface might have small amount of corrosion products since chrome (Cr) and iron (Fe) were identified. However, sulfur is dominant in the analysis and the carbon identified was considered to be from the bakelite. Several areas were found that could be interpreted as pit initiations but the analysis show that these are most possible artefacts. However, similar areas were found on the 304L specimen in the first test from section 6.1.2 where no cracks were identified after 4 weeks of testing, therefore, longer test time is required to verify the absence of cracks for 316L.

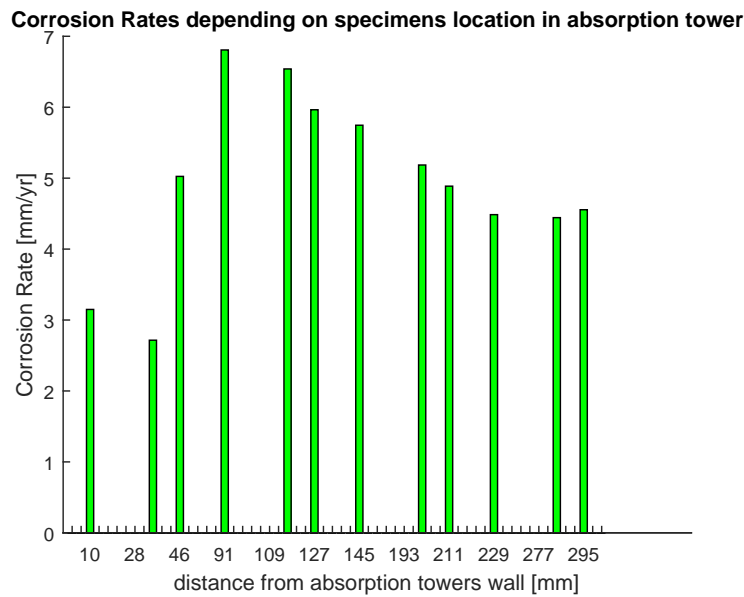
All the samples were weighed before installation and the samples that had the correct 15 mm spacing between each other were cleaned and weight after the test as in previous experiments. The S235 coupons showed signs of high corrosion rate but one sample being more corroded than the other remaining samples was not as eye catching as in previous tests. However two samples near the absorption tower wall showed lower corrosion rate at about 2.7 and 3.1 mm/yr while the other remaining samples showed corrosion rates of 4-7 mm/yr. HIC damages were visible on all of the samples. Corrosion rate for all the samples is shown in Table B.2 in Appendix B. Average corrosion rate for this experiment was ≈ 4.96 mm/yr. Figure 6.45 shows the corrosion rate vs location inside the absorption tower for this experiment. It is clear that near the wall the corrosion rate is lower.

Figure 6.45: Corrosion rates for carbon test 1 vs location inside the absorption tower.

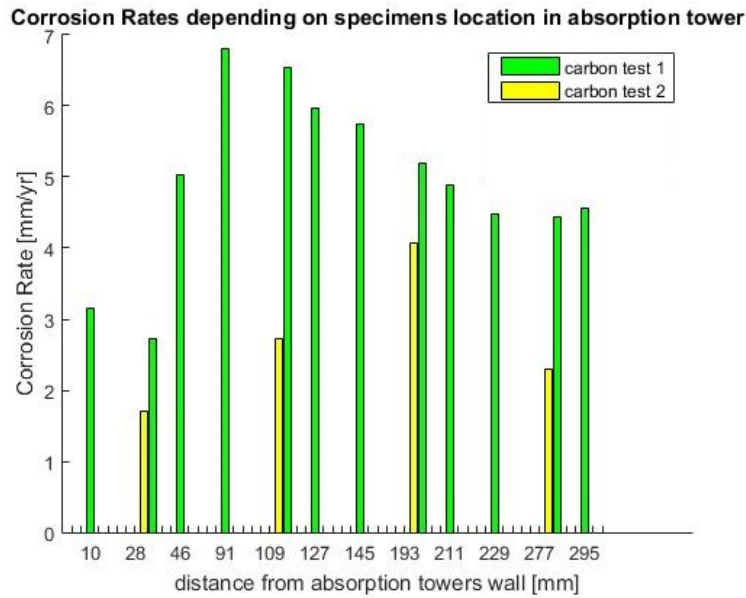
Carbon steel samples were weight loss measured after testing showing an average corrosion rate up to 2.70 mm/yr. Corrosion rate calculations for the tested samples in this test 2 can be seen in Table 6.33. The corrosion rate for this experiment is compared to carbon test 1 in Figure 6.46.

Figure 6.46: Comparison on corrosion rates for carbon test 1 and 2.
