Corrosion in the Kalina cycle

An investigation into corrosion problems at the Kalina cycle geothermal power plant in Húsavík, Iceland

A 30 credit units Master's thesis

Akureyri, February 2009

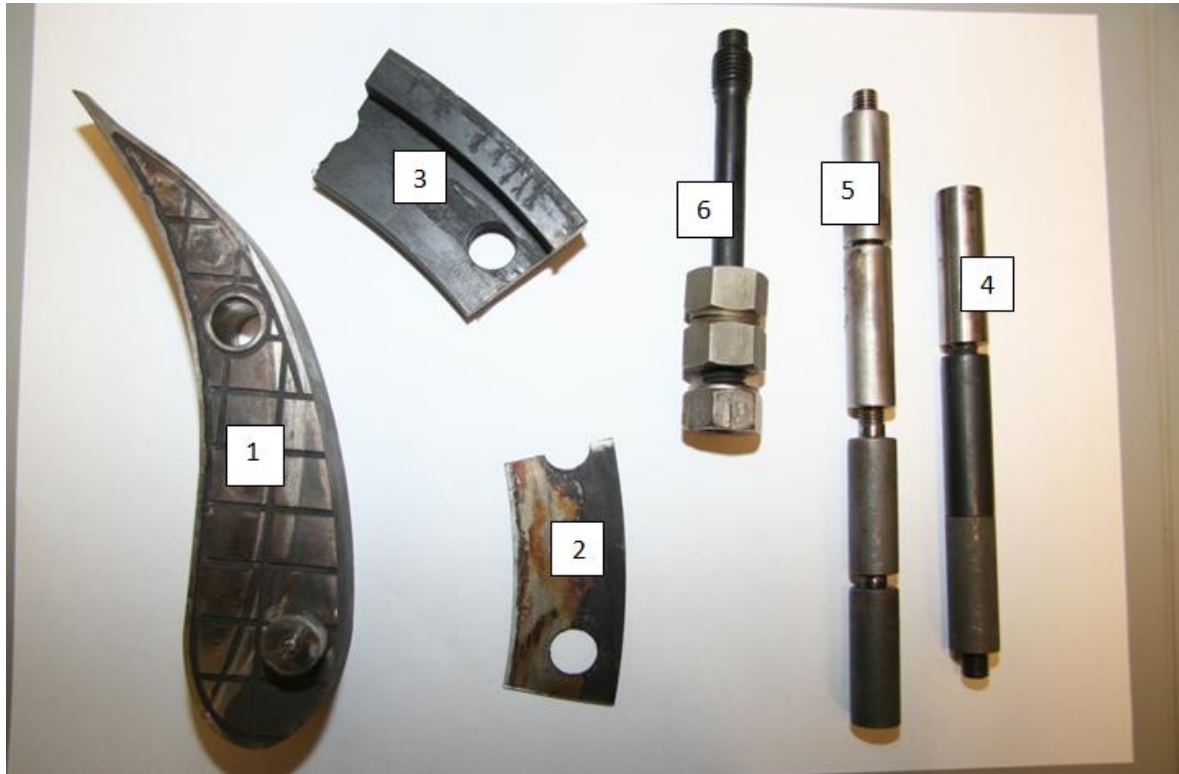
Figure 12. Samples taken from the Húsavík power plant on January 13th 2009.

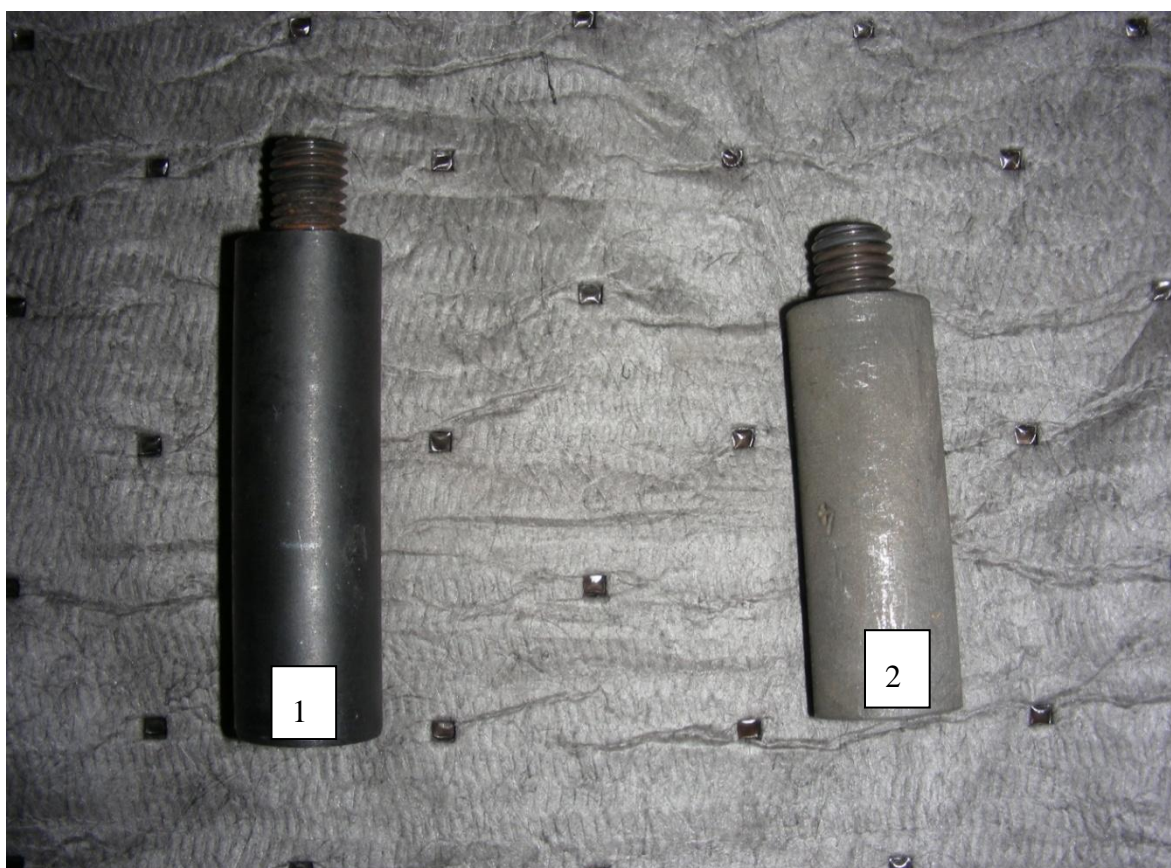
Sample 4 consists of two mild steel cylinders that were placed into the flow stream for several weeks as part of a materials test prior to the current thesis. As pictured in Figure 26, the cylinder on the left, labeled 1, was put in place between the separator and the turbine while cylinder 2, on the right, was placed in the turbine exhaust. Cylinder 1 has developed a hard dark shell of corrosion products typical of most of the piping in the plant while 2 has an uneven, soft, gray surface like the inside of the turbine and the first meters of the turbine exhaust.

Figure 26. Sample 4: 1 is a mild steel cylinder exposed to the conditions between the separator and the turbine, 2 is a cylinder made of the same material but exposed to the conditions of the turbine exhaust.

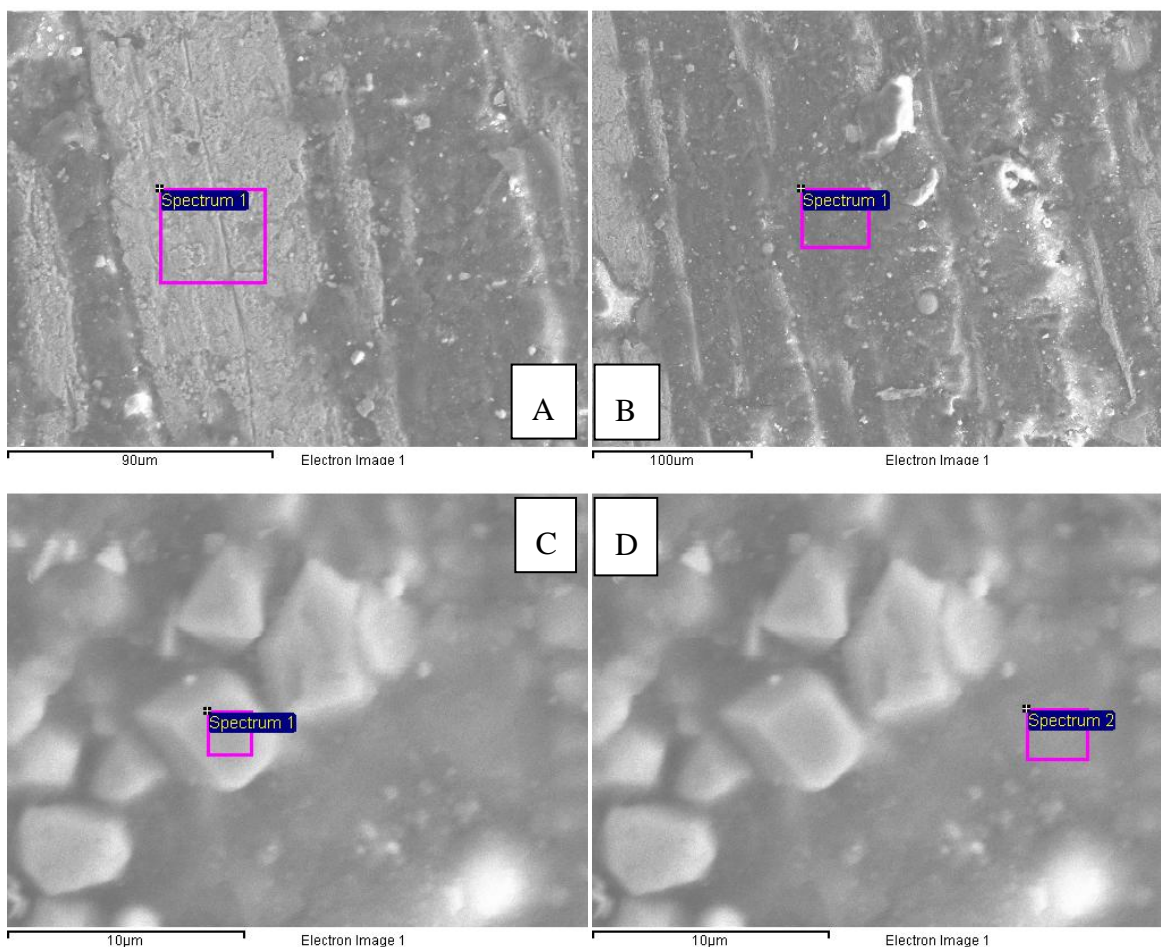
Figure 28. The four regions analyzed by X-ray EDS on sample 4, cylinder 1.

In micrographs C and D of Figure 28, crystals can be seen that are very similar to the crystals found on sample 2, area 1 (Figure 14). However the composition of crystals is somewhat different. The crystals found on sample 1 had a significant amount of chromium while the crystals on cylinder A had no chromium and a greater amount of manganese. In both cases however the crystals were mainly iron oxides.

One hypothesis to explain the carbon is that it is from the metal itself. Steels contain a small amount of carbon, present as cementite as well as interstitial defects and at grain boundaries. In this hypothesis the iron is oxidized to a corrosion product and flakes off, leaving the carbon behind. A possible shortcoming of the hypothesis is that it does not explain why the carbon is found where it is on the samples. If the carbon is from the steel and the iron has oxidized and been removed, the carbon might be expected to be high at metal surfaces and low in the corrosion products, which would be mostly iron oxides. Looking at sample 4, cylinder 1, in Figure 27 and Table 11, it can be seen that the highest concentration of carbon is in the corrosion products in the grooves (56 wt. %) while the metal bands have much lower carbon content (20 wt. %).

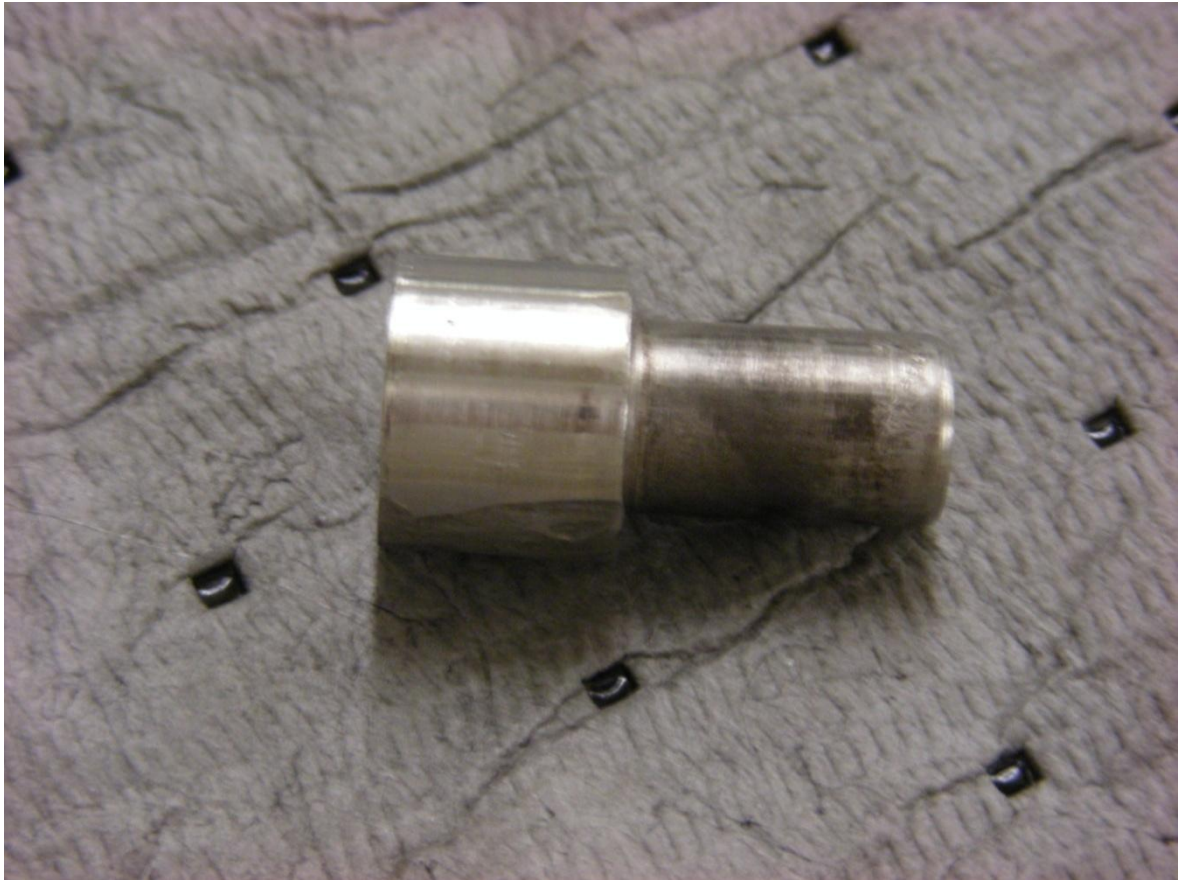
Figure 31. The pin from sample 1, the nozzle vane for the GE-Rotoflow turbine.

The duplex steel pin (Figure 31) is from sample 1, the nitronic 60 nozzle vane of the newer GE-Rotoflow turbine. Sample 1 was too big to put under the microscope but the pin gives an example of a material from the new turbine that did not have corrosion problems. A micrograph on the following page shows the surface of the pin and the region analyzed by X-ray EDS (Figure 32).
